**COMANDO DA AERONÁUTICA**  
**CENTRO DE INVESTIGAÇÃO E PREVENÇÃO DE**  
**ACIDENTES AERONÁUTICOS**

**FINAL REPORT**  
**A - 065/CENIPA/2019**

<b>OCCURRENCE:</b>	<b>ACCIDENT</b>
<b>AIRCRAFT:</b>	<b>PP-MMG</b>
<b>MODEL:</b>	<b>AS 350 B3</b>
<b>DATE:</b>	<b>24APR2019</b>

This is the Final Report of the 24APR2019 accident with the AS 350 B3 aircraft model, registration PP-MMG. The accident was classified as “[LOC-I] Loss of Control in Flight”.

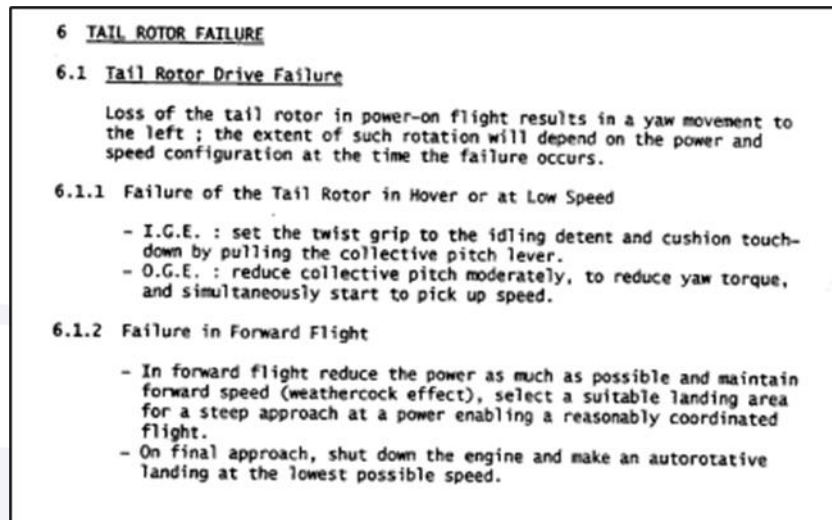
Figure 2 - Tail rotor failure. Source: Flight Manual AS 350 B3.

Item 6 Tail Rotor Failure, Section 3.1 - Emergency Procedures of the AS 350 B3 Flight Manual recorded that a failure of the tail rotor in powered flight would result in a yaw to the left and that the spin speed would depend on the power and the velocity at the time of the event (Figure 2).

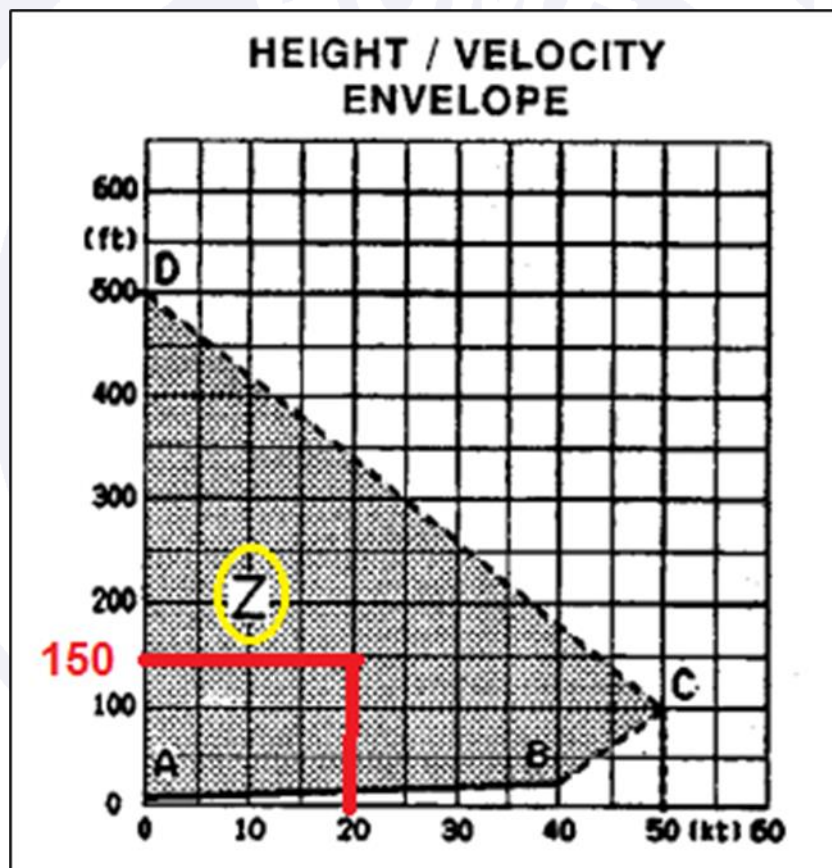
Figure 3 - Height/Speed Envelope. Source: Flight Manual of the AS 350 B3.

Item 4 Airspeed-Height Envelope, of Section 5 - Regulatory Performance Data of the AS 350 B3, established that conducting the flight in zone Z, delimited by points A, B, C, and D, should be avoided (Figure 3).

The graph in Figure 3, also known as the "Dead Man's Curve", refers to the relationship between speed and height at which, in the event of an engine failure, an autorotation flight would guarantee a safe landing, if the flight was being driven outside Zone Z.

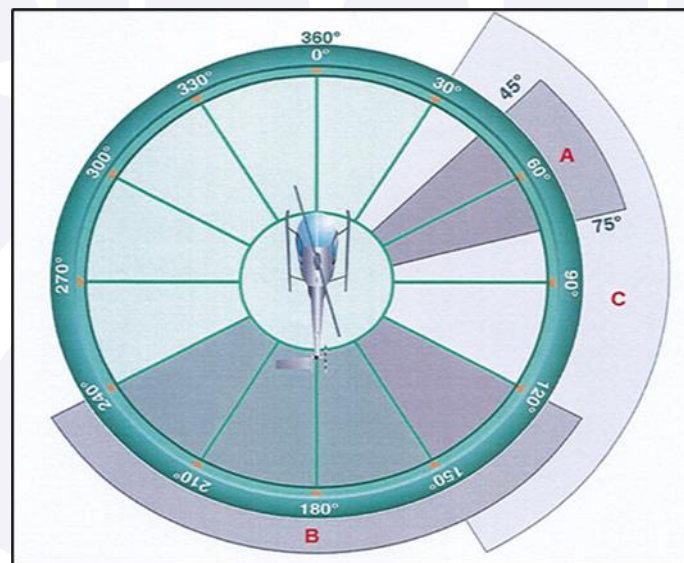
Figure 10 - LTE for helicopter with Clockwise Direction of the Main Rotor. Source: CENIPA, 2018 apud NTSB, 2017.

Relative winds of 45° to 75° (front right sector) at speeds of about 10 to 30 kt can induce vortices from the main rotor towards the tail rotor (Figure 10, letter "A"). As a result, the tail rotor can operate in an extremely turbulent environment, producing a reduction in thrust as it enters the main rotor disk vortex area.

Tailwinds of  $120^\circ$  to  $240^\circ$  typically cause an increase in pilot workload (Figure 10, letter "B"). Given the influence of relative wind on the fuselage and vertical drift, tailwinds act as an accelerator on the yaw rate, requiring corrective pedal action to counter the aircraft's tendency to align with the wind. A delay in this correction or controlling the desired yaw rate can initiate an accelerated turn on the vertical axis.

Region A: Main rotor disk vortex interference towards the tail rotor (relative wind between  $45^\circ$  to  $75^\circ$ );

Relative winds of  $30^\circ$  to  $150^\circ$  (right sector) can cause the tail rotor vortex ring state to develop (Figure 10, letter "C"). Since the tail rotor drives the airflow from left to right (aircraft overhead view), right sector crosswinds oppose this air mass movement imposed by the tail rotor. Thus, conditions can develop for the formation of the state of vortex rings, causing a non-uniform and unstable flow in the tail rotor, with consequent oscillation of the traction of this rotor and deviations in the yaw of the helicopter.

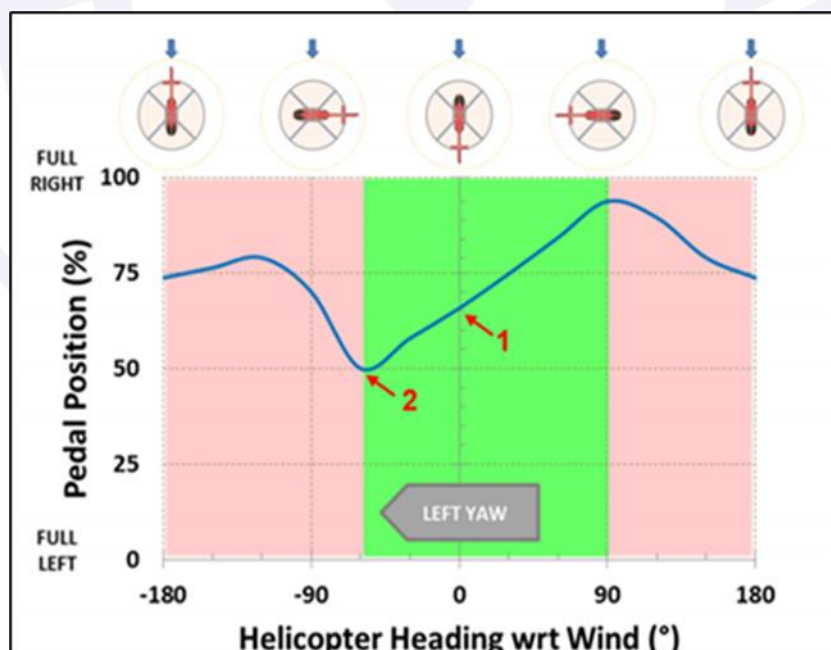
Figure 11 - Stabilized Pedal Position as a Function of Relative Wind. Source: Airbus Helicopters.

For the description of the phenomenon, a graph from the Safety Information Notice n° 3297-S-00 was used, which addresses the pedal position turn, as a function of the relative wind incidence direction of the helicopter, in a stabilized hovering condition. For each combination of weight, altitude, temperature, and wind speed there is a corresponding turn (Figure 11).

Concerning a helicopter with clockwise rotation of the main rotor, maintaining a hover with a relative wind of 0° (figure 11 in Figure 11, wind aligned with the helicopter's heading)

Furthermore, the green area in Figure 11 corresponds to the range of wind direction in which the helicopter is stable in yaw. In this range, if there is a gust of wind changing the helicopter's heading from  $0^\circ$  to  $-10^\circ$  without any pedal input (x-axis to the left with no y-axis variation), the pedal percentage will be at a position above the turn (helicopter heading North to heading  $350^\circ$ , which is equivalent to a helicopter heading  $-10^\circ$  in relation to the wind direction, maintaining the pedal position that existed with a relative wind heading of  $0^\circ$ ). In response (right pedal higher than necessary for this new position), the helicopter yaws to the right until it crosses the turn in a stabilized position for the selected pedal position, which happens at the initial  $0^\circ$  heading. Therefore, when moving away from the stabilized position, a return movement to this position is generated.

The red area in Figure 11 represents a region of yaw instability. When the helicopter is moved from its stabilized position, it moves further away from that initial position. This yaw instability in downwind regions is often recognized by helicopter pilots, generating an increase in the workload for yaw control, especially at low speeds, when vertical drift and the fuselage have little influence on heading maintenance.

The lower limit of the stable range (helicopter heading of about  $-60^\circ$  concerning the wind direction) is indicated as number 2 in Figure 11. From this point ( $-60^\circ$ ), the helicopter's relative heading decrease is linked to the yaw unstable region (left red area of the graph). At this inflection point (number 2 in Figure 11), when a left pedal is applied (from 50% pedal position to 45%), the pedal position is below the lowest point of the pedal turn. This means that a nose-to-left turn will occur, without, however, reaching a stabilized point of relative heading.
