COMANDO DA AERONÁUTICA <u>CENTRO DE INVESTIGAÇÃO E PREVENÇÃO DE</u> <u>ACIDENTES AERONÁUTICOS</u>

FINAL REPORT A - 165/CENIPA/2018

OCCURRENCE: AIRCRAFT: MODEL: DATE: ACCIDENT PP-MTX A109E 03NOV2018

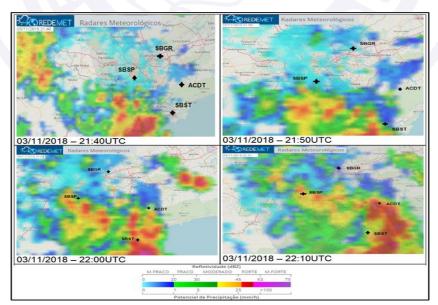
Figure 7 - Weather RADAR images. The accident site is marked "ACDT". Source: REDEMET

The meteorological information researched indicated, therefore, that the atmosphere in the region of the accident was unstable. This instability was characterized by the presence of thunderstorms with electrical discharge, precipitation, and strong wind.

The meteorological radars detected, between 2140 (UTC) and 2210 (UTC), a gradual increase in the intensity of precipitation in the region of the accident. The peak occurred in the image of the last hour, evidencing the degradation of weather conditions at the time of the accident, as shown in Figure 7.

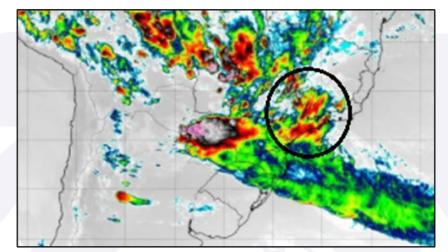
Figure 8 - Satellite image at 2211 (UTC), highlighting the accident region. Source: CPTEC/INPE.

The images from the GOES 16 satellite, channel 16, at 2211 (UTC), showed considerable instability over the Southern and Southeastern regions of Brazil. The red color indicated cloud tops with temperatures below -60°C, indicating high potential for Cumulonimbus (CB) clouds. The storm was associated with this type of cloud (Figure 8).

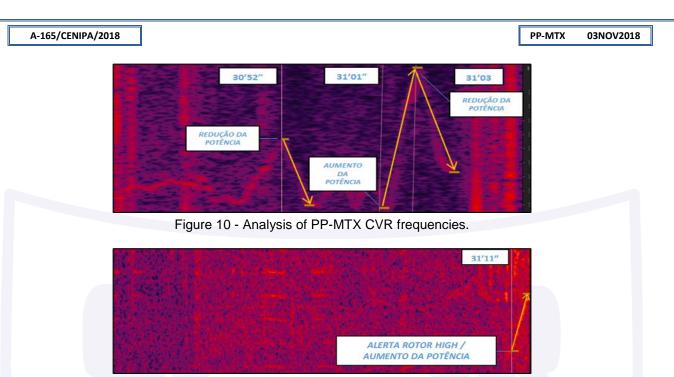
Figure 11 - Analysis of PP-MTX CVR frequencies.

Thus, based on the analysis of the CVR frequencies, it was possible to identify that, from the moment the pilot reduced speed and decoupled the NAV mode (NAV OUT), a series of variations in the engine power began, until the moment of the accident (Figures 9, 10 and 11).

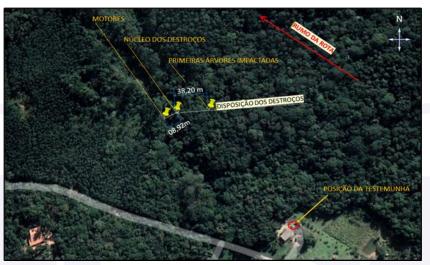
Figure 16 - Sketch of the wreckage layout. Source: adapted from Google Maps.

The wreckage was found dispersed in three large groups: cabin, engines, and tail cone section.

Figure 16 shows the sketch corresponding to the top view of the accident site, as well as the position of an observer of the occurrence.

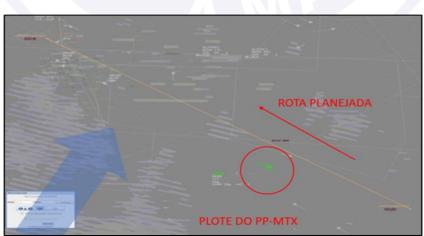
Figure 26 - Image of the SAGITARIO, highlighting the rapid advance of meteorological formations, characterized by gray lines.

- at 22:03:46, there was a shift of some meteorological formations from the West and South sectors of SBSP from Southwest to Northeast, on the South coast of São Paulo, between the cities of Santos and Itanhaém, and in the region of Mogi das Cruzes (Figure 26).

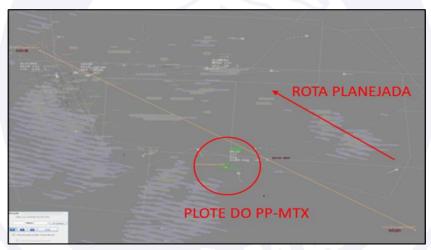
Figure 27- Image of the SAGITARIO, highlighting the presence of formations close to the last position of the PP-MTX.

Figure 27 shows the presence of formations, characterized by gray lines, plotted on the SAGITARIO system screen close to the last position of the PP-MTX.

The last position of the PP-MTX estimated by the SAGITARIO system was the point of geographic coordinates 23°42'25"S/046°13'02"W, about 0.6 NM from the accident site.

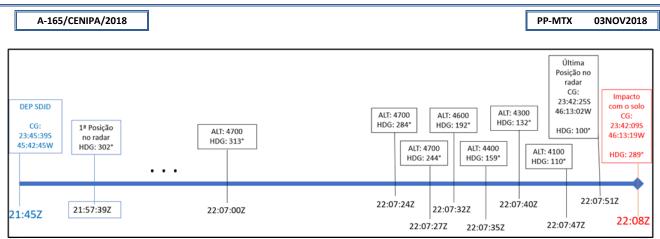
Figure 28 – STEP of the PP-MTX.

Despite a standard turn being performed with a variation of 3° per second (180° per minute), values above 6° per second (360° per minute) were verified, in other words, far above the recommended.

The graph in Figure 28 summarizes the movements of the aircraft, in the moments before the accident.
