COMANDO DA AERONÁUTICA
CENTRO DE INVESTIGAÇÃO E PREVENÇÃO DE
ACIDENTES AERONÁUTICOS

FINAL REPORT
A-133/CENIPA/2022

OCCURRENCE:	ACCIDENT
AIRCRAFT:	PP-OBL
MODEL:	AT-502A
DATE:	18NOV2022

This is the Final Report on the accident that occurred on November 18th, 2022, involving the AT-502A aircraft with registration marks PP-OBL. The occurrence was classified as “[LOC-I] Loss of control in flight and [LALT] Low altitude operation”.

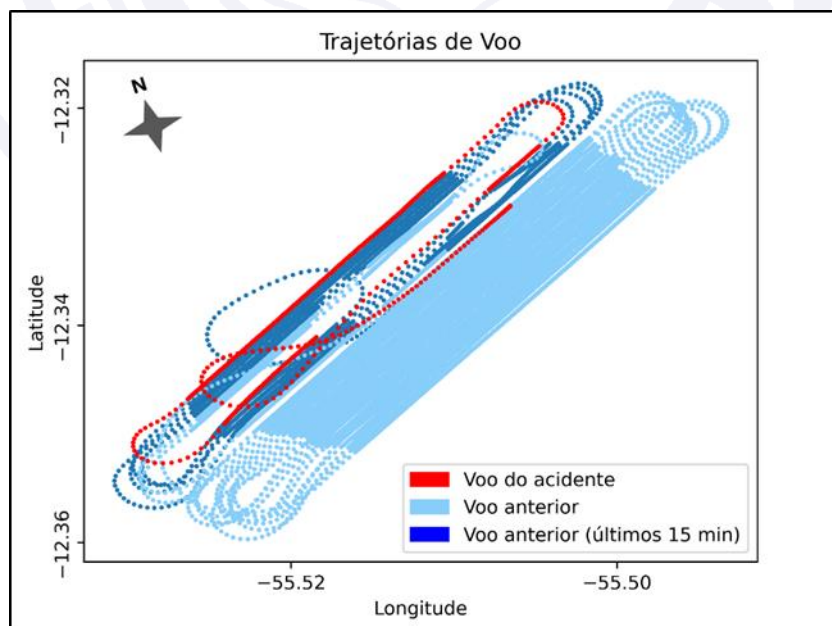
Figure 6 - Comparison of flight trajectories.

One found that the axes of the spraying runs were generally oriented on the 056° and 236° magnetic headings, with two reversal turns made in the northeastern and southwestern sectors of the application circuit, respectively.

The circuit flown by the aircraft had a counterclockwise rotation, that is, with turns made to the left. Analysis of the flight prior to the accident showed a similar flight pattern.

Figure 6 shows the trajectories of the previous flight in light blue, with the last 15 minutes highlighted in dark blue, and the trajectory of the accident flight in red.

The solid lines indicate the trajectory where a stage of spraying, commonly known as “run” was carried out. The visibly spaced dots indicate the locations where the aircraft’s agricultural product application system was off.
