FINAL REPORT IG-136/CENIPA/2013

OCCURRENCE:	SERIOUS INCIDENT
AIRCRAFT:	PP-PTU
MODEL:	ATR-72-212A
DATE:	26JUL2013

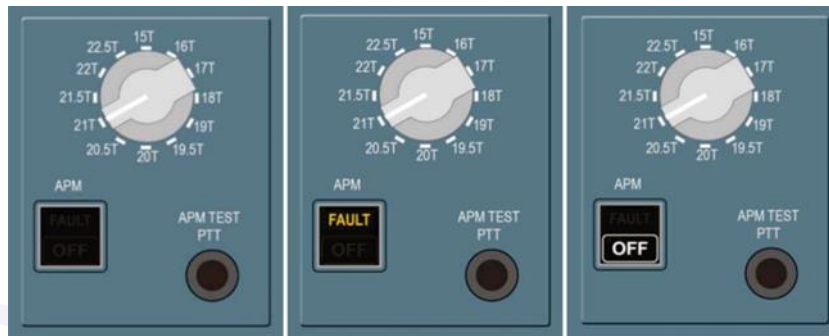
Figure 10 - ATR-72-212A APM Control Panel set to 21T under three conditions: Normal (ON), Fault (FAULT), and OFF indications (respectively).

The fact that the DFDR data indicate that the APM remained in OFF status contradicts the crew's claim that they did not observe any indication that the equipment was OFF, as this indication would appear on the APM panel (Figure 10). Similarly, six other flight captains in which the APM was OFF stated that the equipment was "set" according to the checklist, that it remained ON and that there was no indication that it was OFF or in FAULT.

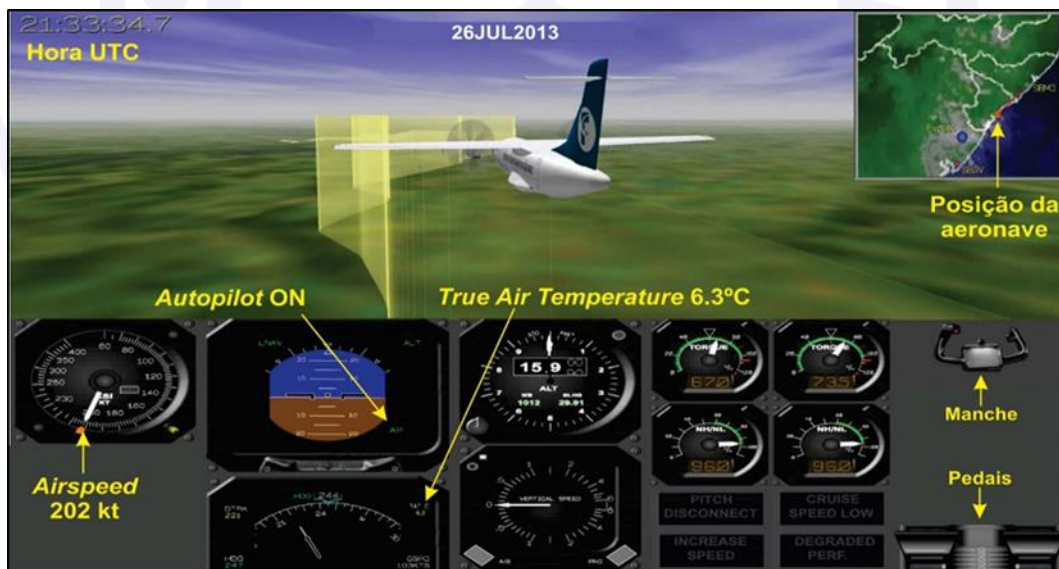
At 21h33min (UTC), the aircraft flew leveled on the FL160 with Autopilot, coupled, 202 kt IAS and 6.3°C TAT. The torque developed in the engines corresponded to 67% on the left engine and 73.5% on the right engine. Propeller speed was stable at 82%, high-pressure spool rotation speed was stable with 96% NH (Figure 14).

Figure 14 - Flight parameters of the PP-PTU aircraft at 21h33min34s (UTC).
