COMANDO DA AERONÁUTICA
CENTRO DE INVESTIGAÇÃO E PREVENÇÃO DE
ACIDENTES AERONÁUTICOS

FINAL REPORT
A-128/CENIPA/2018

OCCURRENCE:	ACCIDENT
AIRCRAFT:	PP-SZN
MODEL:	C90GTI
DATE:	29JUL2018

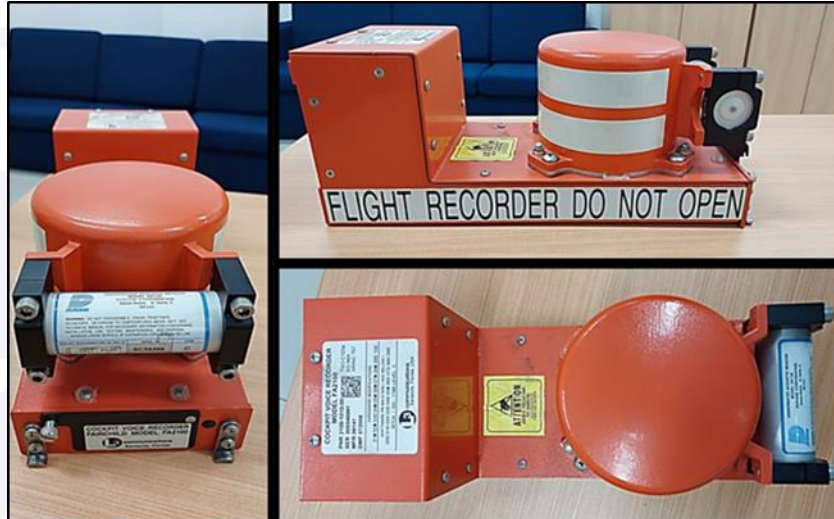
Figure 19 - Image of the CVR of the PP-SZN airplane.

The equipment operated normally and contained data related to the occurrence flight. The information found also allowed for a spectral analysis of engine noise and identification of the alarms emitted by the aircraft.

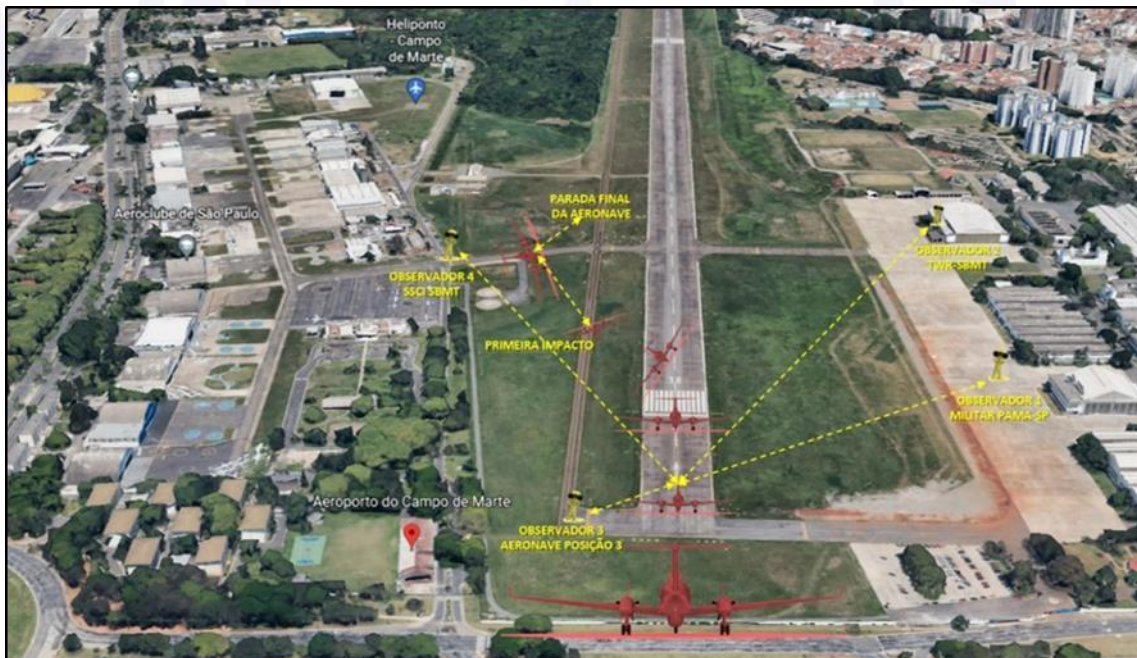
Figure 21 - Sketch from the final approach to the threshold of runway 30 SBMT and the positions of the observers.

Several witnesses positioned in different spots (Figure 21) observed the final approach, the crossing of threshold 30, and the first impact.

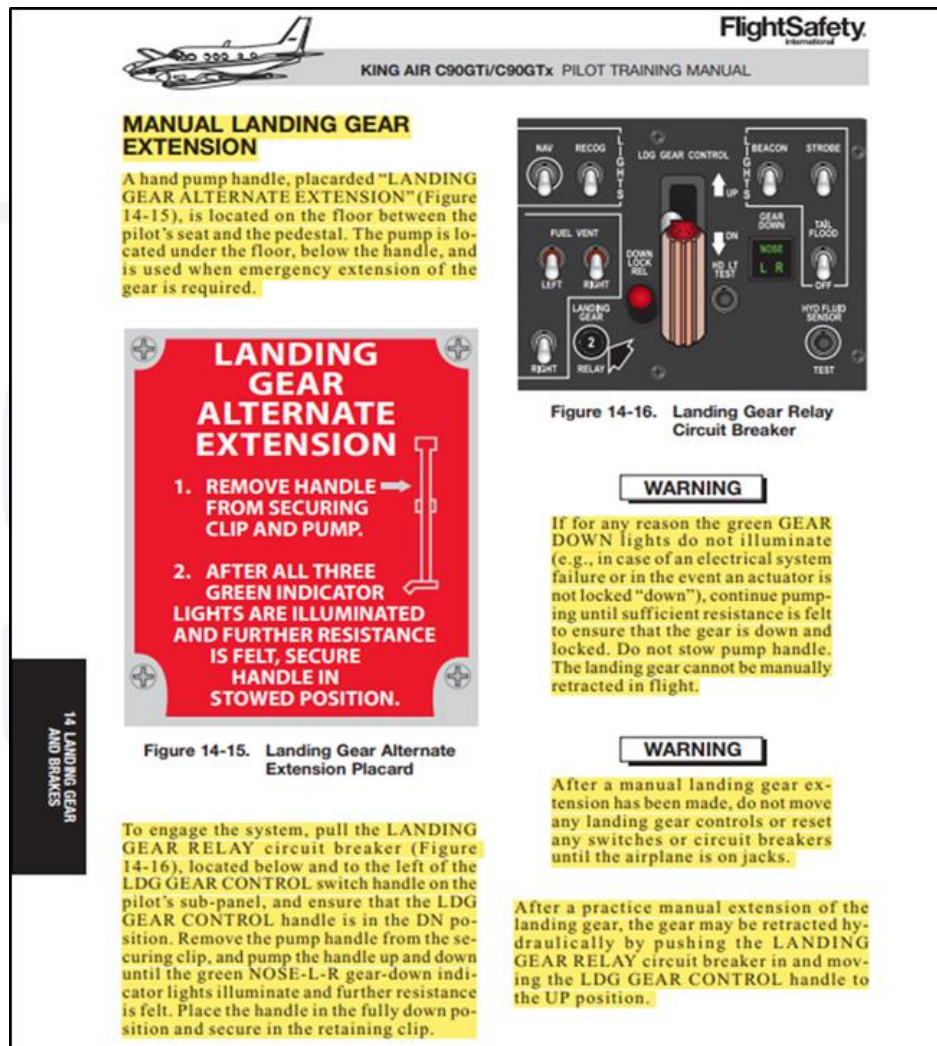
Figure 28 - Copy of a page the manual found by the Investigation Committee on the left side of the cockpit.

During the analysis of the airplane, the Investigation Committee found the copy of a page of the Pilot Training Manual (Manual Land Gear Extension procedure) in the cockpit.

The original aircraft manual and checklists were also located; however, it was not possible to determine which checklist/manual the PIC used by during the emergency, since they were together with various items found on the floor of the aircraft.

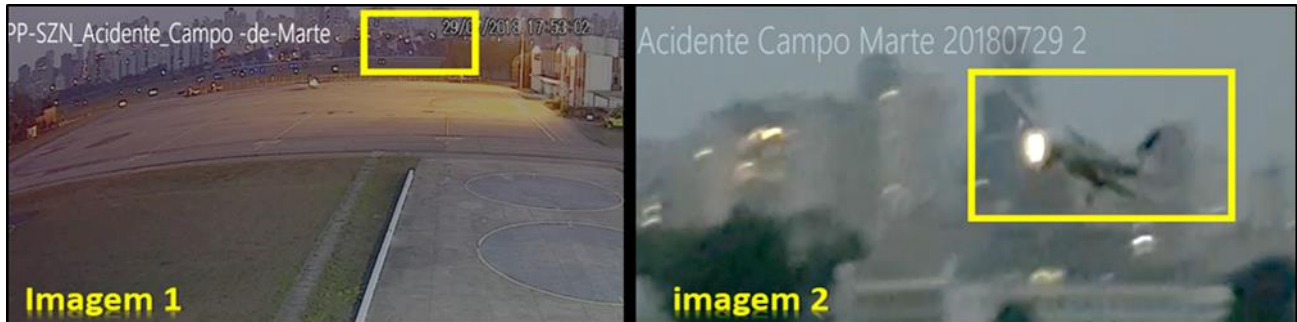
Figure 30 - Images of the airplane in flight without evidence of fire before the impact with the ground.

There was no evidence of fire in flight. Images provided to the Investigation Committee captured the moment of final approach and impact, confirming the absence of fire in flight (Figure 30).

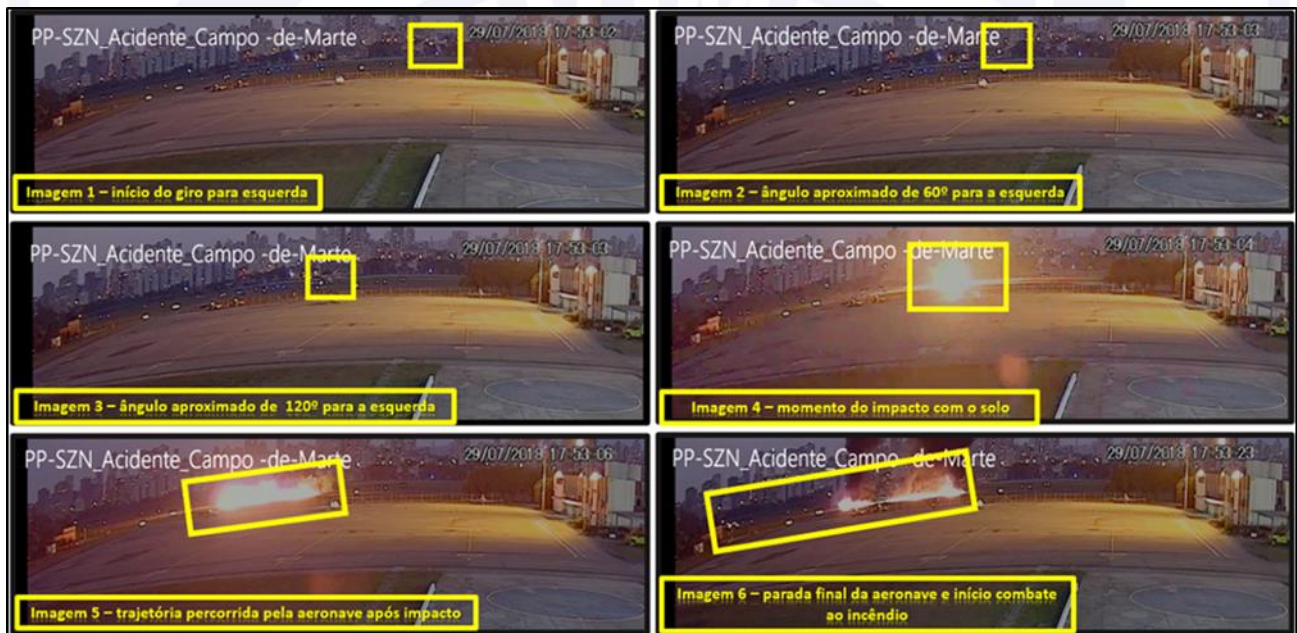
Figure 31 - Dynamics of the impact and the onset of fire.

The fire started after the airplane impacted the ground, and followed the trajectory of the aircraft, spreading to the wings, fuselage, and engines.

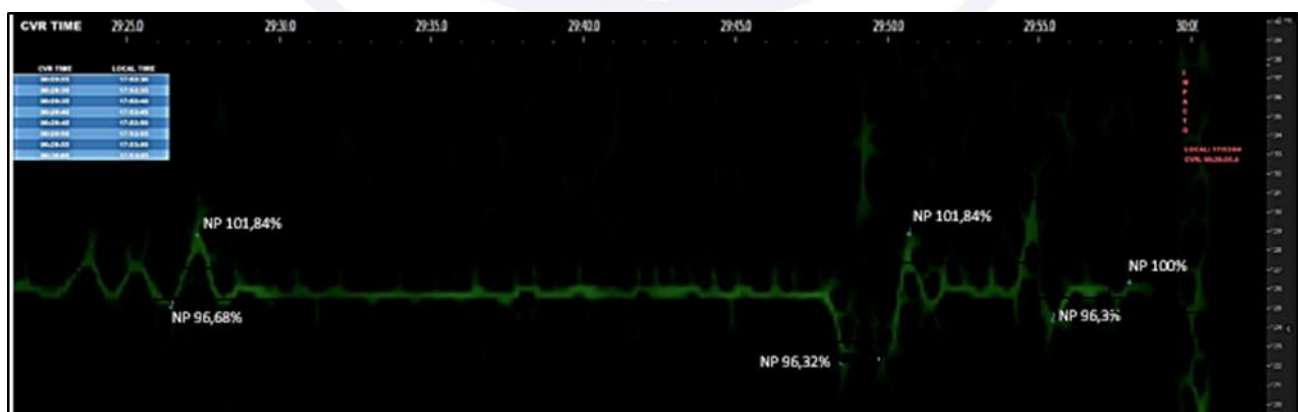
Figure 32 - Variation of the propeller rotational frequencies indicated in the spectrum.

In the sound signatures of the propellers, one was able to observe that the rotational frequencies of both propellers coincided throughout the flight, with a slight variation noted at the end of the recording period. Figure 32 shows only one line for the NP of both engines, indicating that there was no difference between them; if there had been any difference, two lines would have been displayed.

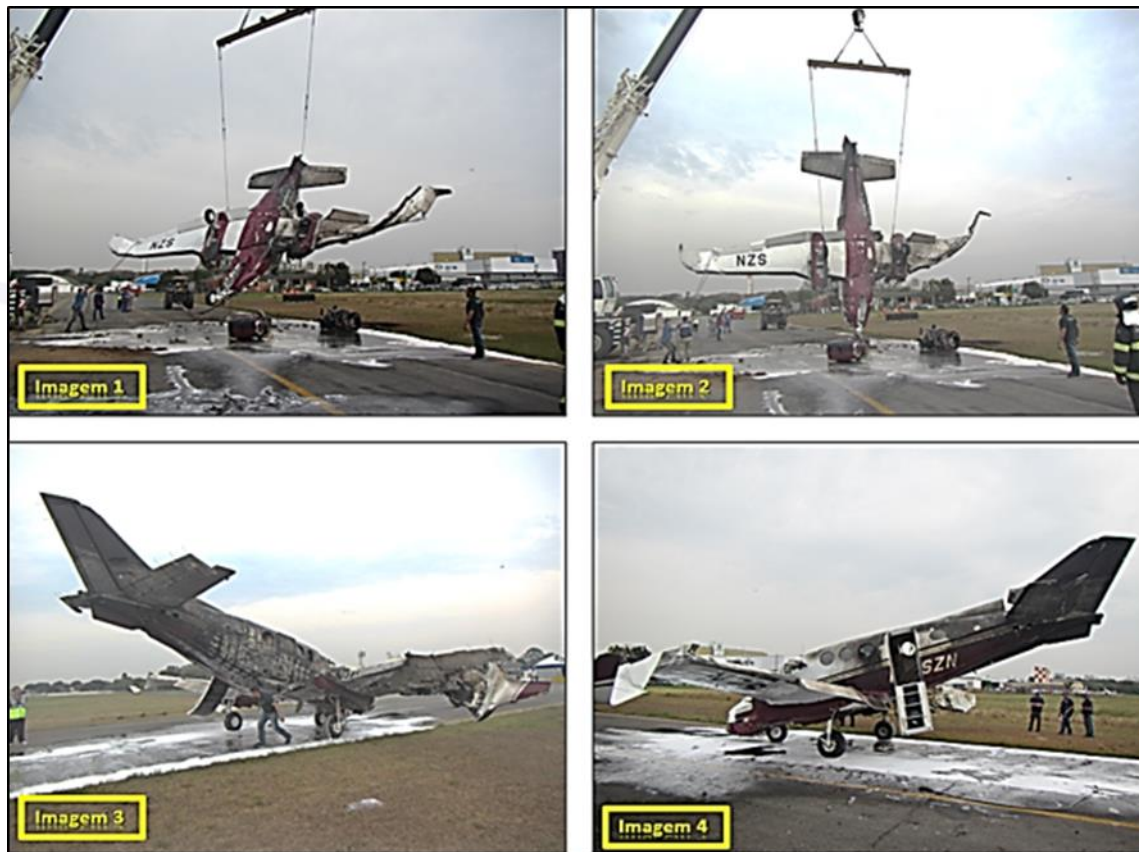
Figure 37 - Aircraft repositioning process.

When the airplane returned to its normal position, it was possible to note that the main landing gear assembly, which was down and locked, supported the weight of the aircraft.

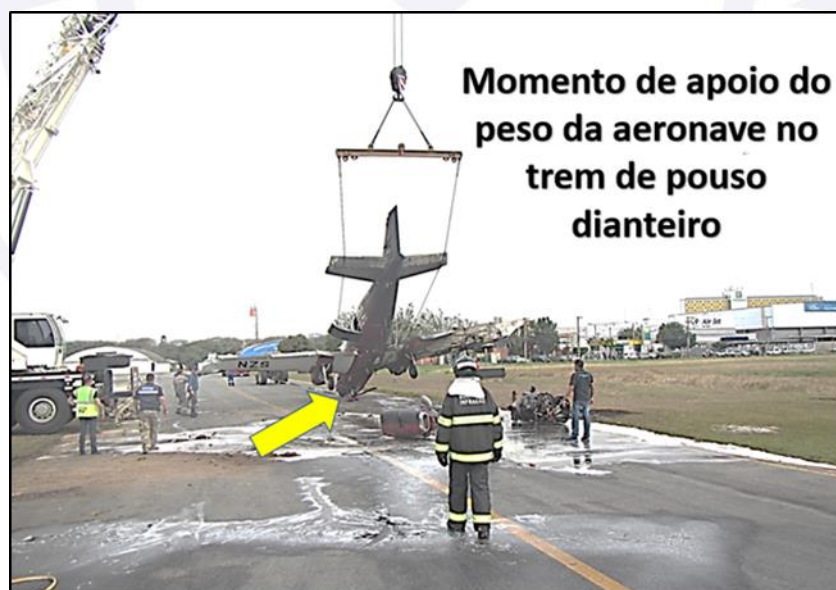
Figure 38 - Moment at which the nose landing gear returned to its housing.

The nose landing gear partially retracted into its housing compartment after receiving the weight of the airplane during the process of repositioning the aircraft in normal configuration with the landing gear down. (Figure 38).

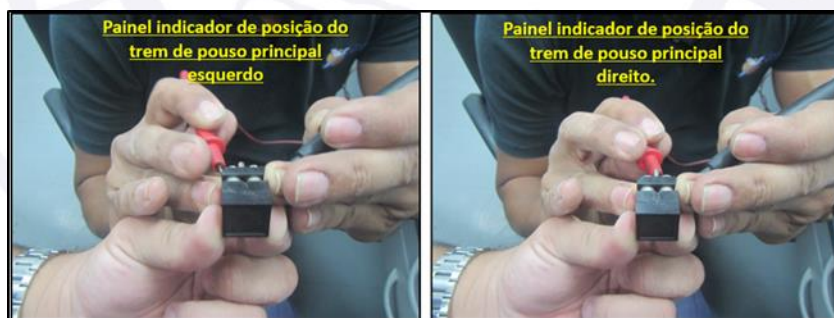
Figure 40 - Bench test of the main landing gear position indicator lamps.

The left and right main landing gear position indicator lights were not functional during the bench test.

The respective lights were sent for laboratory testing, and showed fracture characteristics typical of breakage when the lights are off (Figure 41).

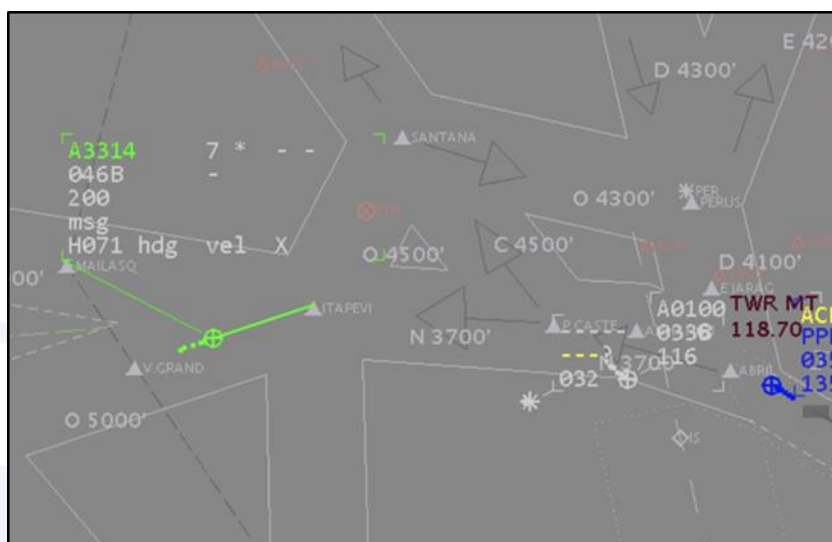
Figure 43 - Data from PP-SZN in the TMA-SP 2 at 20:26 UTC.

Highlighted in green, the transponder's Alpha mode with code 3314 activated, and just below, the altitude from the Charlie mode, indicating 4,600 ft. Next, the radar-calculated ground speed of around 200 kt., and the heading of 071° (Figure 43).

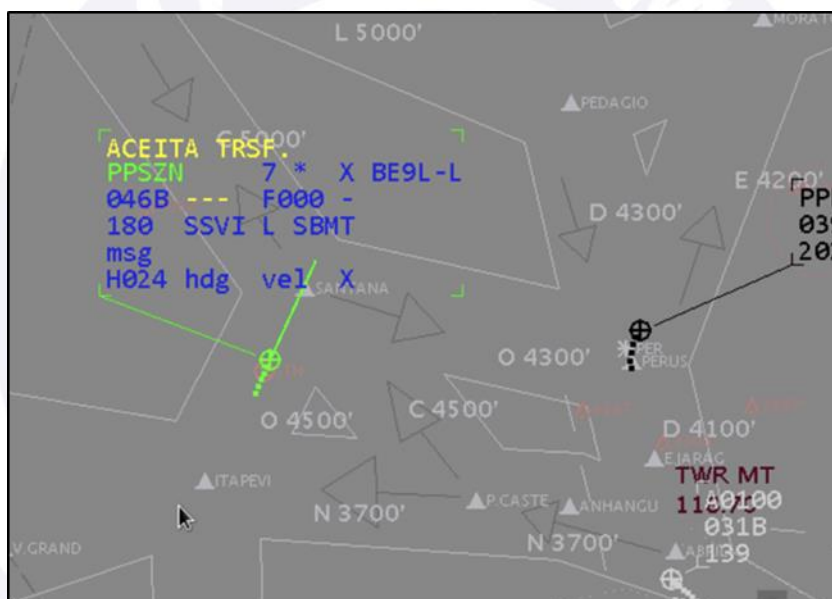
Figure 44 - PP-SZN data in the TMA-SP 2 at 20:29 UTC, with the airplane's radar track correlated.

At 20:29 UTC, the aircraft appeared on the radar screen with its track already correlated with the assigned transponder code, remaining in the REA near *Santana* position, in the municipality of *Santana de Parnaíba*, State of *São Paulo*. The data block indicated an altitude of 4,600 ft., with a radar-calculated ground speed of around 180 kt., and a course of 024° (Figure 44).

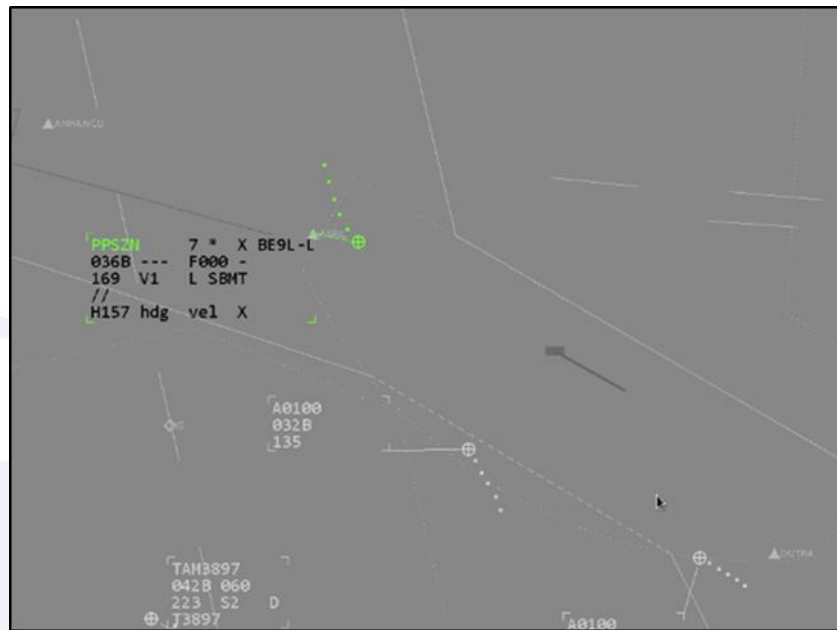
Figure 45 - PP-SZN data in the ATZ-MT at 20:34 UTC.

At 20:34 UTC, the airplane entered the Traffic Zone of SBMT (ATZ-MT) after passing vertically over *ABRIL* position, indicating an altitude of 3,600 ft., a ground speed of around 169 kt., and a course of 157° (Figure 45).

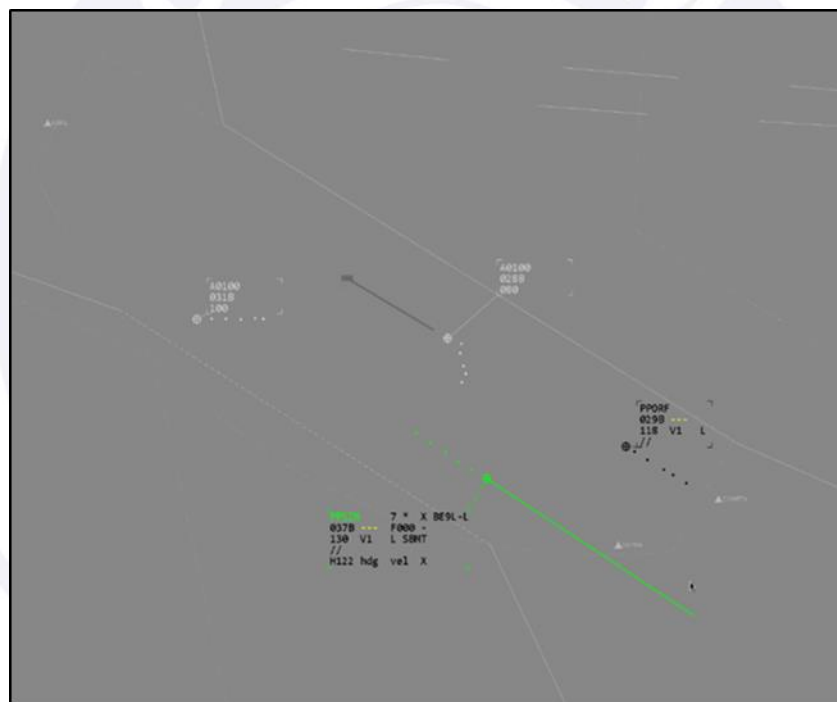
Figure 46 - PP-SZN data on the downwind leg of SBMT at 20:36 UTC.

At 20:36 UTC, the radar image showed PP-SZN on the downwind leg for runway 30 of SBMT for the first approach, indicating an altitude of 3,700 ft., a ground speed of around 130 kt., and a course of 122° (Figure 46).

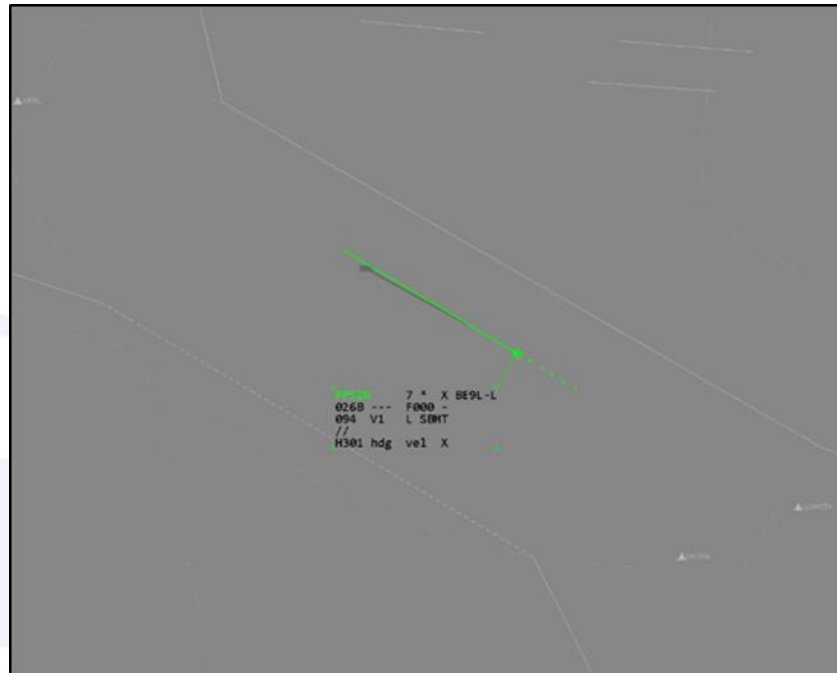
Figure 47 - PP-SZN data on the short final of SBMT at 20:38 UTC.

At 20:38 UTC, the radar image showed the airplane on the short final for runway 30 of SBMT, at a speed of 94 kt., an altitude of 2,600 ft., and a course of 301° (Figure 47).

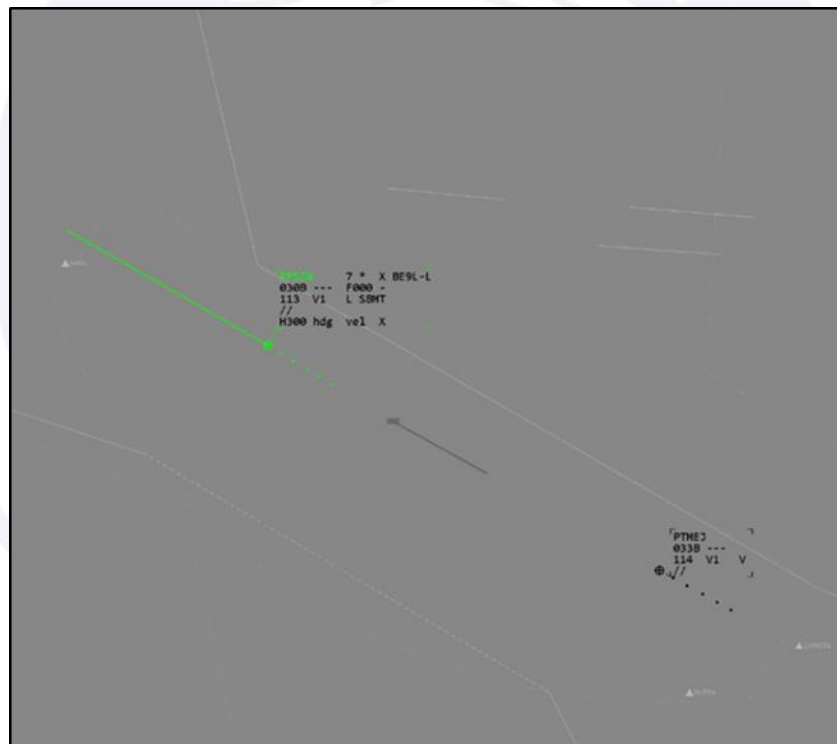
Figure 48 - Radar image of the PP-SZN airplane on its first go-around at SBMT.

At 20:40 UTC, the radar showed the airplane executing its first go-around procedure from the runway 30 of SBMT (Figure 48).

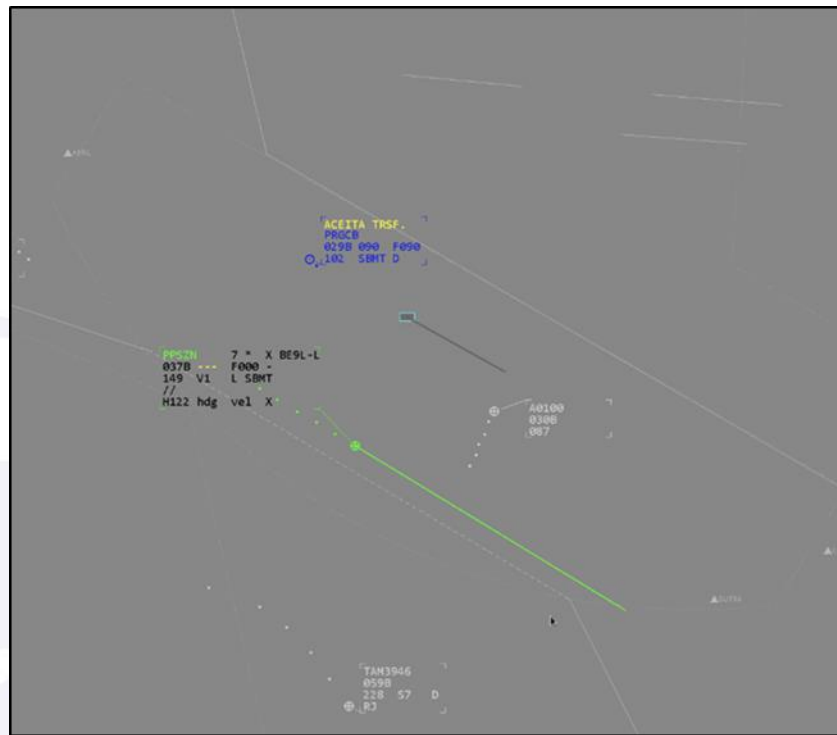
Figure 49 - Radar image of the PP-SZN airplane joining the downwind leg at 20:43 UTC.

At 20:43 UTC, the radar captured the image of the PP-SZN airplane entering the downwind leg for runway 30 of SBMT for the second time (Figure 49).

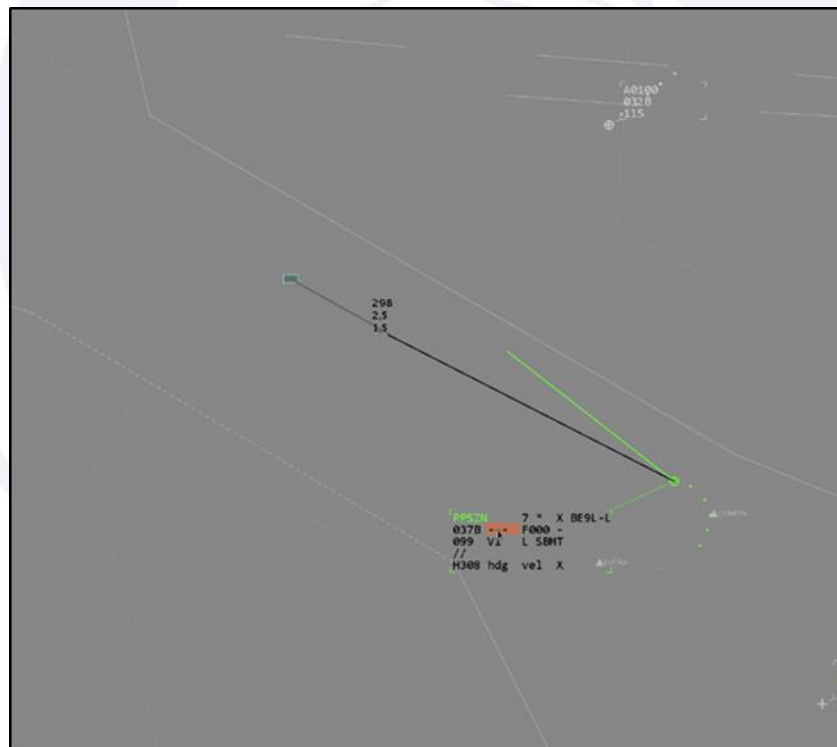
Figure 50 - Radar image of the PP-SZN airplane recorded at 20:45 UTC, showing the aircraft entering the final approach for the second time.

At 20:45 UTC, the radar image showed the PP-SZN entering the final approach for runway 30 of SBMT for the second time, at a speed of 99 kt. (Figure 50).

At 20:45:02 UTC, PP-SZN informed TWR-MT that it would perform a low pass over the runway because the left landing gear lock confirmation light had not illuminated, requesting the ATC controller to observe the condition of the gear assembly. The radar images confirmed the low pass of the airplane over the runway.

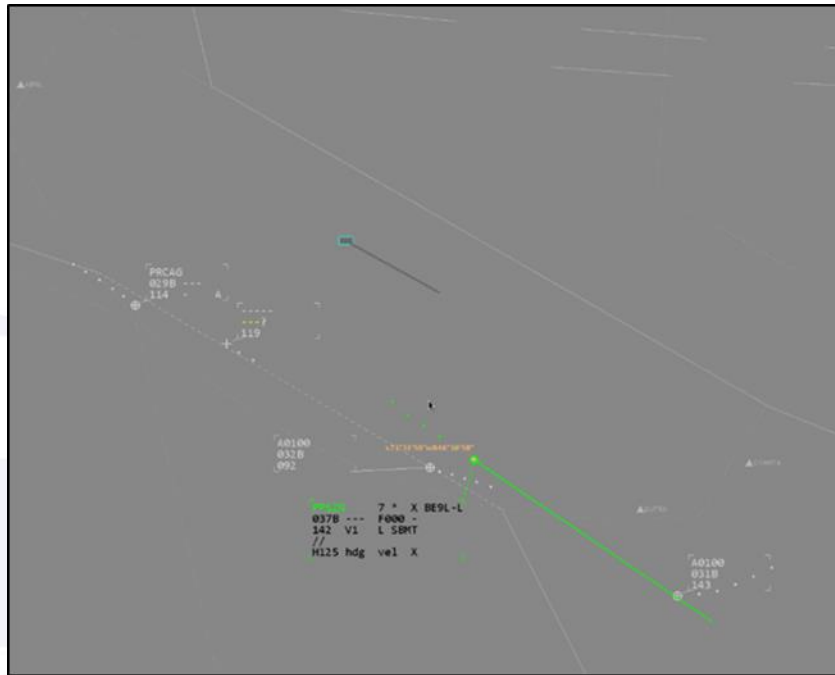
Figure 51 – Radar image of the PP-SZN airplane on the downwind leg for the third time.

At 20:48 UTC, the radar showed the PP-SZN airplane on the downwind leg for runway 30 of SBMT for the third time (Figure 51).

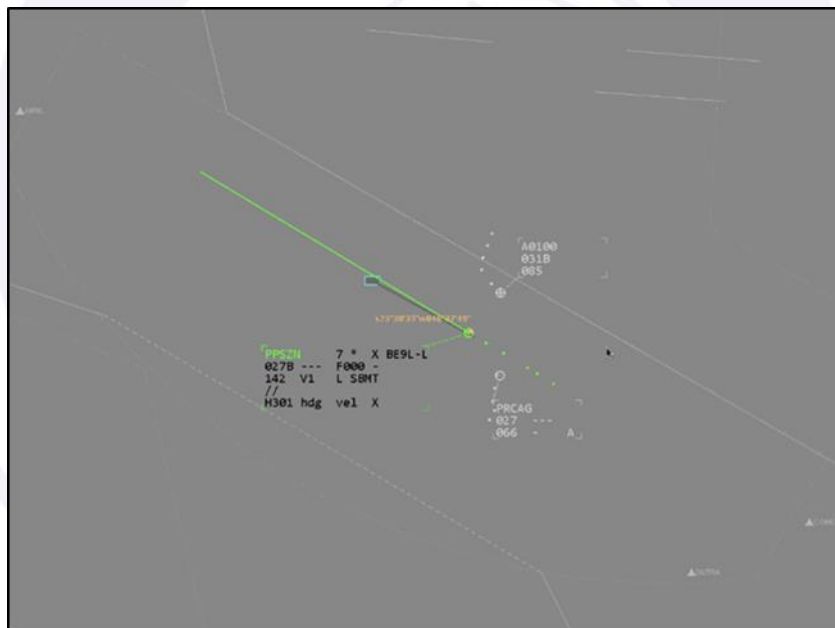
Figure 52 – radar image of PP-SZN on the final leg of SBMT at a speed of 142 kt.

At 20:50 UTC, the radar image showed the PP-SZN airplane on the short final for runway 30 of SBMT at a speed of 142 kt. due to the touch-and-go maneuver that the PIC informed ATC that he would execute (Figure 52).

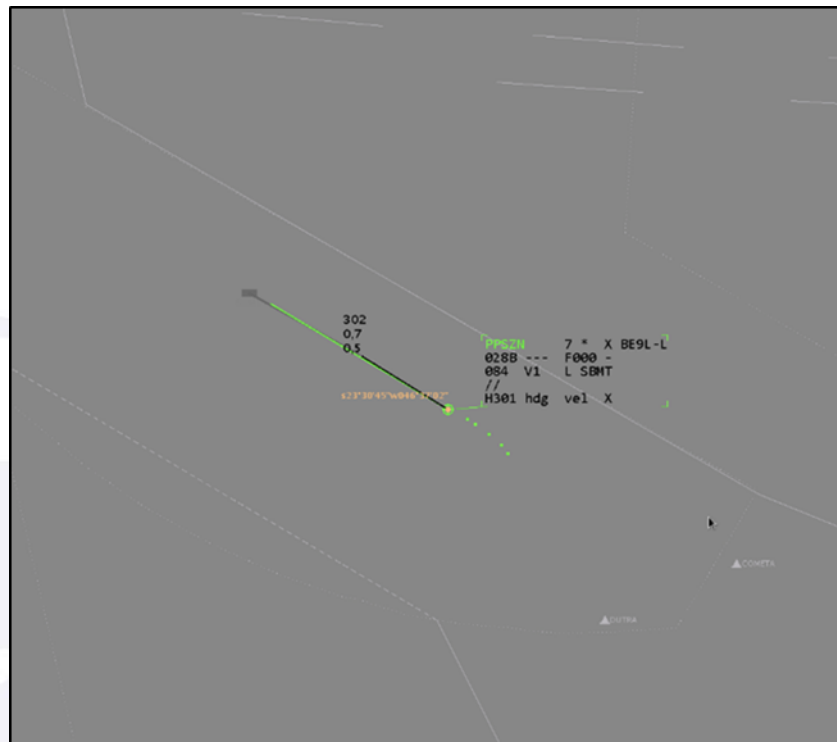
Figure 53 – Radar image showing the PP-SZN airplane on the final approach to SBMT at a speed of 84 kt.

At 21:00:13 UTC, the aircraft performed a new traffic pattern as in the previous situations, and the radar image showed the PP-SZN airplane on the short final for runway 30 of SBMT at a speed of 84 kt. (Figure 53).

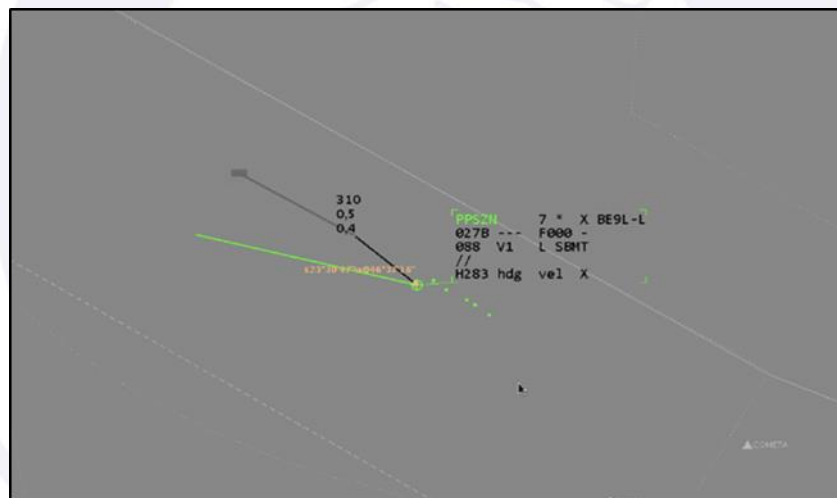
Figure 54 – Radar image showing a deviation to the left of the runway axis.

At 21:00:21 UTC, the radar image shows a deviation to the left of the approach axis at a distance of approximately 0.5 NM to the threshold 30 of SBMT (Figure 54)

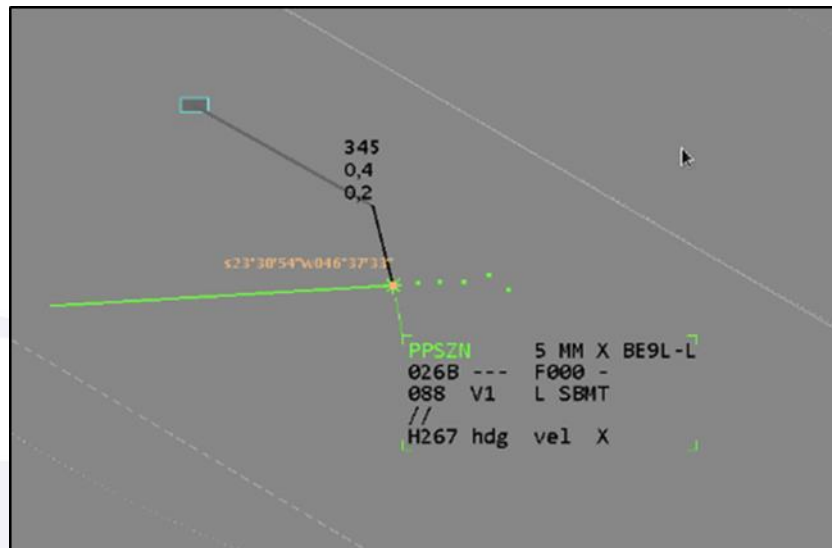
Figure 55 - Image of the last presentation with the airplane's radar track.

At 21:00:33 UTC, the radar shows the last image of the correlated radar track of the PP-SZN airplane, with the aircraft at a distance of 0.4 NM to the threshold of runway 30 of SBMT, slightly to the left of the approach axis at a speed of 88 kt. (Figure 55).

- s) on the fourth traffic pattern, after crossing the runway threshold, the aircraft rolled to the left around its longitudinal axis and crashed into the ground;
- t) the aircraft suffered substantial damage; and
- u) the PIC received fatal injuries, two of the passengers suffered serious injuries, and the other four were slightly injured.

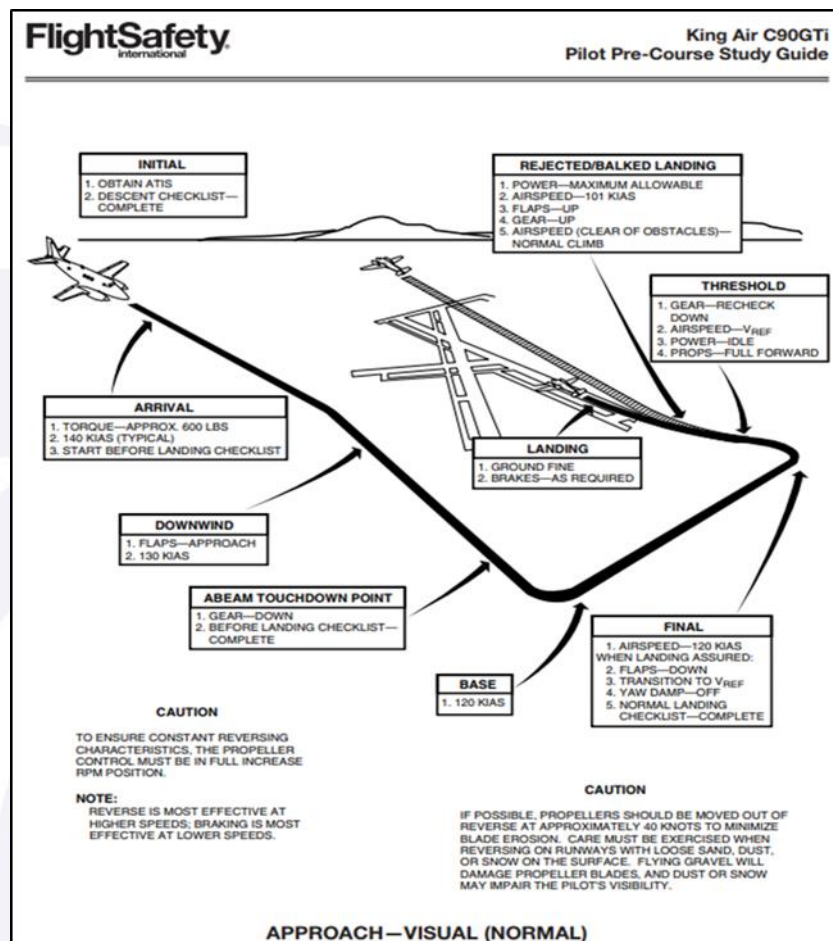
Figure 56 - Approach profile and configurations in a visual flight circuit.

Page 26 of the manual provided to the Investigation Committee outlined the approach profile to be followed by the aircraft under normal operating conditions and in visual approach conditions.

The pre-landing checklist was read only during the first approach. On subsequent approaches, it was observed that the PIC was primarily focused on communications with the controller, air traffic, and the on condition of the landing gear.
