FINAL REPORT
A-028/CENIPA/2022

OCCURRENCE:	ACCIDENT
AIRCRAFT:	PP-XDB
MODEL:	---
DATE:	27FEV2022

This is the Final Report of the 27 February 2022 accident involving the aircraft of registration marks PP-XDB. The accident was typified as “[SCF-PP] Engine failure or malfunction and [LOC-I] Loss of control in flight”.

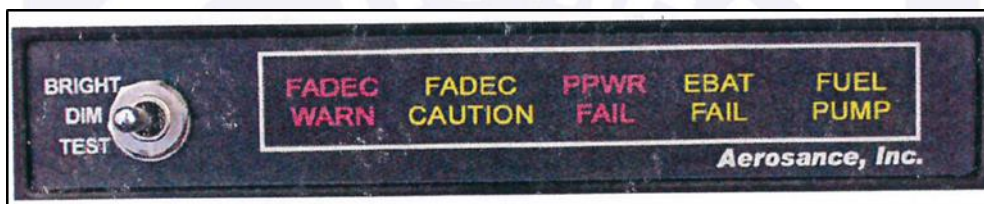
Figure 6 - HSA warning and alarm panel, extracted from the AFM.

The aircraft had a specific panel for warnings and alarms, known as Health Status Annunciator (HSA), which allowed to identify, by means of lights, the systems managed by FADEC that could be malfunctioning (Figure 6).

- FADEC WARN light - would illuminate if more than one cylinder was failing. This light would also be preceded and/or accompanied by the illumination of the FADEC CAUTION light. On page 3-18, section 3 of the AFM, there was information that this light would indicate a potential threat of total or partial loss of engine power;

- FADEC CAUTION light - would illuminate if the temperature and pressure sensors were defective; if the temperature and pressure were abnormal or above the limit; and, also, if there was a misfire in any cylinder, or if one of the cylinders was not able to burn the mixture because the ignition key was in the OFF position or out of position "BOTH";

- PPWR FAIL light – would illuminate to indicate that the FADEC was consuming energy from the secondary battery, should the main battery have its supply interrupted;

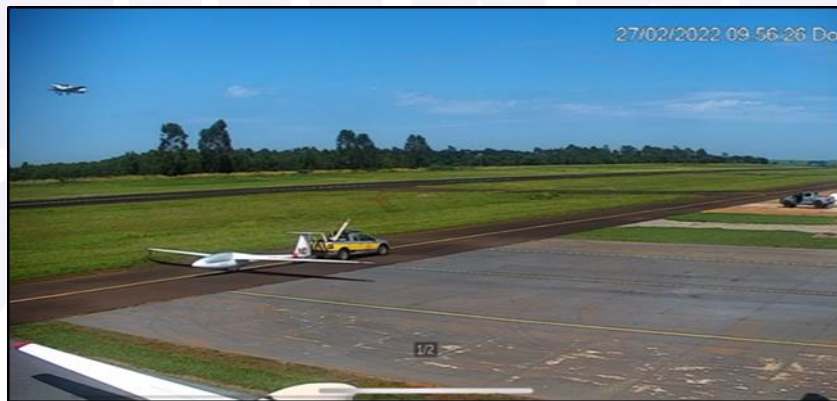
Figure 7 – Video frame of the surveillance camera of Aerodrome of Bebedouro during the takeoff of the PP-XDB.

Images recorded by a surveillance camera of *Aeroclube de Bebedouro* confirmed that the visibility, at the time of takeoff, was consistent with VFR flights. There were few clouds, and the wind had an intensity between 5 and 7 kt., with a direction close to 130° (Figure 7).

Taking into account the Area Meteorological Forecasts, the video recording of the takeoff, and the testimony of observers on site, one verified that the weather conditions were above the minima for the flight, with visibility of more than 10 km and few clouds.

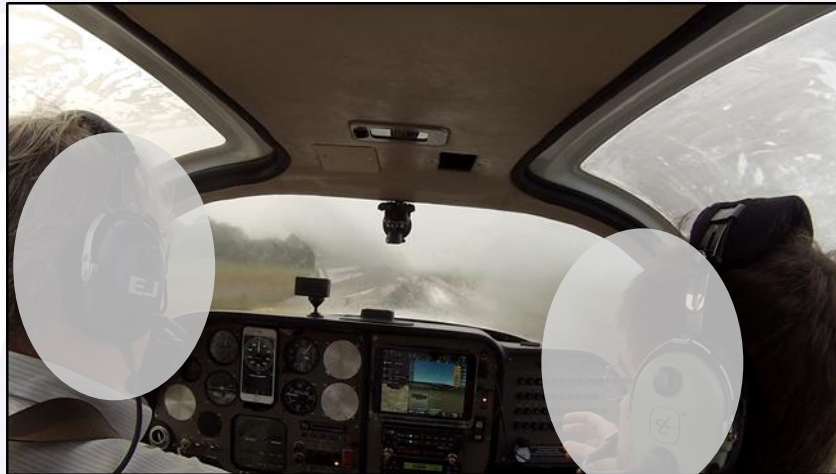
Figure 11 – Video frame of the moment the PIC was giving the briefing for the takeoff from SDNI.

As can be seen from the images obtained by the camera positioned in the back of the cabin (Figure 11), the weather in SDNI was below the VFR minimums, a situation that was also included in the briefing given to the passenger, when the PIC mentioned his expectation to reach VMC during the climb.

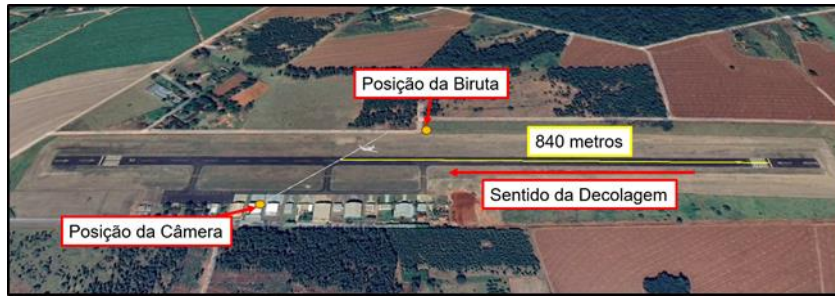
Figure 19 - Estimated distance traveled by the aircraft as per the antecedent Figure 18 (adapted from Google Earth).

As for the takeoff from SDBB, images from a camera installed at the *Aeroclube de Bebedouro* made it possible to observe that, at approximately halfway down the runway, the PP-XDB was off the ground but had not yet reached the height of the neighboring trees, which were approximately 10 m tall. (Figures 18 and 19).

The images collected allowed one to observe just part of the takeoff. It was possible to notice that the aircraft maintained a low rate of climb after rotating. External observers, who also watched this video, described that the aircraft gained little or no height at all after passing over the left lateral limit of the image captured by the camera (Figure 20).
