**FINAL REPORT**  
**IG - 048/CENIPA/2017**

<b>OCCURRENCE:</b>	<b>SERIOUS INCIDENT</b>
<b>AIRCRAFT:</b>	<b>PP-PTQ</b>
<b>MODEL:</b>	<b>ATR-72-212A</b>
<b>DATE:</b>	<b>23MAR2017</b>

This is the Final Report of the 23MAR2017 serious incident with the ATR-72-212A aircraft model, registration PP-PTQ. The accident was classified as “[SCF-NP] System/Component Failure or Malfunction Non-Powerplant – With Flight Commands”.

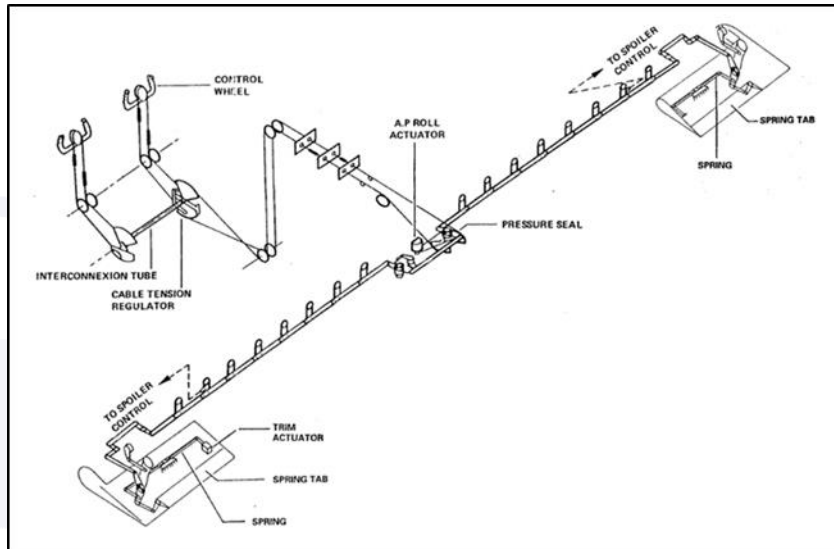
Figure 3 - Schematic of the ailerons control system.

Figure 3 shows the location of the Servo Drive in the aileron control system. In it, the component is identified as A. P. ROLL ACTUATOR.

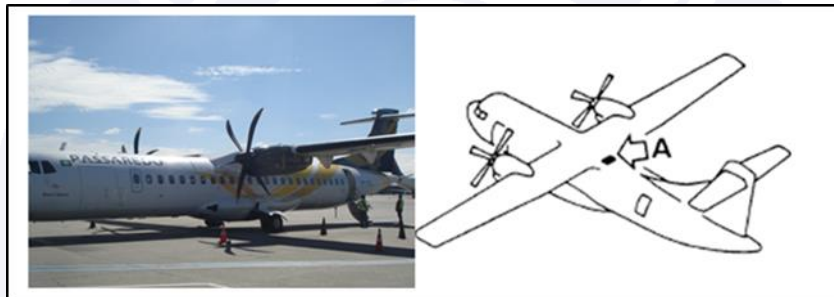
Figure 4 - General view of the aircraft and location of the Servo Drive.

Figure 4 shows the location of the Servo Drive on the aircraft (A).

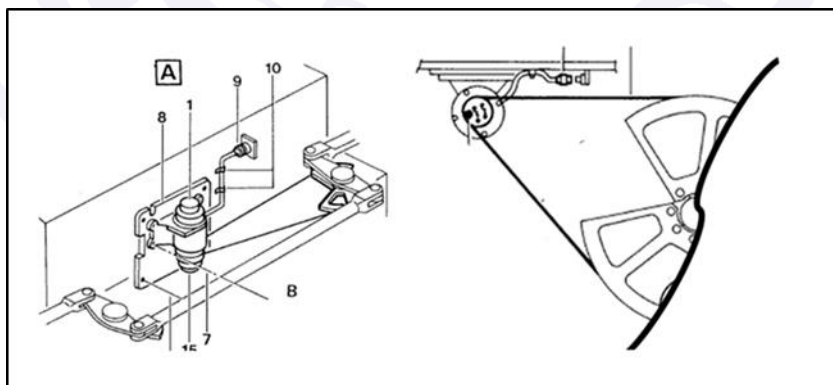
Figure 5 - Servo Drive (item 1) connected to the bellcrank using PN S2211001100000 control cables.

Figure 5 shows the Servo Drive (item 1) connected to the bellcrank, using the PN S2211001100000 control cables.

The examination of the aircraft showed that one of the control cables PN S2211001100000, which connected the autopilot's Servo Drive to the aileron control bellcranks (Quadrant Assy), was broken.

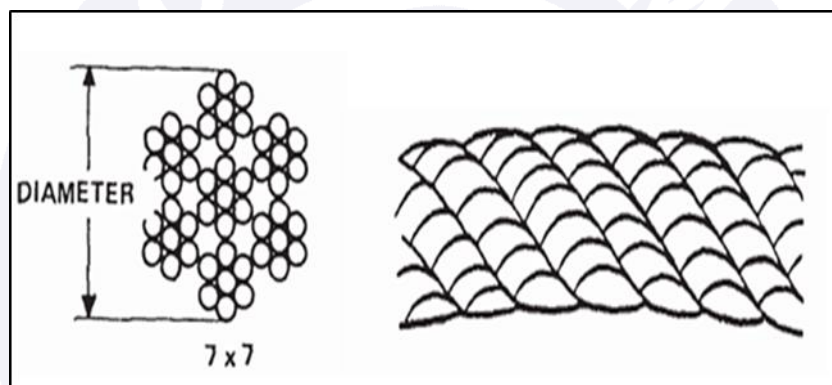
Figure 11 - Drawing of a transversal and lateral section of a cable PN S2211001100000.

The control cable PN S2211001100000 is a 7 x 7 construction wire rope. A wire rope of this construction consists of 6 outer strands of 7 wires each laid around a strand core of 7 wires.

According to ATR, in service experience shows 16 events over approximately 26 million flight cycles of AP roll cable failure amongst ATR 72-212A history. The current definition of the cable is 7x7. The AP actuator capstan diameter increases the sensitivity to internal cable friction. The definition of a cable with the same external dimensions but having a higher number of wires will decrease the relative movement of the wires during the actuation of the cable hence will reduce the internal friction as per ARP 5770. ATR has launched the development of a modification to replace the cable 7x7 by a cable 7x19.

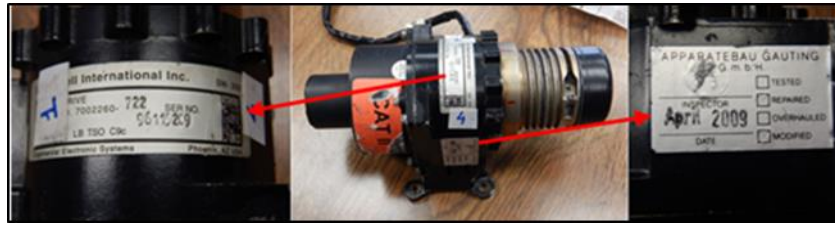
Figure 16 - Servo Drive and its identification plates.

The analysis started with the identification of the Servo Drive, followed by a visual check, in order to know the condition in which the part had arrived for the analysis.

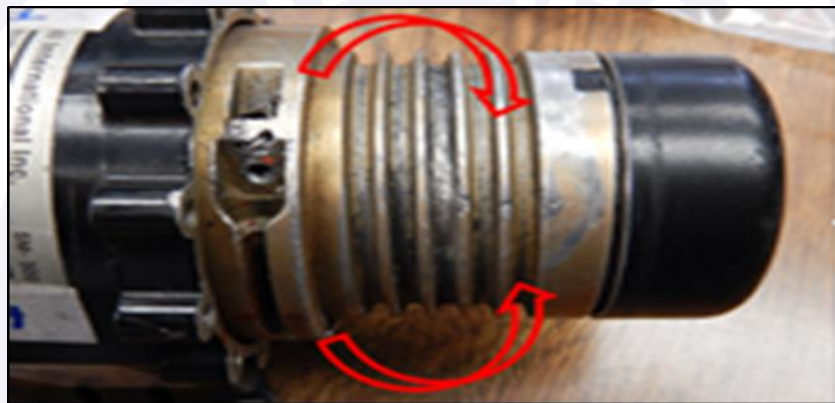
- the cable drum, or capstan, was free to rotate.

Figure 18 - Capstan free to rotate in both directions, clockwise and counterclockwise.

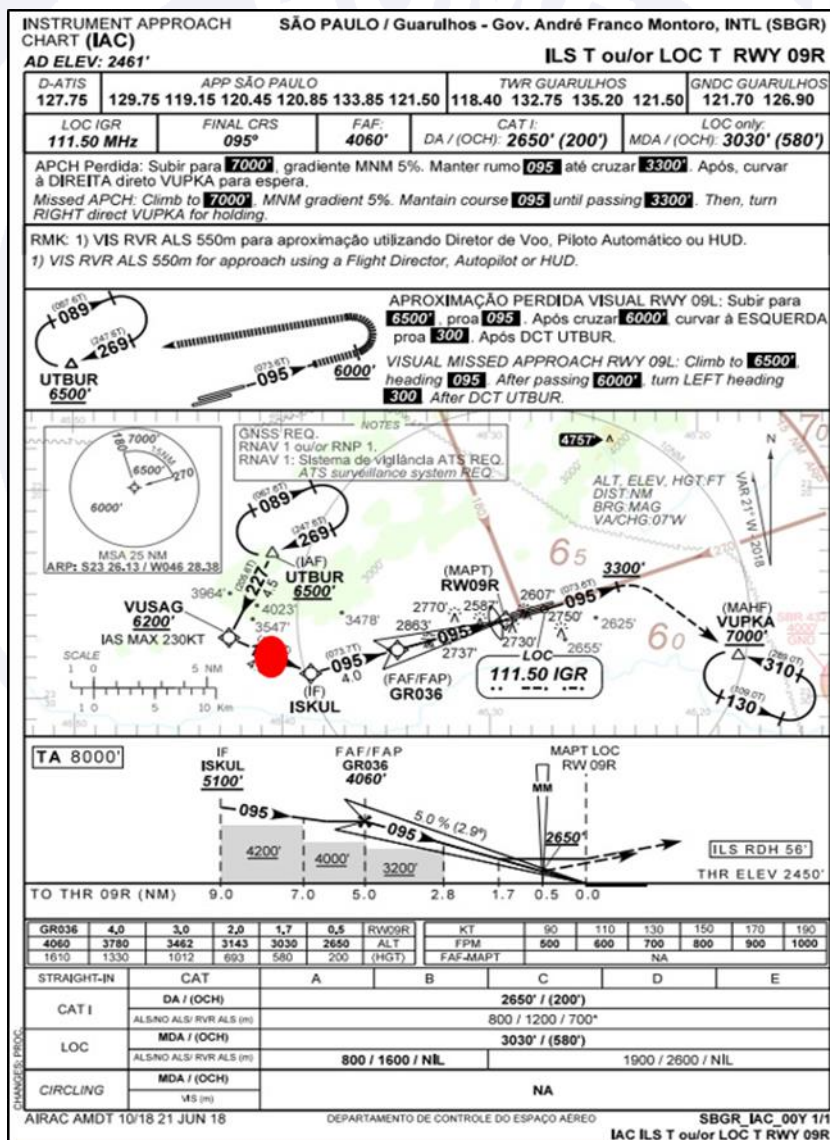
During the descent, crossing 5.500ft to intercept the locator of the ILS T procedure for runway 09R (Figure 23), in approach to the ISKUL point (Intermediate Fix), the AILERON MISTRIM message was lit.

Figure 23 - Approximate point of the AILERON MISTRIM alarm (in red), during the execution of the ILS T RWY 09R procedure.
