COMANDO DA AERONÁUTICA
CENTRO DE INVESTIGAÇÃO E PREVENÇÃO DE
ACIDENTES AERONÁUTICOS

FINAL REPORT
A-050/CENIPA/2022

OCCURRENCE:	ACCIDENT
AIRCRAFT:	PR-AUG
MODEL:	SR22
DATE:	17ABR2022

This is the Final Report of the 17 April 2022 accident involving the SR22 aircraft, registration marks PR-AUG. the accident was typified as “[SCF-NP] System/Component Failure or Malfunction and [RE] Runway Excursion”.

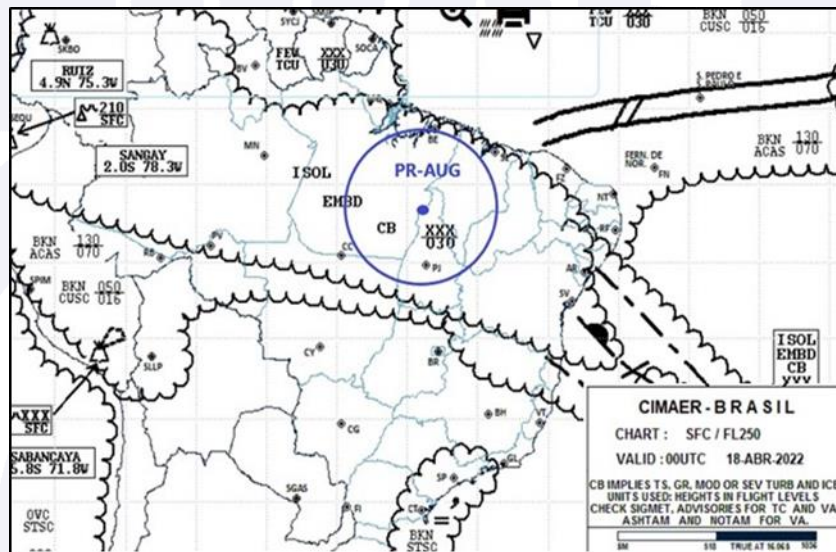
The Significant Weather Chart (SIGWX) generated at 09:55 UTC on the day of the occurrence, valid until 00:00 (UTC) of the following day, forecasted the presence of isolated and embedded Cumulonimbus (CB) clouds with base at 3,000 ft. and a top above FL250 (Figure 2).

Figure 2 - SIGWX chart generated at 09:55 UTC on the day of the occurrence and valid until 00:00 UTC of the following day.

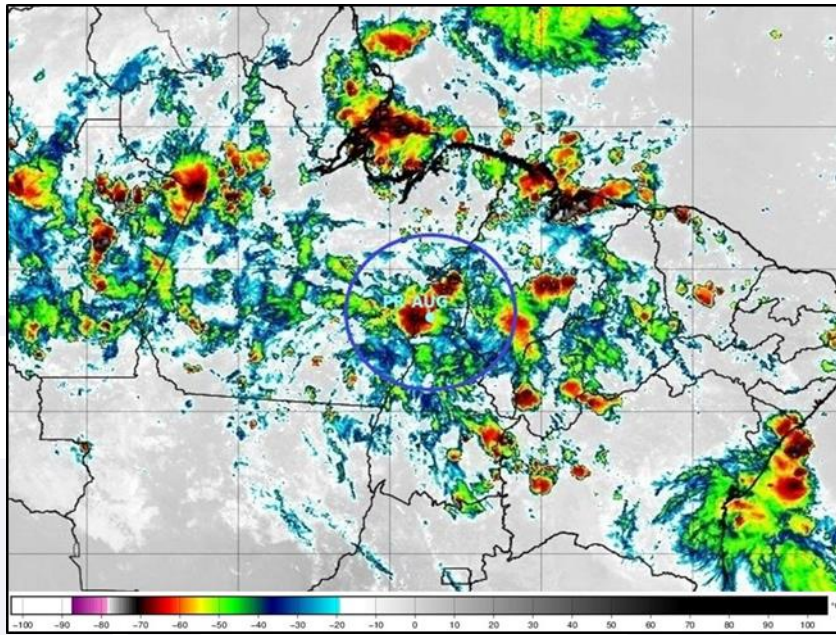
In addition to the above, the satellite image generated at 15:50 UTC by the Weather Forecast and Climate Studies Center (CPTEC) showed the presence of significant meteorological formations (Figure 3) along the route and in the surroundings of the destination aerodrome.

Figure 3 - Enhanced satellite image, showing the meteorological conditions around the time of the occurrence. Source: CPTEC.

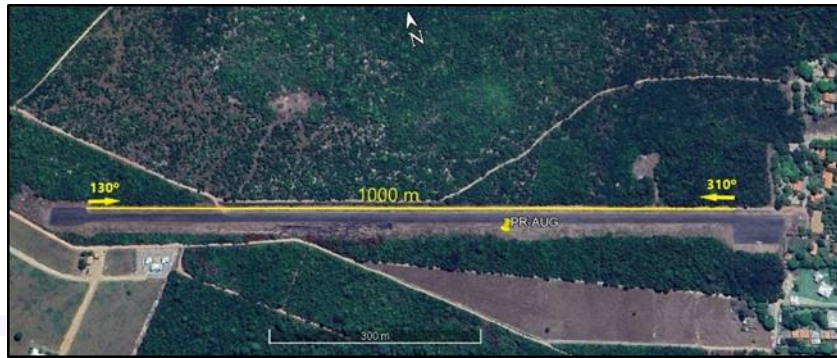
The asphalt-paved airstrip where the precautionary landing took place was not registered. It measured 1,000 m x 14 m at an elevation of 479 ft. The magnetic azimuths of the thresholds were 310° and 130° (Figure 4).

Figure 4 - Length of the Escapole Reserve airfield.
Source: adapted from Google Earth.

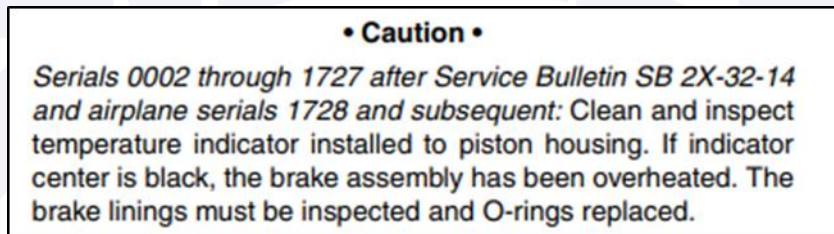
Given the report of a malfunction in the right main landing gear brake and the fact that, during the Initial Action of the investigation, its temperature indicator window was found to be black, this component was also analyzed.

However, according to the aircraft's operating manual, the black landing gear inspection window indicated that the system had overheated (Figure 10).

Figure 10 - Information from the aircraft operating manual with instructions for checking the landing gear brake temperature inspection window.

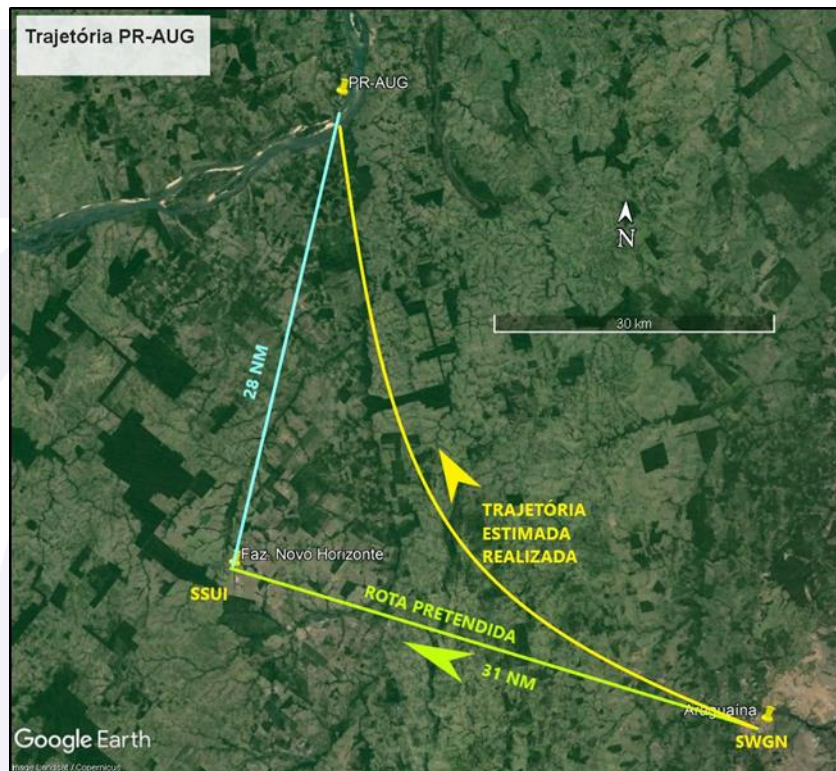
However, the PIC reported having sighted the runway of *Reserva Escapole*, and decided to make a precautionary landing at that location.

Figure 11 - Intended trajectory and trajectory performed according to the PIC.
Source: adapted from Google Earth.
