COMANDO DA AERONÁUTICA
CENTRO DE INVESTIGAÇÃO E PREVENÇÃO DE
ACIDENTES AERONÁUTICOS

FINAL REPORT
IG - 146/CENIPA/2017

OCCURRENCE:	SERIOUS INCIDENT
AIRCRAFT:	PR-GXW
MODEL:	737-8EH
DATE:	18NOV2017

This is the Final Report of the 18NOV2017 serious incident with the 737-8EH aircraft, registration PR-GXW. The serious incident was classified as “[RE] Runway Excursion / Overshoot”.

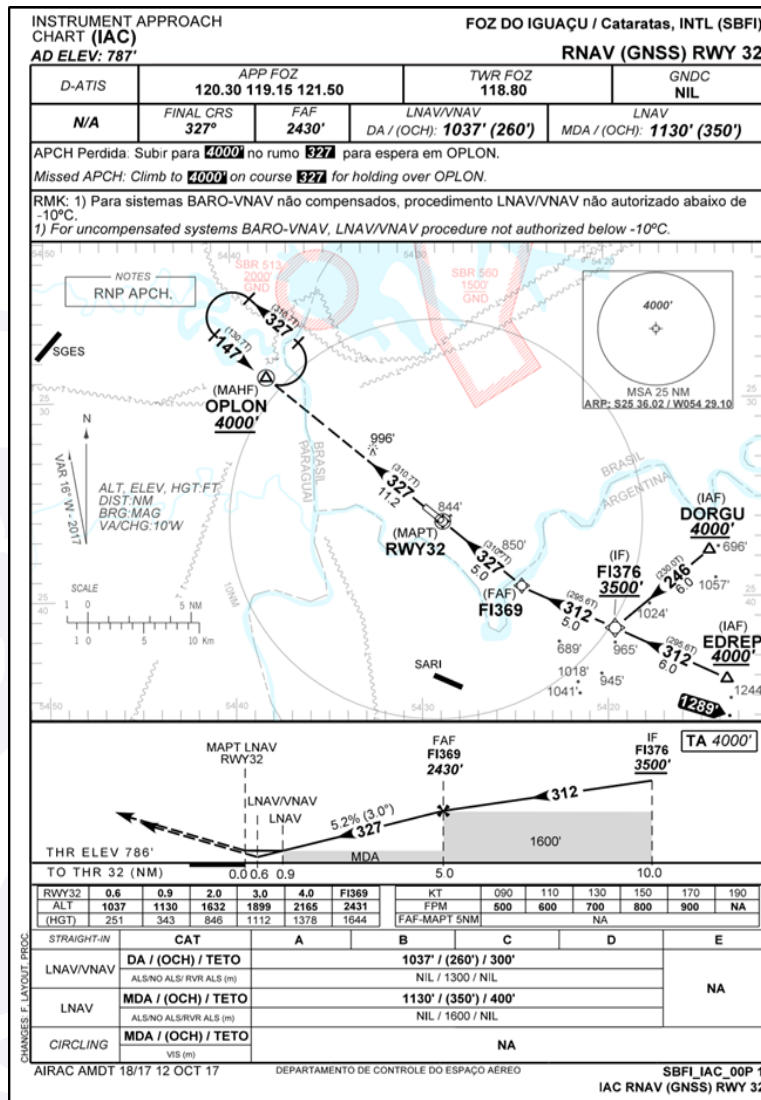
The take-off took place at 0137 (UTC), so the entire flight was conducted at night. The phases of takeoff, climb and cruise were performed without any abnormality. Detours were en route to avoid weather formations. The crew was prepared to perform the RNAV procedure of runway 32, on 12OCT2017, according to the guidelines of the air traffic control bodies. An approach and landing procedure briefing was held, including the possibility of a go-around procedure.

Figure 7 - Instrument approximation chart (RNAV of runway 32) for SBF1, valid on 18NOV2017.

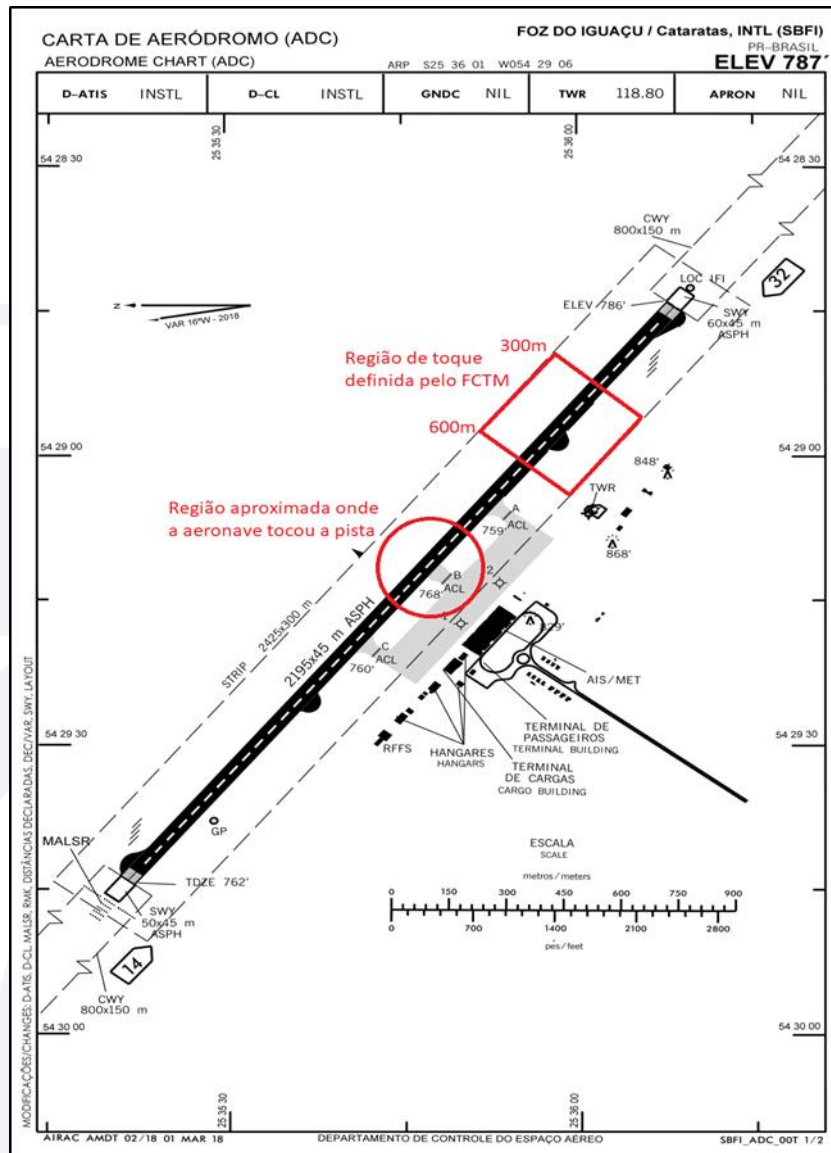
Figure 9 - SBFI ADC chart, with emphasis on TWY B.

All of these factors contributed to the touch down of the aircraft occurring approximately 1.000m ahead of runway 32's threshold at a point near taxiway B (Figure 9).
