COMANDO DA AERONÁUTICA
CENTRO DE INVESTIGAÇÃO E PREVENÇÃO DE
ACIDENTES AERONÁUTICOS

FINAL REPORT
A-151/CENIPA/2016

OCCURRENCE:	ACIDENTE
AIRCRAFT:	PR-IDR
MODEL:	AS 350 B3
DATE:	19NOV2016

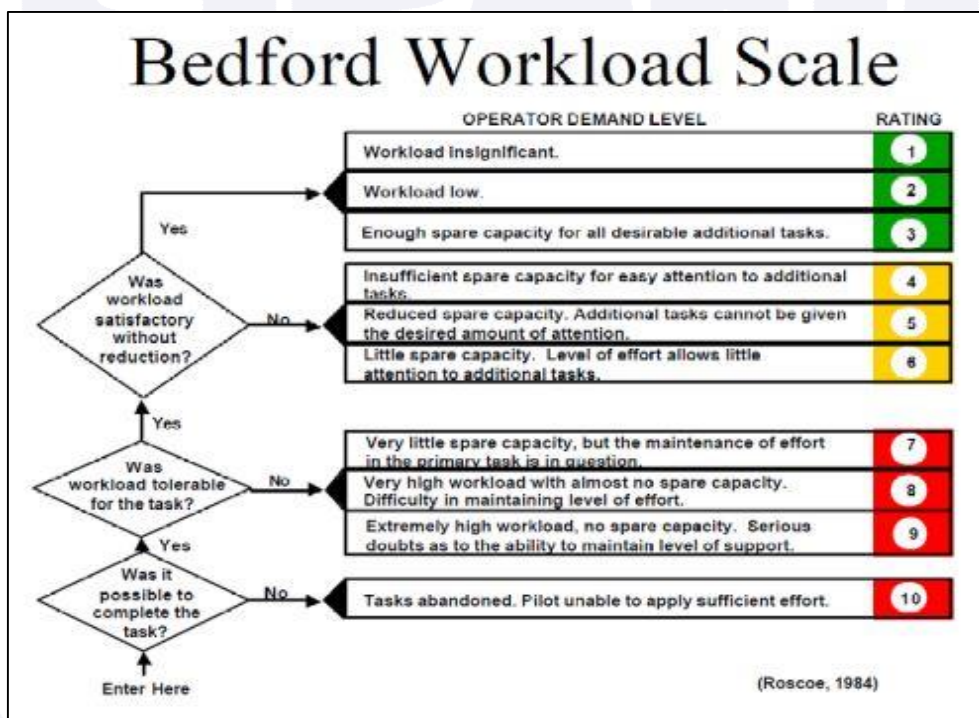
Subsequently, another test was carried out to verify the workload required for regaining control of the helicopter after the failure simulation. For that purpose, the Bedford Workload Scale was chosen as a reference, since it is used in test flights, with the purpose of identifying the workload of a pilot when performing a task, assigning levels that vary from 1 (workload negligible) up to level 10 (pilot unable to apply required effort).

Figure 18 - Bedford Workload Scale.

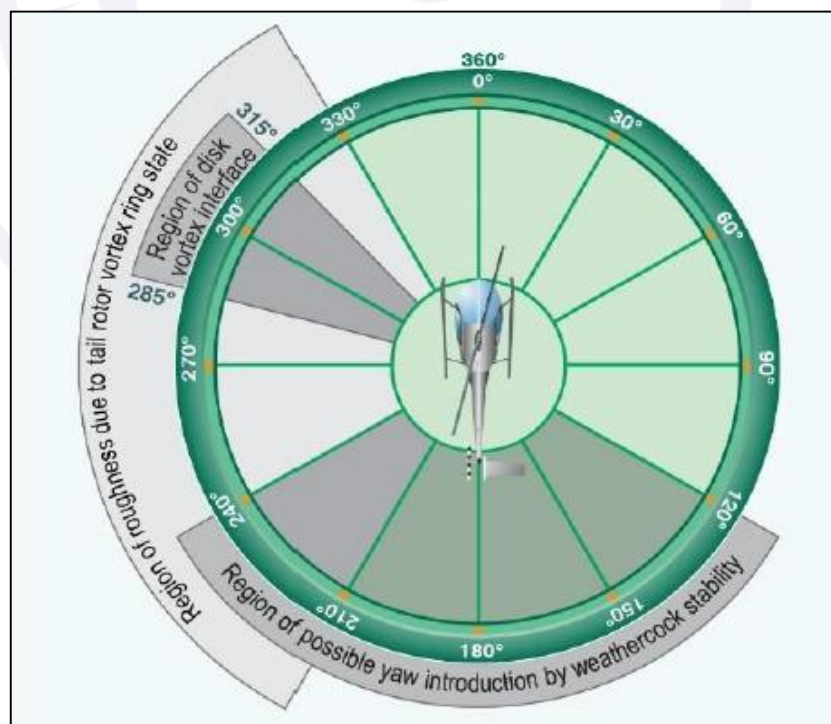
As shown in Figures 19 and 20, the following wind conditions may favor the emergence of an LTE:

- a) Operations with relative wind direction within $\pm 15^\circ$ of the 10 o'clock position (counterclockwise main-rotors) or within $\pm 15^\circ$ of the 2 o'clock position (clockwise main-rotors) generate swirly winds that blow directly on the tail rotor, and may drastically decrease its efficiency;
- b) Tailwinds hitting a helicopter at angles between 120° and 240° may increase the pilot's workload and drastically reduce the tail rotor's efficiency
- c) Crosswinds between 210° and 330° (counterclockwise main rotors) or between 30° and 150° (clockwise main rotors) may cause the development of a vortex ring in the tail rotor, which will produce a non-uniform and unbalanced air flow that will be sucked by the rotor. The direct consequence is the oscillation of the tail-rotor thrust, i.e., loss of its efficiency.

Figure 19 – Helicopter with main rotor turning counterclockwise.
Source: adapted from CENIPA, 2018 apud NTSB, 2017.

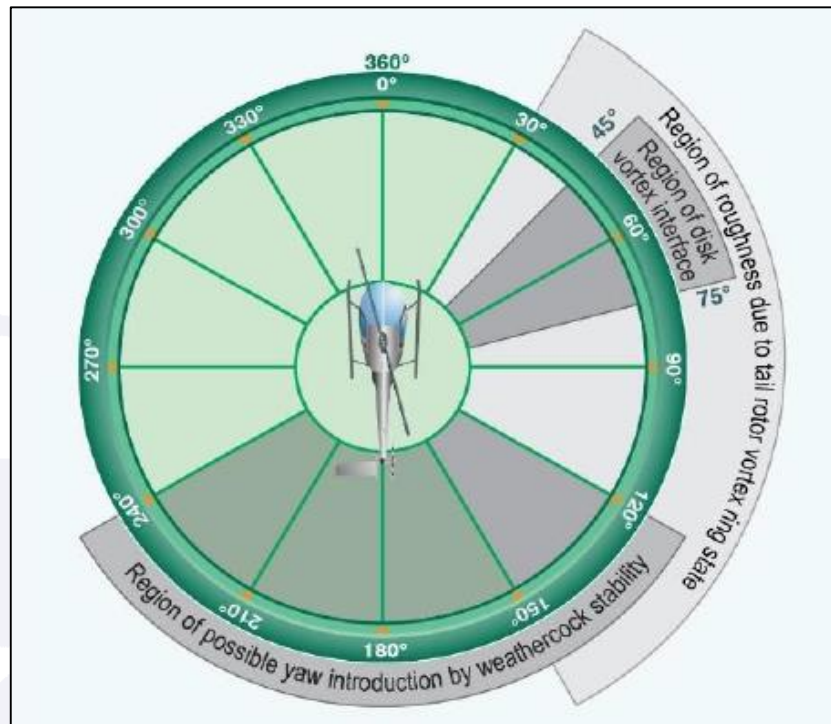
Figure 20 – Helicopter with main rotor turning clockwise.
Source: adapted from CENIPA, 2018 apud NTSB, 2017.
