COMANDO DA AERONÁUTICA
CENTRO DE INVESTIGAÇÃO E PREVENÇÃO DE
ACIDENTES AERONÁUTICOS

FINAL REPORT
A-008/CENIPA/2022

OCCURRENCE:	ACCIDENT
AIRCRAFT:	PR-JGV
MODEL:	Baron 58
DATE:	19JAN2022

This Final Report pertains to the 19 January 2022 accident involving the Beechcraft Baron 58 aircraft, registration marks PR-JGV. The occurrence was typified as “[SCF-PP] Engine failure or malfunction”.

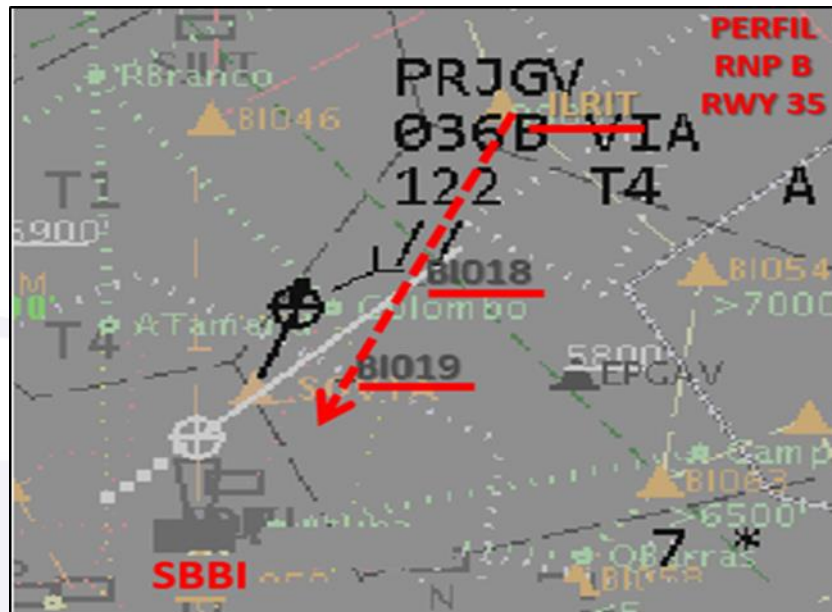
Moments before initiating the RNP B RWY 36 procedure, the PIC flew a direct heading toward SBB, aiming to land on runway 18. This resulted in the aircraft being to the right of the procedure profile, as shown in Figure 8.

Figure 8 - PR-JGV following a profile to the right of the course prescribed
For the RNP B RWY 36 procedure.

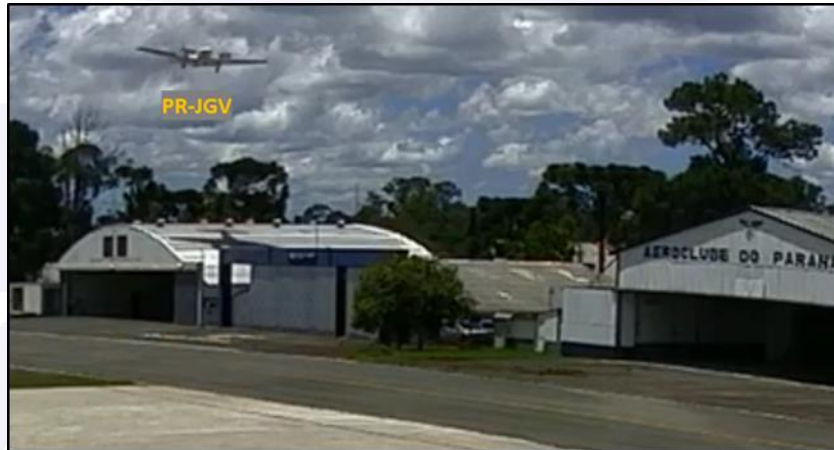
The aircraft overflew the hangar area, as shown in Figure 11.

Figure 11 - Surveillance camera image of the PR-JGV overflying the hangar area before the emergency landing.

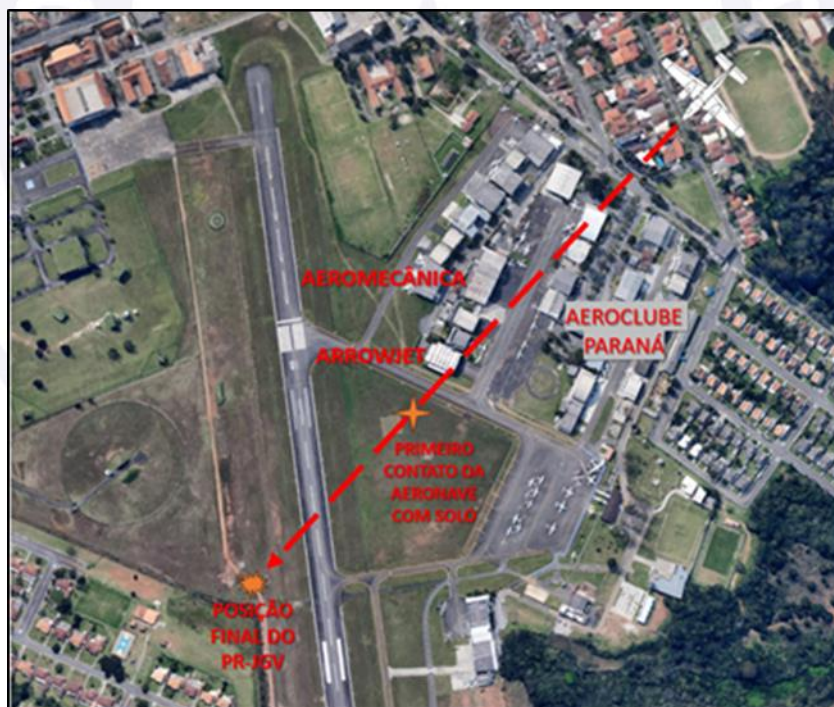
The landing occurred on a grassy area between taxiways C and B. The aircraft traveled approximately 250 meters until crossing the runway and colliding with a containment embankment (Figure 12).

Figure 12 - PR-JGV trajectory over Bacacheri Aerodrome until coming to a stop.

The left main landing gear and the nose gear detached from the aircraft during the post-landing roll on uneven terrain.
