FINAL REPORT
A-033/CENIPA/2022

OCCURRENCE:	ACCIDENT
AIRCRAFT:	PR-LCT
MODEL:	S-76C++
DATE:	16MAR2022

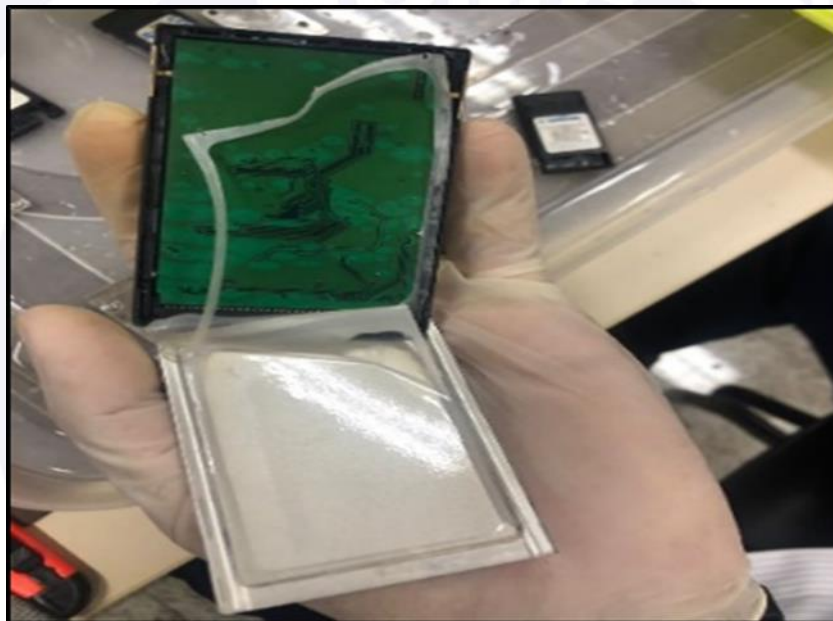
Figure 15 - Opening of the PCMCIA256 card at the LABDATA facilities.

One verified that there was no major damage sustained by the card after exposure to seawater. After being dried with a residue-free absorbent fabric, the material was cleaned with isopropyl alcohol.

Next, the cardboard was placed in the oven to dry for a period of 18 hours, at a nominal temperature of 40°C, with application of an upward (heating) and downward (cooling) ramp of 30 minutes each, as recommended by the manufacturer.

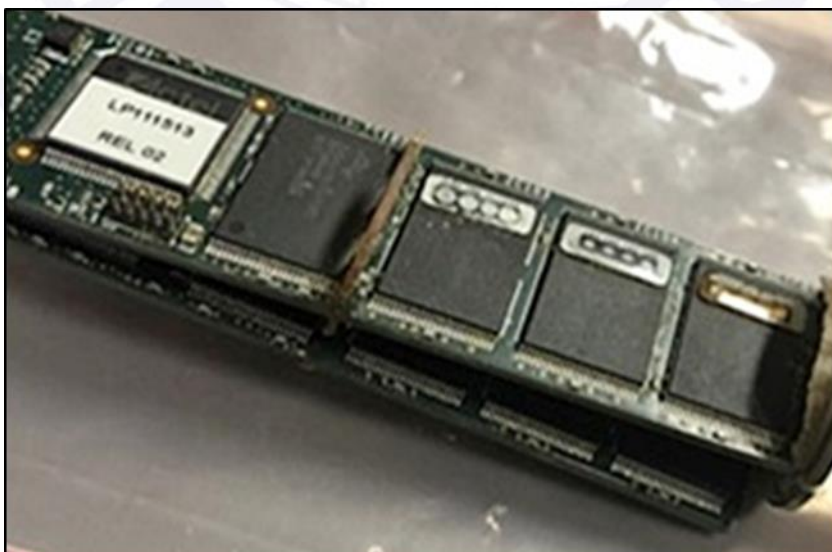
Figure 18 - MPFR memory after being cleaned up at the LABDATA.

The salt water, which penetrated the MPFR memory compartment, initiated a corrosion process in some of the internal components (Figure 17).

The cleaning process obtained satisfactory results.

LABDATA technicians cleaned up the memory board in order to prevent the occurrence of short circuits with the equipment connected to a source of power (Figure 18).

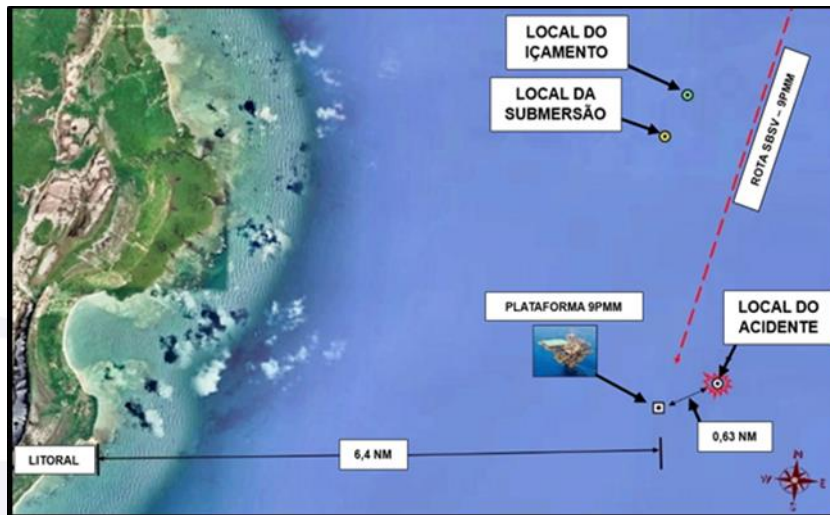
Figure 20 - Croquis of the PR-LCT wreckage site.

According to the aircraft operator, the helicopter sank at 21:35 UTC at the coordinates 13°26'32.28"S / 038°48'48.39"W. On 05 April 2022, in an operation under the coordination and responsibility of the aircraft operator, the wreckage of the helicopter was located at the coordinates 13°26'5.66"S / 038°48'35.02"W, and retrieved from a depth of 50 m by means of a crane installed on a vessel. These latter coordinates corresponded to a distance of approximately 3.5 NM away from the accident site (Figures 20 and 21).

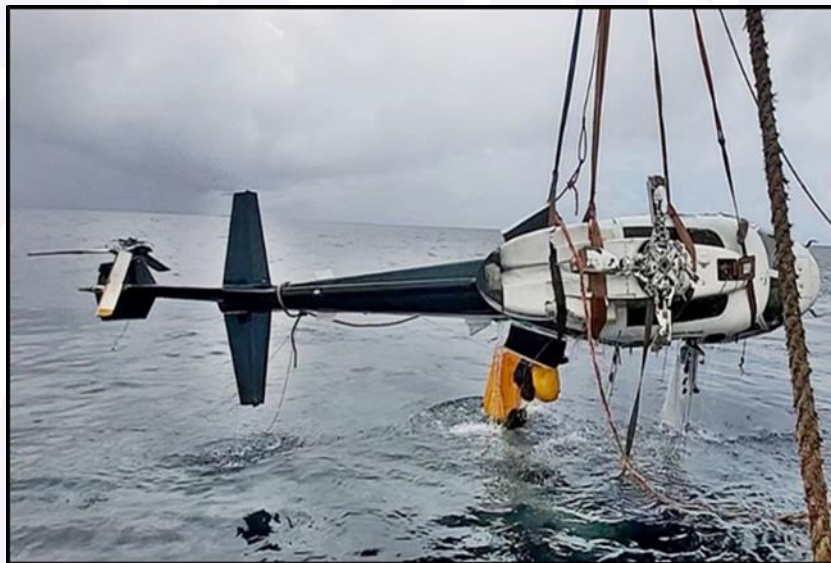
Figure 21 - View of the PR-LCT's removal from the sea.

The aircraft suffered substantial damage to the main rotor, tail rotor, radome, and windshield, in addition to internal damage to the engines and deformations in the fuselage.

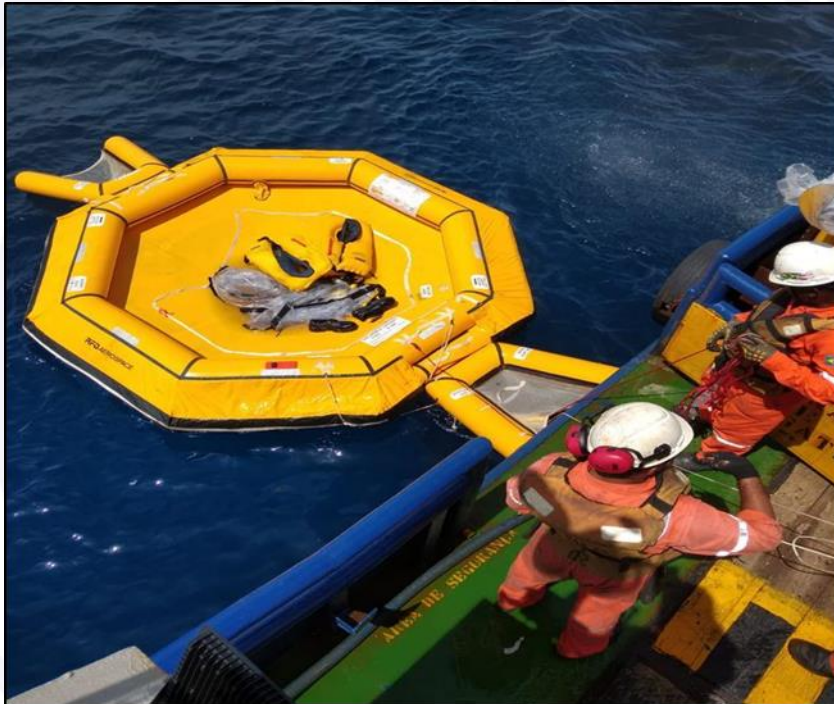
The right-hand life raft inflated adequately after external activation by means of the Outside Release Handle, and accommodated the PR-LCT's crew and passengers until they were rescued.

Figure 23 - View of the PR-LCT's inflated boat, shortly after the rescue of the crew and passengers.

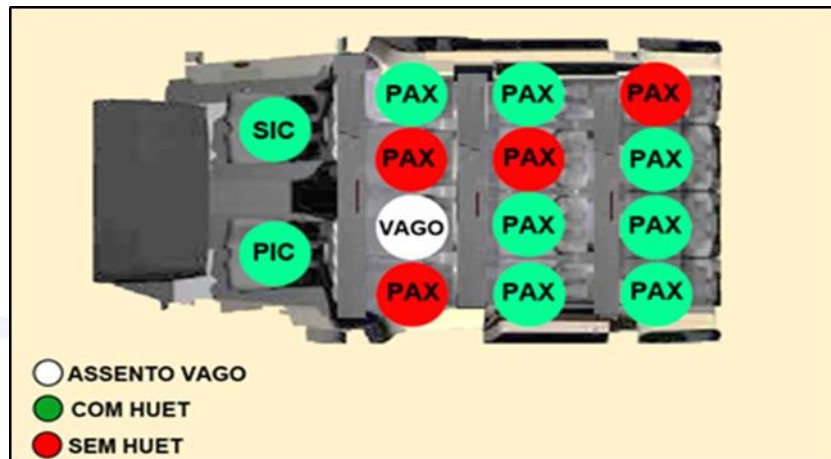
Figure 24 - Arrangement of seats for crewmembers and passengers of the PR-LCT helicopter at the time of takeoff.

According to Figure 24, one noticed that the two passengers who did not have HUET training occupied the seats close to the emergency exits, in contrast with the recommendation of letter "d" above mentioned.

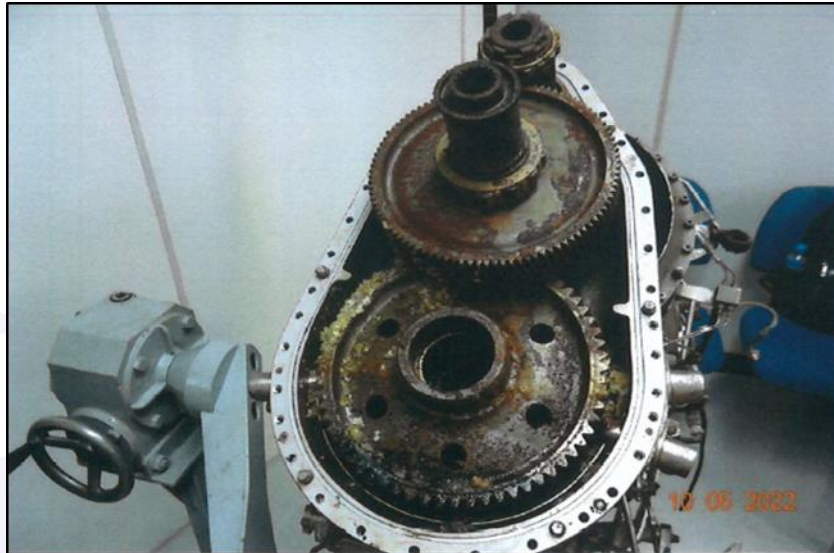
Another evidence of normal engine operation was found in the module 05.

Figure 29 - General view of the reduction gears of the module 05 of the SN 42326TEC engine.

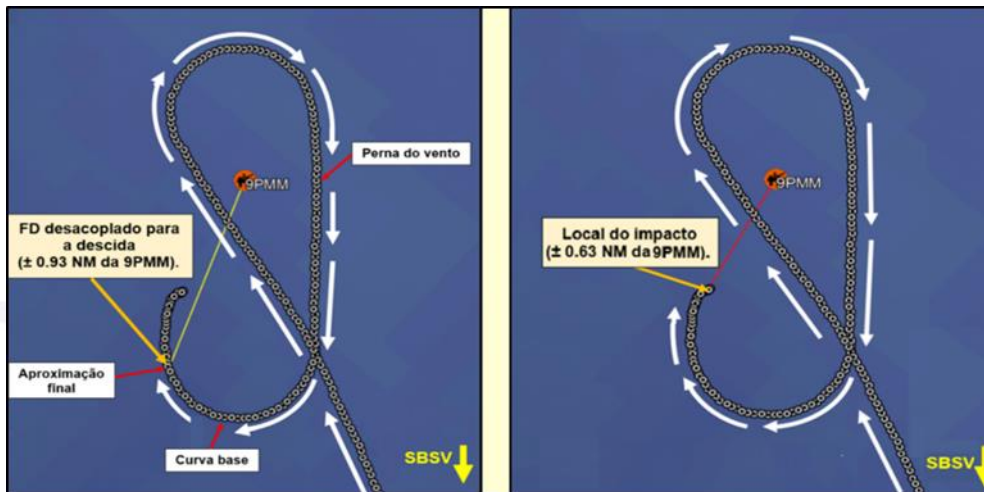
Afterwards, the helicopter flew over the maritime platform at a height of about 500 ft. AGL at an Indicated Air Speed of 80 kt, leaving the platform to the right-hand side, identifying it as 9PMM, and deciding that the traffic circuit and the landing would be performed by the SIC, due to wind direction. On the downwind leg of the visual traffic circuit (Figure 33), the SIC informed the PIC that he (SIC) would perform a standard landing profile for the helideck, performance class 2.

Figure 33 - Visual traffic profile performed by the PR-LCT helicopter for approach to the 9PMM Platform until the moment of impact.

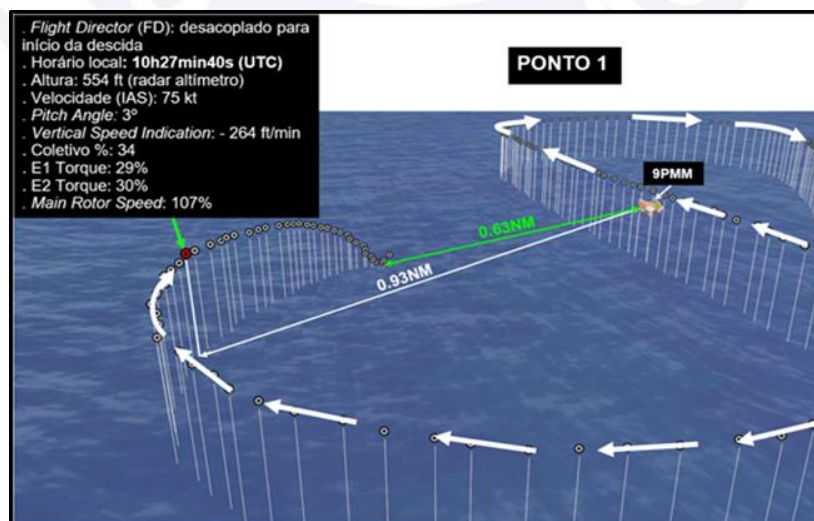
The SIC, at the end of the base turn, when aligning with the final approach of the traffic circuit, on the 250° magnetic heading, at a distance of approximately 0.93 NM from the helideck, informed the PIC that he (SIC) would uncouple the *flight director (altitude - FD_ALT OFF, heading - FD_HDG OFF and speed - FD_IAS OFF)* and begin the descent, assuming, from that moment on, the effective operation of the flight controls.

Figure 34 - PR-LCT's flight path on the final approach, highlighting the parameters at point 01.

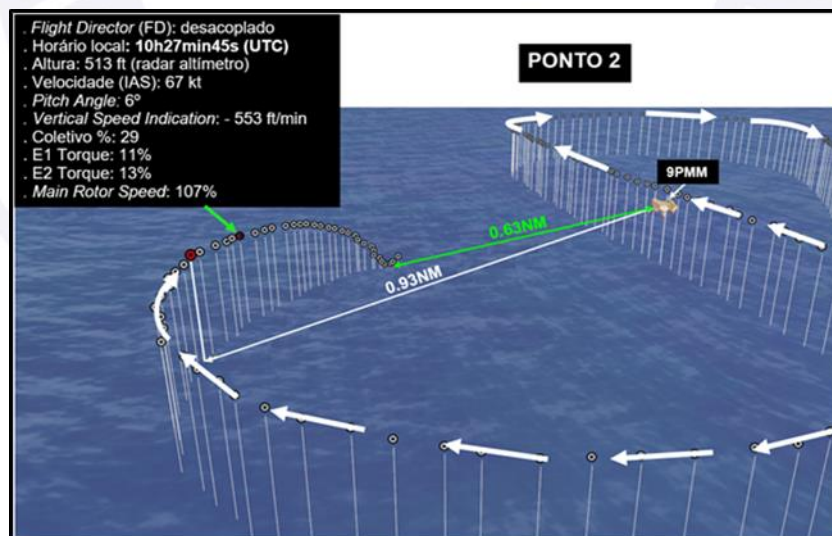
One verified that, 5 seconds after the uncoupling the *flight director* and beginning of descent, the PIC informed the SIC that he (PIC) was waiting for the SIC to request the *final checklist*, at which point the data extracted from the MPFR indicated that the helicopter presented the following parameters, as shown in Figure 35.

Figure 35 - PR-LCT's flight path on the final approach, highlighting the parameters at point 02.

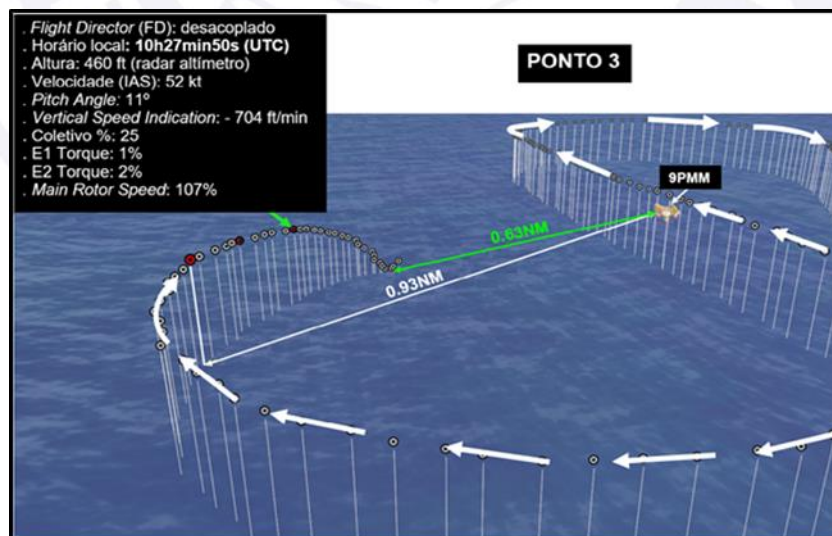
The SIC answered, "okay", but did not request the *Final Checklist* from the PIC. The PIC then informed the SIC that he (PIC) would arm the rafts, at which point the data extracted from the MPFR indicated that the helicopter had the following parameters, as shown in Figure 36.

Figure 36 - PR-LCT's flight path on final approach, highlighting the parameters at point 03.

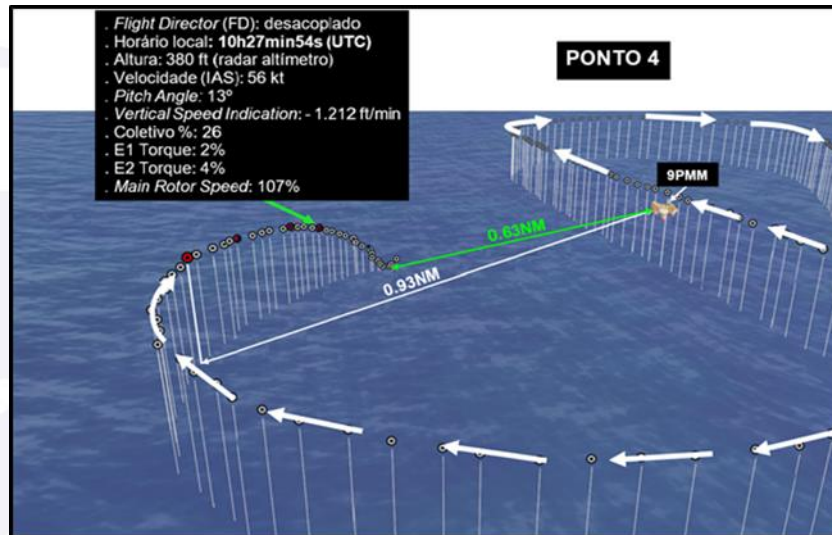
transmitting such information via the intercom, the SIC maintained the helicopter's torque close to zero and, at the same time, continuously actuated on the cyclic command, in order to pitch up the aircraft.

Figure 37 - PR-LCT's flight path on final approach, highlighting the parameters at point 04.

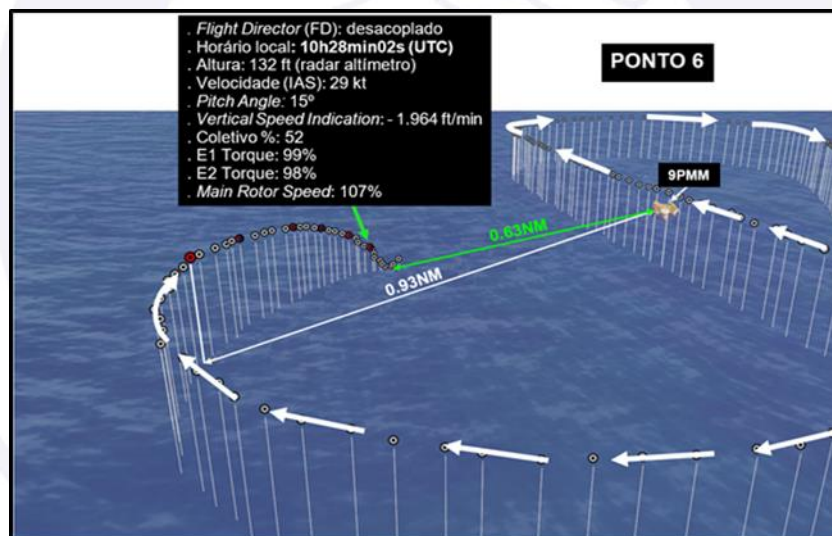
The PIC warned that the SIC was losing speed, and the SIC confirmed that he was high, while actuating on the collective command, continuously increasing the helicopter's torque. Data extracted from the MPFR indicated that, on the occasion, the helicopter had the following parameters, as shown in Figure 39.

Figure 39 - PR-LCT's flight path on final approach, highlighting the parameters at point 06.

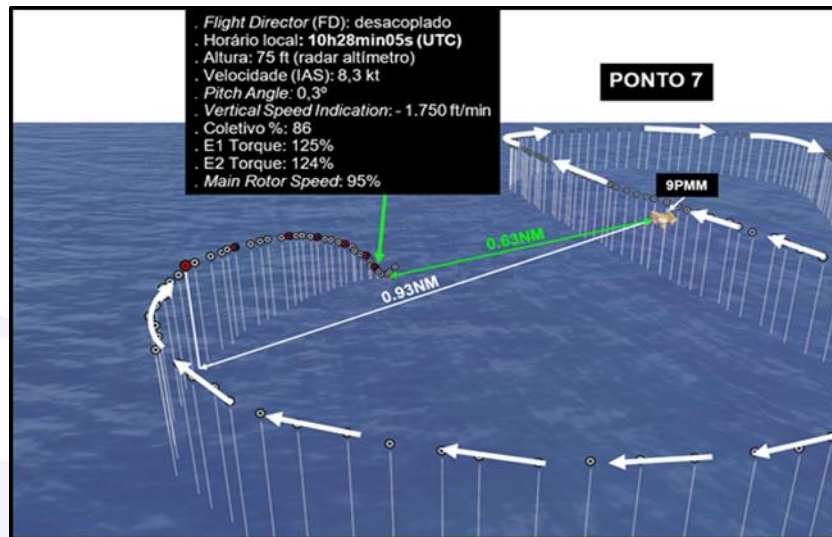
From then on, the SIC actuated intensively in the cyclic command, varying the aircraft's longitudinal attitude from a pitch-up 16.0° to 0.0° in 1 second. At that moment, the application of collective command exceeded the torque transient limit specified by the manufacturer (115% for each engine).

Figure 40 - PR-LCT's flight path on final approach, highlighting the parameters at point 07.

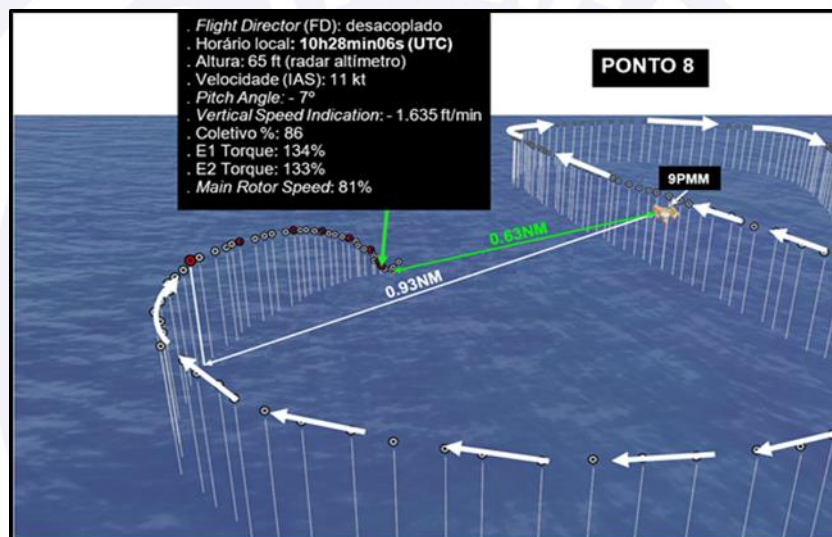
The PIC alerted the SIC a last time before the crash, “Speed!!!” Data extracted from the MPFR indicated that, on the occasion, the helicopter had the following parameters, as shown in Figure 41.

Figure 41 - PR-LCT's flight path on final approach, highlighting point 08.
