COMANDO DA AERONÁUTICA
CENTRO DE INVESTIGAÇÃO E PREVENÇÃO DE
ACIDENTES AERONÁUTICOS

FINAL REPORT
A-136/CENIPA/2020

OCCURRENCE:	ACCIDENT
AIRCRAFT:	PR-LMP
MODEL:	EMB-500
DATE:	30OUT2020

This is the Final Report of the 30 October 2020 accident with the EMB-500 aircraft, registration marks PR-LMP. The accident received the typification of “[RE] Runway Excursion”.

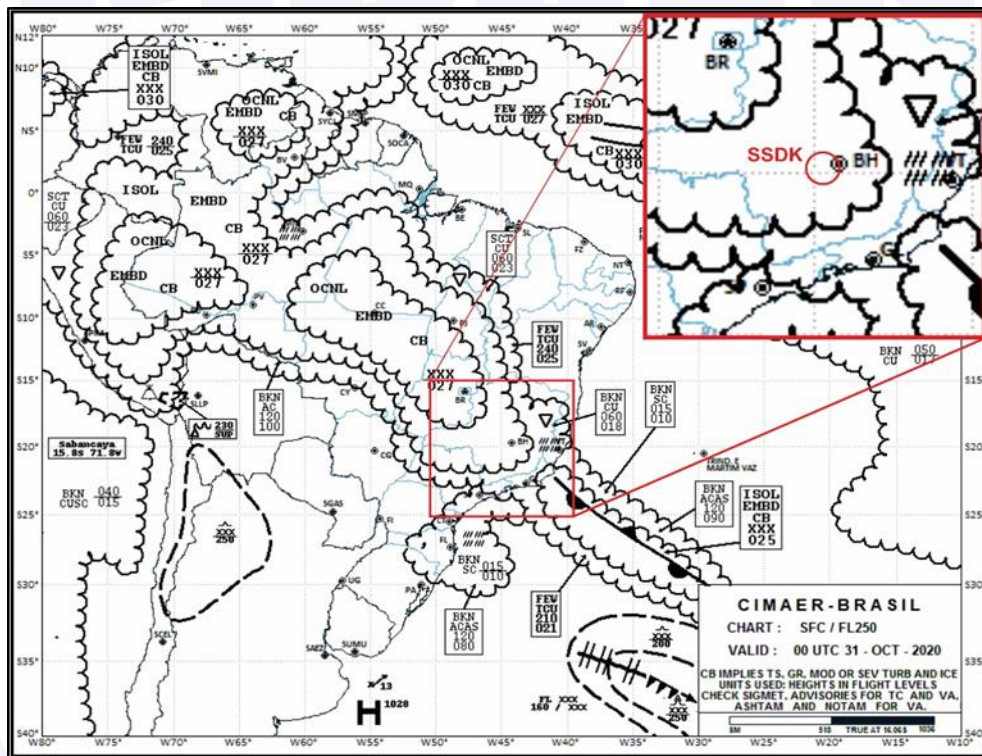
Figure 2 - SIGWX chart generated at 09:50 UTC on 30 OCT 2020.
Source: Command of Aeronautics' Meteorology Network (REDEMET).

The SIGWX (Significant Weather Chart), generated at 09:50 UTC on 30 October 2020, valid until 00:00 UTC of 31 October 2020, showed the presence of rain showers and embedded CBs (cumulonimbus clouds) with base at 2,700 ft and tops above FL 250.

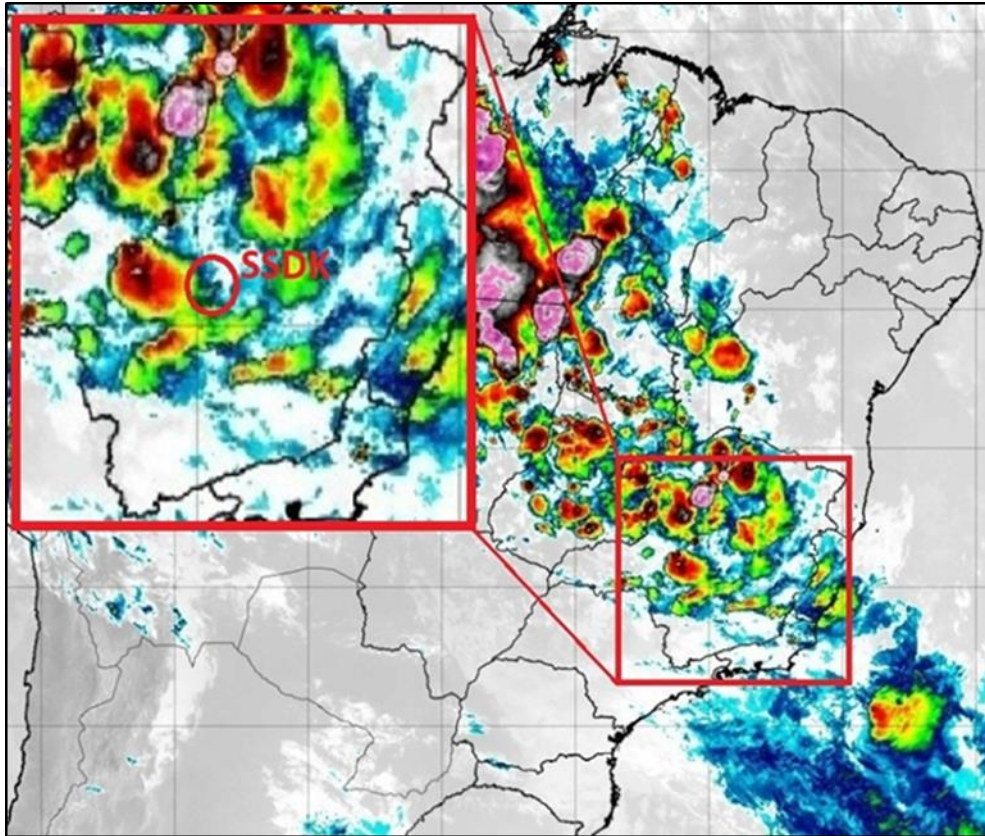
Figure 3 - GOES 16 satellite image channel 16, from 30OCT2020 at 20:50 (UTC).
Source: adapted from the Center for Weather Forecast and Climatic Studies (CPTEC).

The 20:50 UTC satellite image of 30 October 2020, channel 16, showed low clouds with characteristics indicative of the presence of precipitation west of SSDK.

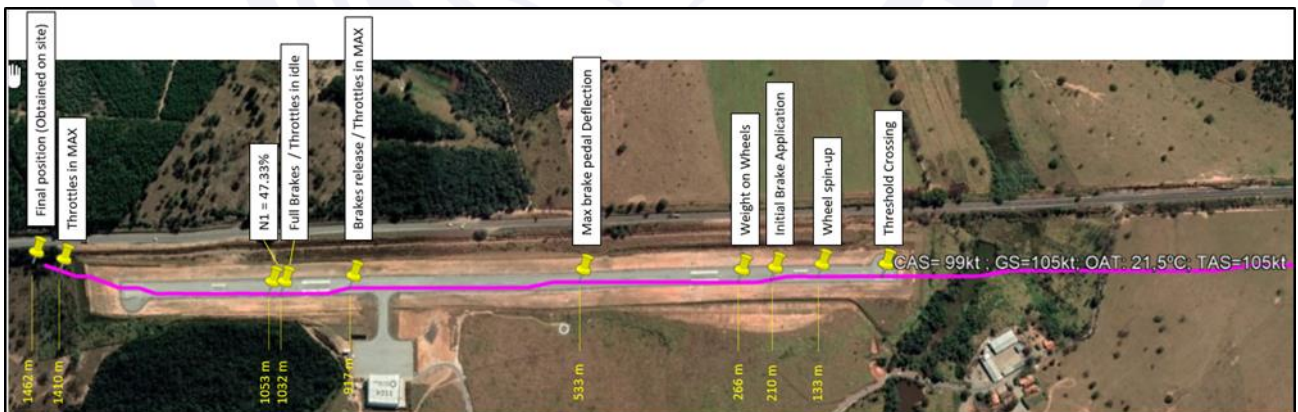
Figure 11 - Sequence of events during the landing with their respective distances in relation to the threshold of runway 11. Source: adapted from Google Earth.

The data retrieved from the CVDR allowed identifying the events related to the landing, with their respective distances in relation to the threshold of runway 11, as detailed in Figure 11.

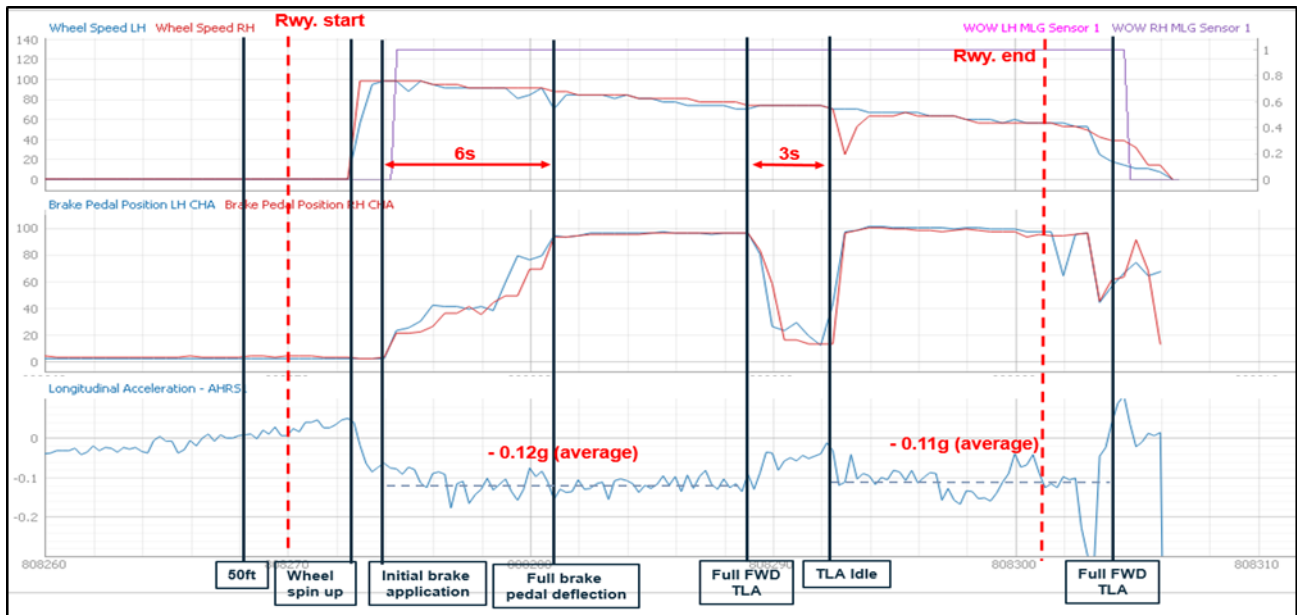
Figure 14 – Data on the speed of the wheels, position of the brake pedals, and longitudinal acceleration.

The analysis of the event involving the PR-LMP led to the conclusion that the brake pedals were activated in a gradual fashion until reaching their maximum amplitude.

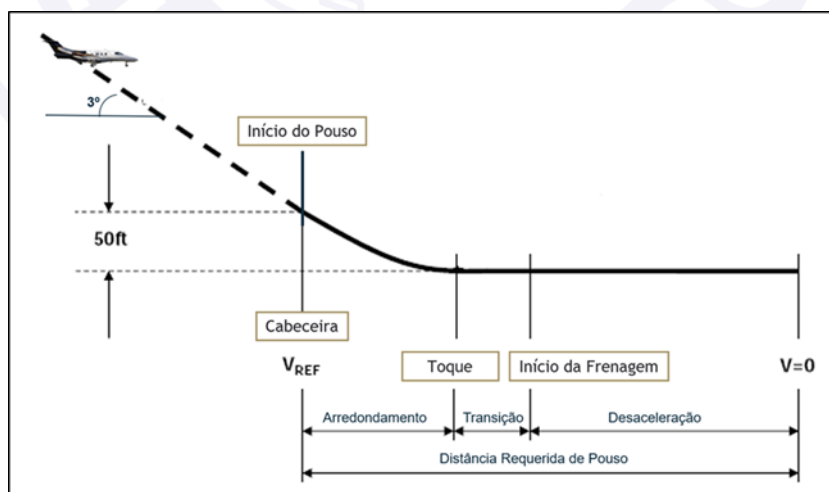
Figure 15 - Conditions considered for calculation of the required landing distance.

According to the manufacturer, the calculated values of actual landing distance (ALD) took into account an approach where the aircraft passed through 50 ft above the threshold at the reference speed, on a stabilized 3°-slope, and maximum application of the brakes immediately after touching down, as shown in Figure 15.

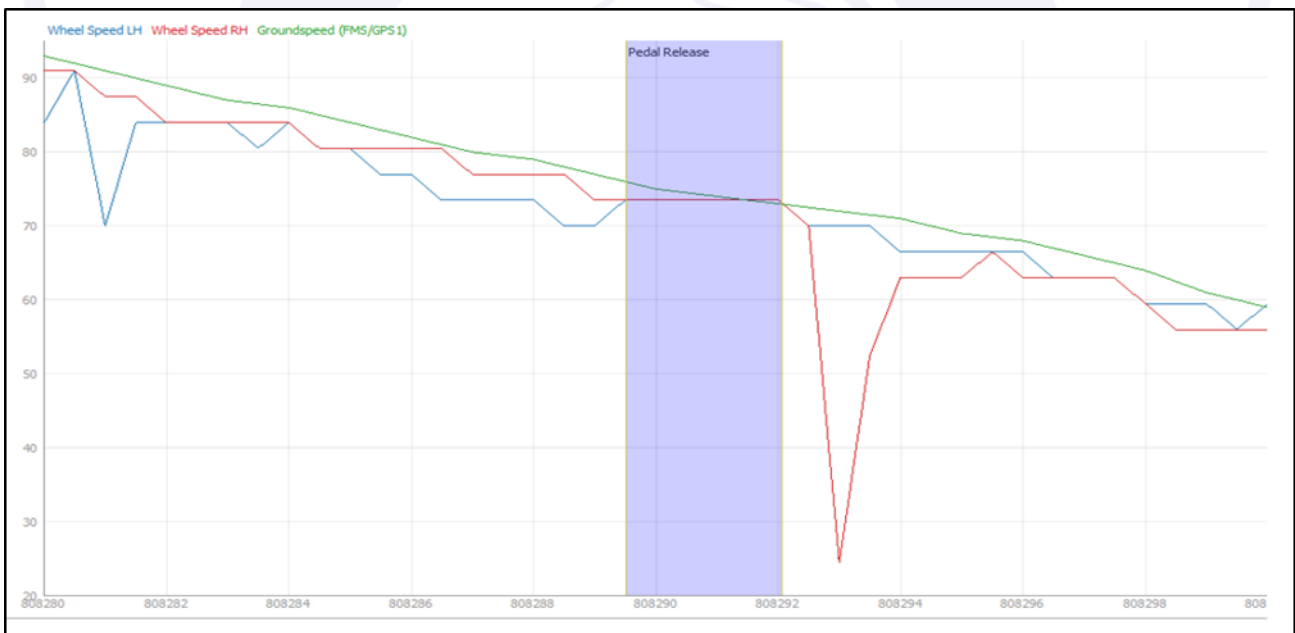
Figure 17 - Data on the speed of the wheels and on the aircraft ground-speed.

When observing the speed of the wheels and the speed of the aircraft on the ground, with the exception of the moment when the brakes are released, one verified a positive braking action (Figure 17).
