FINAL REPORT
A-075/CENIPA/2020

OCCURRENCE:	ACCIDENT
AIRCRAFT:	PT-MBV
MODEL:	EMB-121A
DATE:	14JUN2020

This Final Report refers to the accident with the EMB-121A aircraft, registration PT-MBV, on 14 June 2020. The accident was typified as “[LOC-I] Loss of control in flight”.

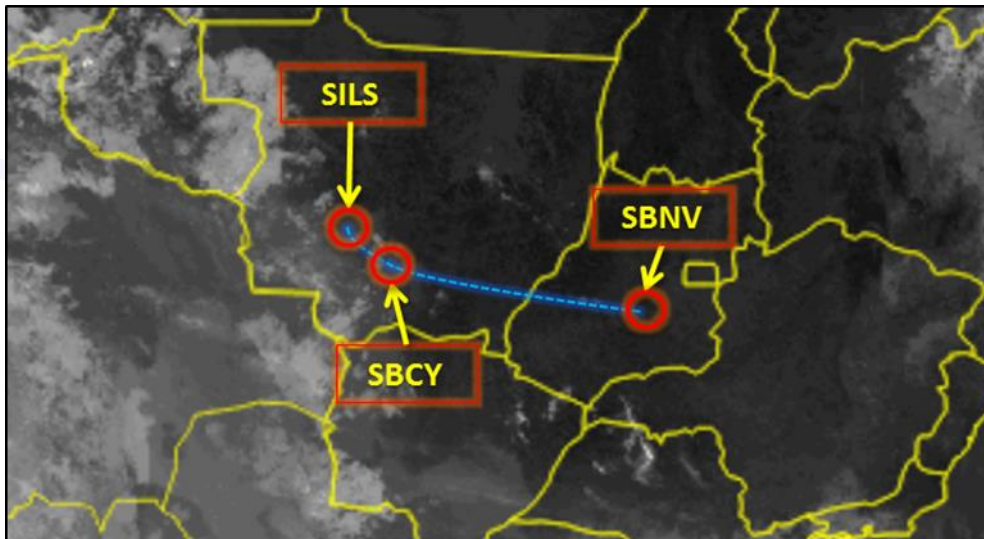
The enhanced satellite image of 14 June 2020, generated at 12:30 UTC, shows the presence of clouds near the locations of SILS and SBCY, possibly with similar conditions (Figure 5).

Figure 5 - Enhanced satellite image 14JUN2020, 12:30 UTC. Highlight for the locations of SILS, SBCY and SBNV, in addition to the intended route. Source: REDEMETS.

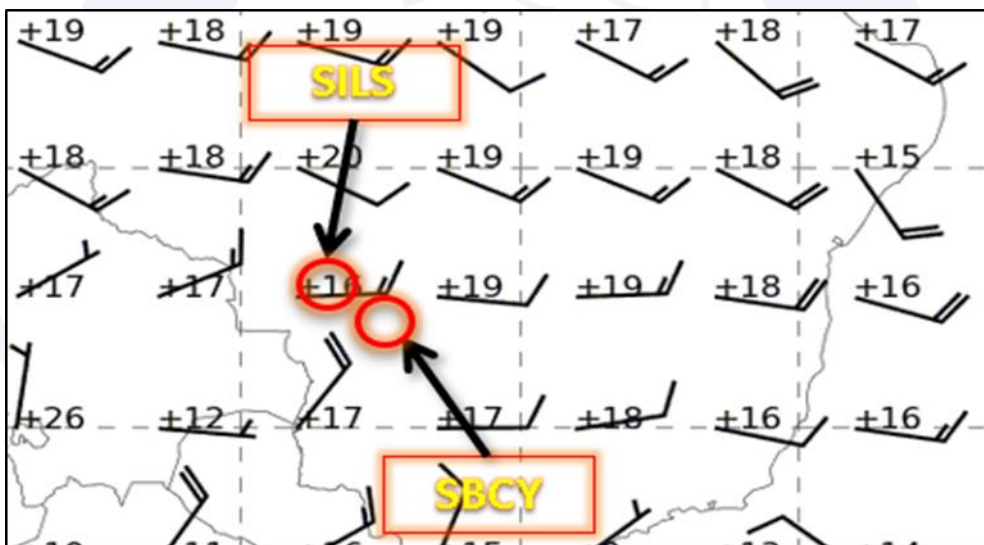
The wind and temperature chart of 14JUN2020, for flight level 050, generated at 12:00 UTC, made it possible to identify the prevalence of wind direction between 120° and 150°, with intensity from 10 to 15 kt in the region of the localities of SILS and SBCY (Figure 6).

Figure 6 - Wind and temperature chart for 14JUN2020, for FL050, generated at 12:00 UTC. Source: REDEMETS.

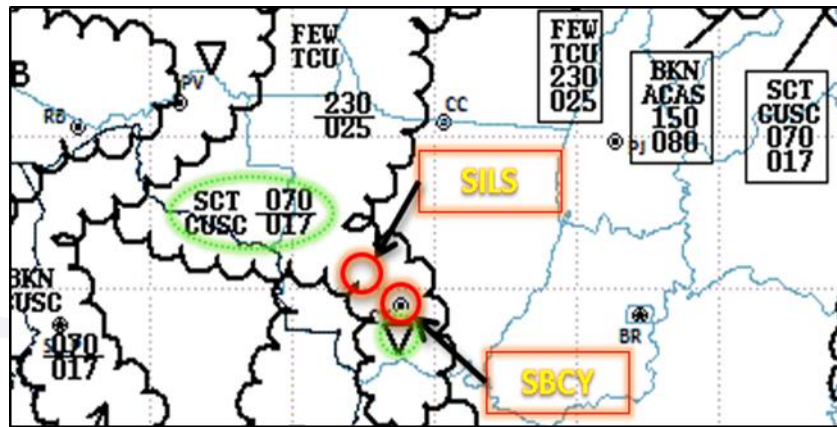
The Significant Weather chart (SIGWX - significant weather) of 14JUN2020, from the surface to flight level 250 (FL250), valid until 18:00 (UTC), allowed to identify scattered clouds, cumulus and stratocumulus types, with base at 1,700 ft and top at 7,000 ft, with isolated showers of rain (Figure 7).

Figure 7 - SIGWX chart of 14JUN2020 from the surface to FL250 with validity until 18:00 UTC. Source: REDEMET.

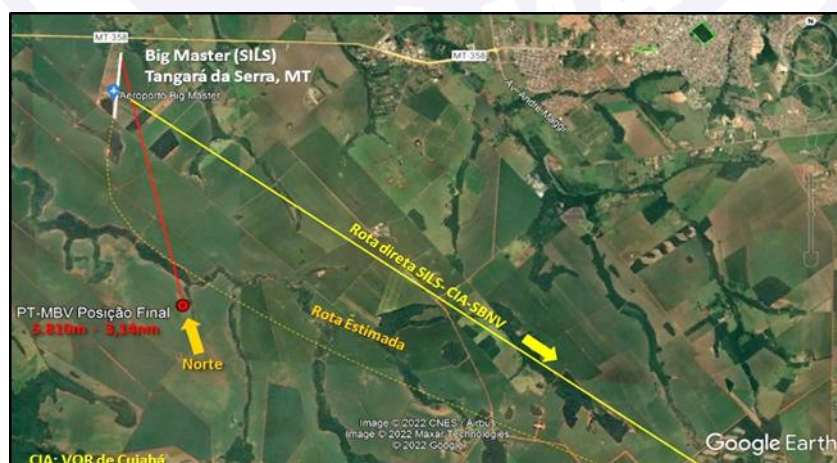
The distance between the accident site and the threshold of the takeoff runway (RWY 20) of SILS, was approximately 5,810 m (3.14 NM) along a straight line, azimuth 006° (Figure 8).

Figure 8 - Sketch of the aircraft's estimated trajectory for the intended route. Source: Adapted from Google Earth.
