COMANDO DA AERONÁUTICA
CENTRO DE INVESTIGAÇÃO E PREVENÇÃO DE
ACIDENTES AERONÁUTICOS

FINAL REPORT
A-160/CENIPA/2023

| AIRCRAFT: | PR-MCL |

This Final Report pertains to the December 15, 2023 accident involving the aircraft model 510 of registration marks PR-MCL. The occurrence was typified as “[RE] Runway excursion.”

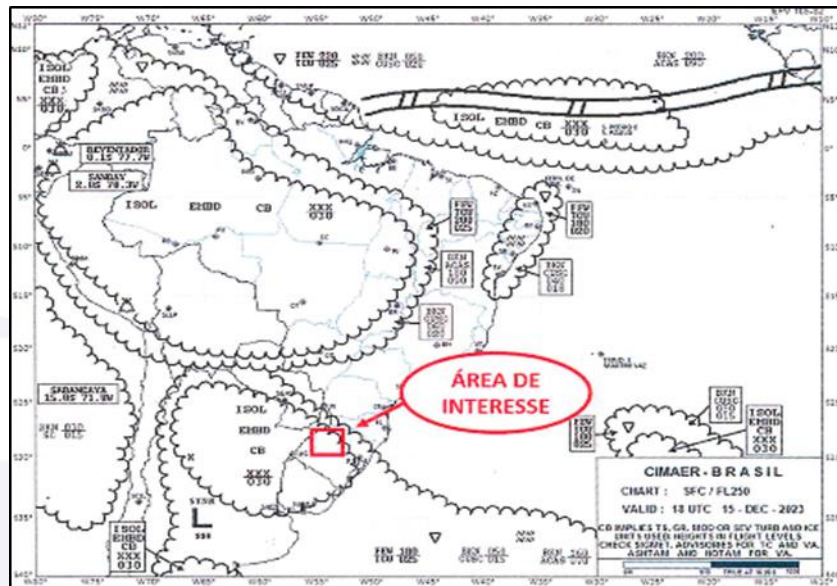
The Significant Weather Chart (SIGWX) for 1800 UTC of December 15, 2023, from the surface to FL250, showed the presence of Tower Cumulus (TCU) clouds with base at 2,500 ft. and tops at 18,000 ft., covering 1 to 2 oktas (FEW); isolated and embedded Cumulonimbus (CB) clouds with base at 3,000 ft. and tops above FL250; medium-level clouds and rain showers and/or continuous rain over the SSIJ region (Figure 3).

Figure 3 – SIGWX Chart highlighting the region of interest.
Source: adapted from REDEMET.

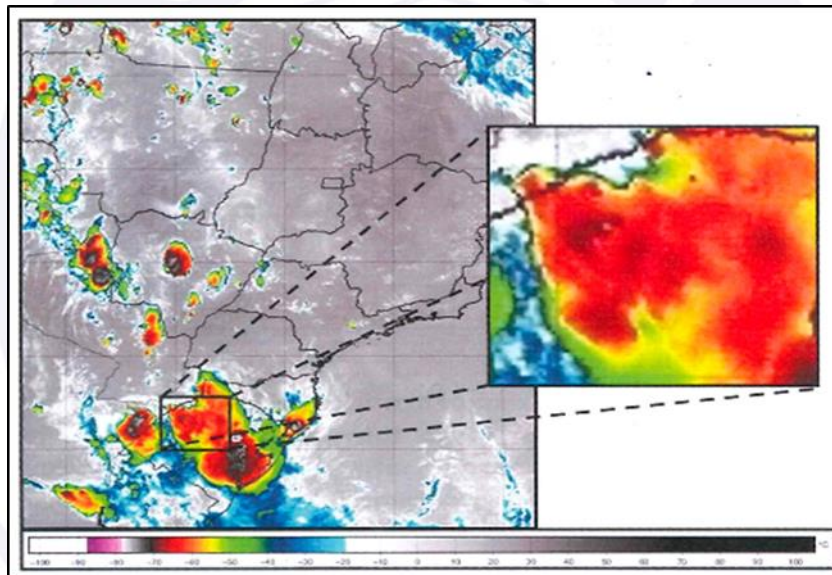
The Geostationary Operational Environmental Satellite (GOES) 16, channel 13, imagery from 2020 UTC of December 15, 2023, showed a cluster of clouds of varying types and altitudes over the region of interest, resulting from the development of thunderstorms (Figure 4).

Figure 4 – GOES-16 satellite image, channel 13. Source: adapted from the Center for Weather Forecasting and Climate Studies (CPTEC).
