COMANDO DA AERONÁUTICA
CENTRO DE INVESTIGAÇÃO E PREVENÇÃO DE
ACIDENTES AERONÁUTICOS

FINAL REPORT
A - 036/CENIPA/2017

OCCURRENCE:	ACCIDENT
AIRCRAFT:	PR-MEY
MODEL:	S-76C
DATE:	01MAR2017

This is the Final Report of the 01MAR2017 accident with the S-76C aircraft model, registration PR-MEY. The accident was classified as “[ARC] ABNORMAL RUNWAY CONTACT – Abrupt Landing”.

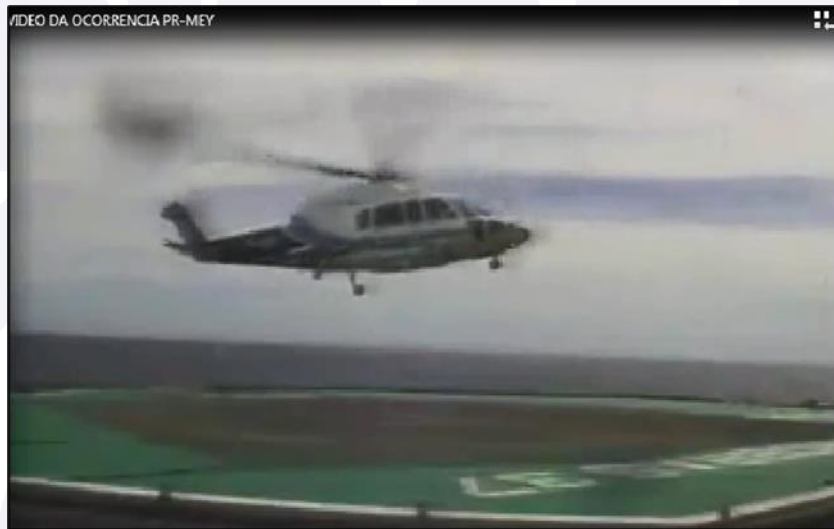
The landing took place in a left roll attitude (approximately 5°), causing the left landing gear to touch the helideck before the right one. Then there was the tip-over of the helicopter on the right and the breakage of the main rotor and tail rotor blades, as well as damage to the aircraft structure.

Figure 4 - Frame of the footage, highlighting the aircraft approach for landing on the helideck.

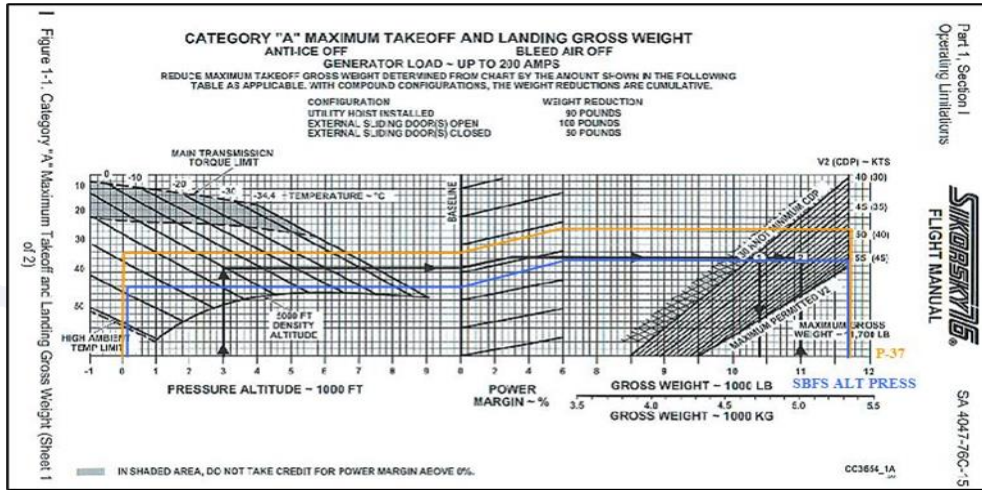
The weight of the aircraft at the time of landing on the P-37 was calculated, considering an estimated fuel consumption of 420 lb/h. Thus, the aircraft would have 880 lbs of fuel and a total weight of 10,934.2 lbs at the time of landing.

Considering the Maximum Takeoff and Landing Gross Weight CAT A chart on page 4-13, figure 4-8, part 1 of the RFM of the S -76C++, it was verified that, both on take-off from SBFS and on arrival at P-37, the aircraft was within the limits of CAT A takeoff and landing operation (Figure 8).

Figure 8 - CAT A Maximum Take-off and Landing Gross Weight graph of the S-76C++ aircraft.

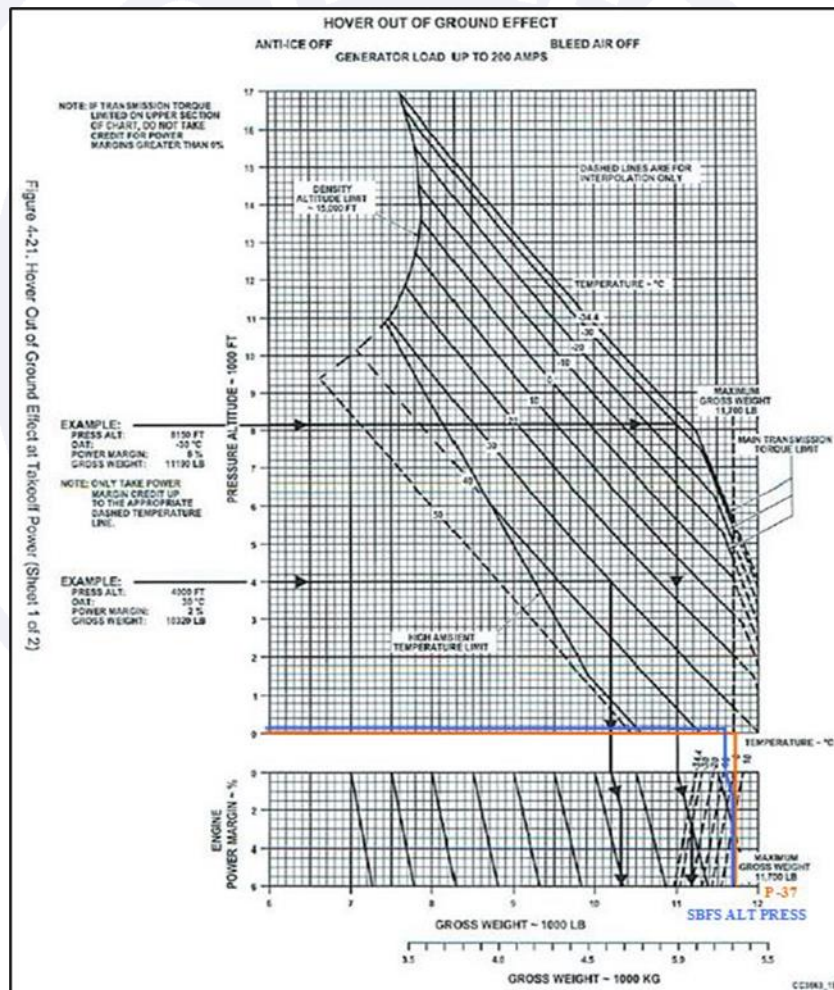
Similarly, using the HOGE graph on pg. 4-32, figure 4-21, Part 1 of the S76C++ RFM, it was verified that, both on take-off from SBFS and on arrival at P-37, the aircraft was within the weight and balance limits, and in conditions to perform the Hover In and Out of Ground Effect (HOGE) and Hover Margin In Ground Effect (HIGE) (Figure 9).

Figure 9 - Hover Out of Ground Effect graphic of the S-76C++ aircraft.

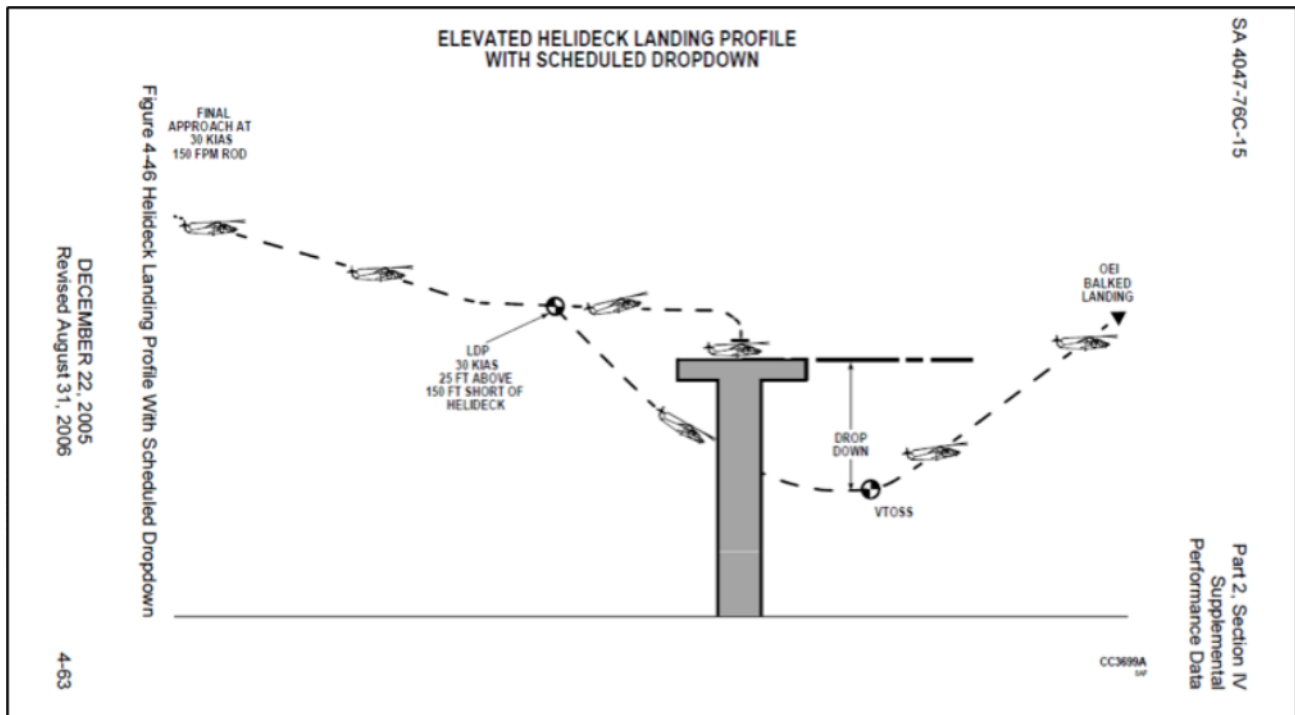
The same manual also established the procedures for landing on an elevated helideck, as shown in Figure 10 and the subsequent translated description.

Figure 10 - Illustration of procedures for landing on an elevated helideck.

The approach started with a speed of 45 kt and a height of 400 ft above the landing surface. The indicated speed of the aircraft on the final approach (45 kt), for wind components up to 20 kt, should be increased by half the component value, while for wind components above 20 kt, it should be increased by 10 kt, in addition to adjustment for wind components up to 20 kt.

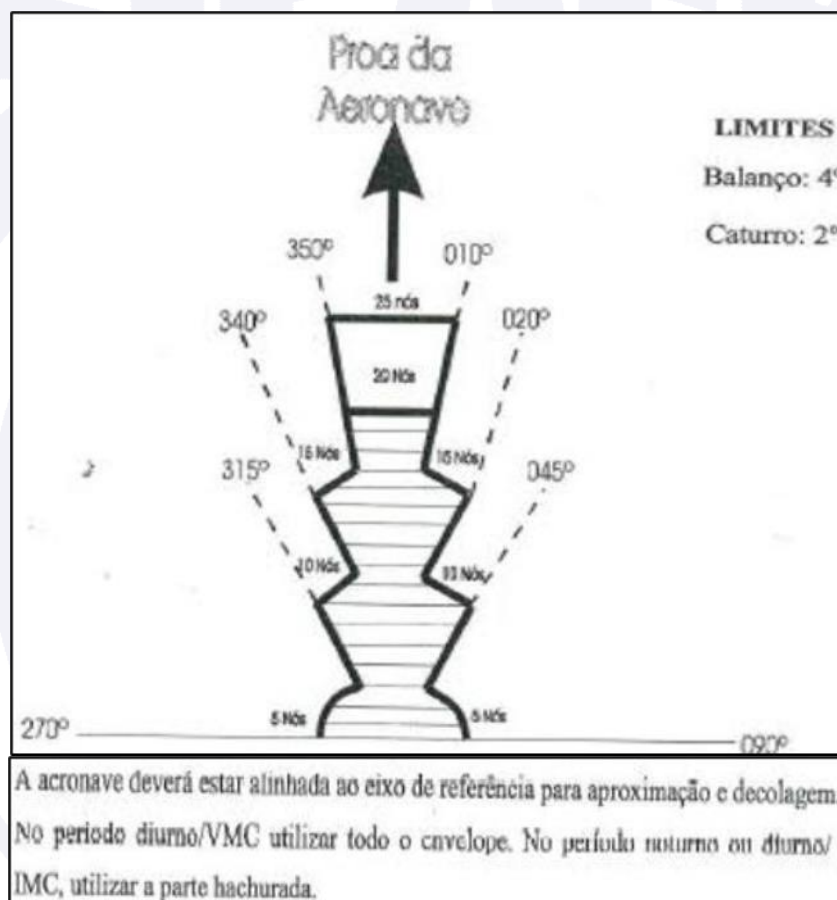
The Brazilian Navy, by way of comparison, had specific take-off and landing envelopes for certain aircraft and selected ships. However, so that the entire fleet of aircraft, in all available helidecks, could be safely operated, it also had a generic flight envelope, which contained wind limitations (Figure 15).

Figure 15 - Generic flight envelope used by the Brazilian Navy.
