FINAL REPORT
IG - 057/CENIPA/2015

OCCURRENCE:	SERIOUS INCIDENT
AIRCRAFT:	PR-MHV
MODEL:	A320-214
DATE:	08APR2015

This is the final report of the serious incident with the A320-214 aircraft, registration PR-MHV, occurred on 08APR2015. The event was classified as “[USOS] Undershoot/Overshoot”.

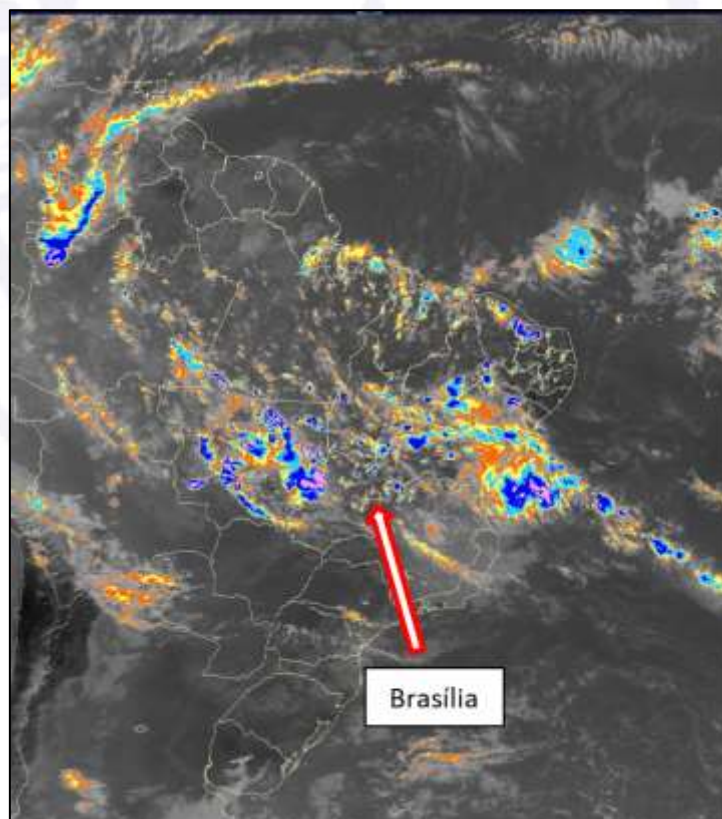
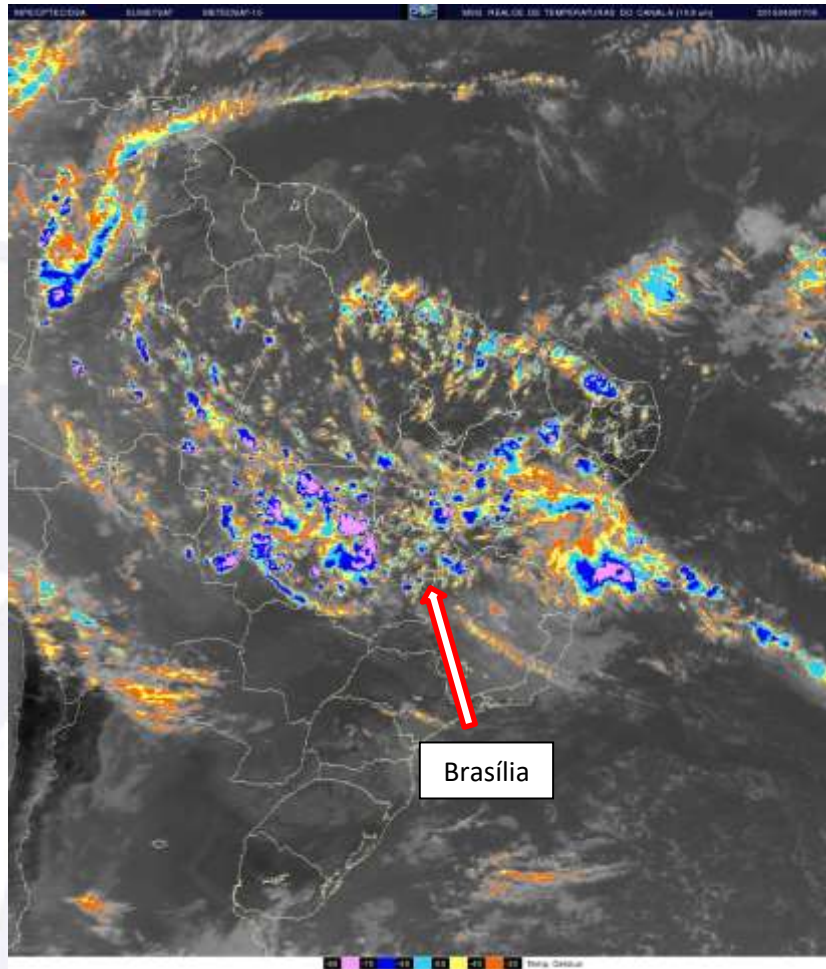
Brazil's satellite images on 08APR2015, between 1600 and 1700 UTC, depicted large area of instability, with isolated CBs over North and Center-West regions, associated to a cold front on the coast of the Northeast region (figures 4, 5, 6, 7, 8, 9 and 10). It is possible to see CB areas over *Brasília*, where SBBR is located.

Figure 4 - Satellite image of temperature enhanced with rainbow coloring - 08APR2015 at 1600UTC.

Figure 5 - Satellite image of temperature enhanced with rainbow coloring - 08APR2015 at 1700UTC.
Credit: CPTEC-INPE.

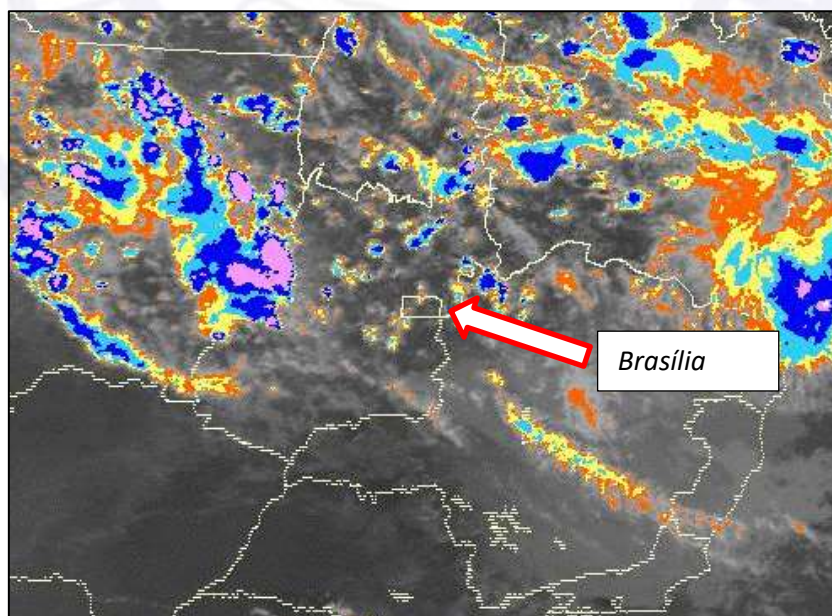
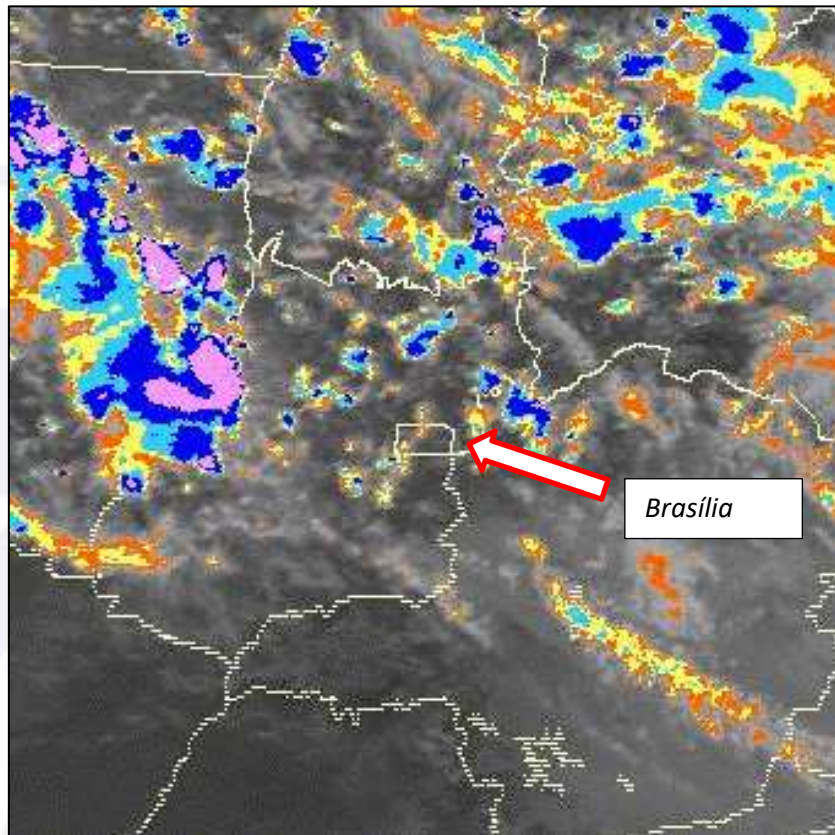
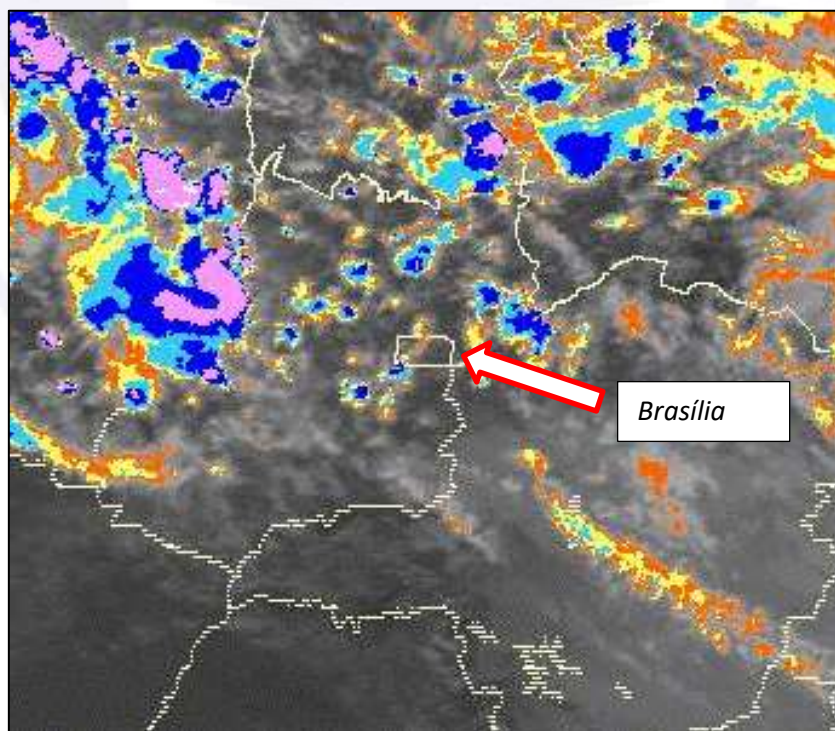
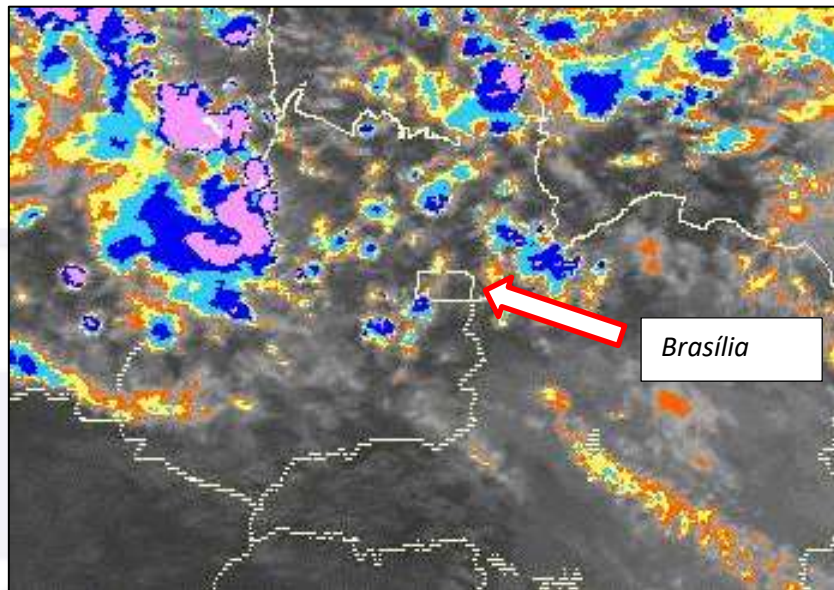
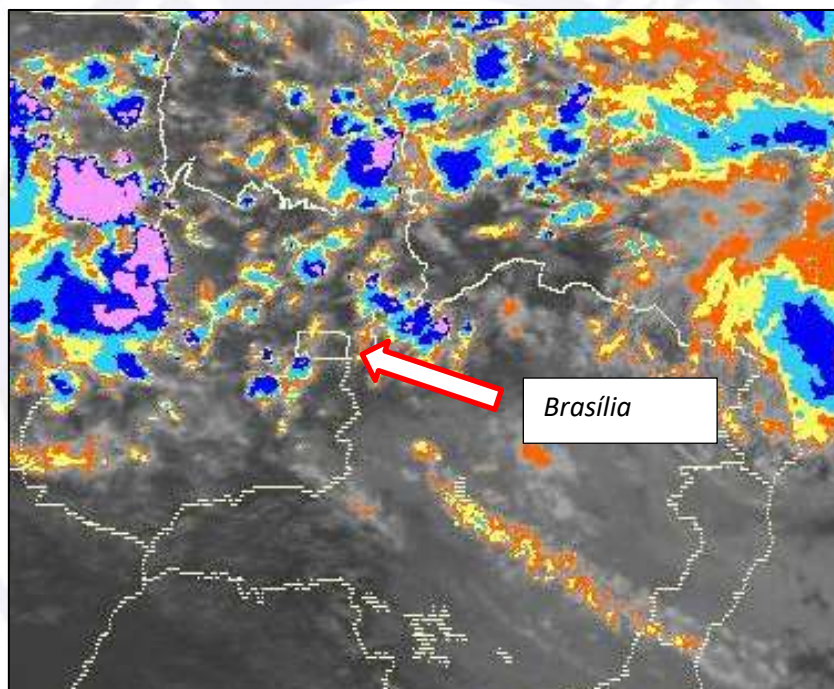
Figure 6 - Satellite image of temperature enhanced with rainbow coloring - 08APR2015 at 1600UTC. (*Brasília* area detailed)
Credit: CPTEC-INPE.

Figure 7 - Satellite image of temperature enhanced with rainbow coloring - 08APR2015 at 1615UTC. (*Brasília* area detailed)
Credit: CPTEC-INPE.

Figure 8 - Satellite image of temperature enhanced with rainbow coloring - 08APR2015 at 1630UTC. (*Brasília* area detailed)
Credit: CPTEC-INPE.

Figure 9 - Satellite image of temperature enhanced with rainbow coloring - 08APR2015 at 1645UTC. (*Brasília* area detailed)
Credit: CPTEC-INPE.

Figure 10 - Satellite image of temperature enhanced with rainbow coloring - 08APR2015 at 1700UTC. (*Brasília* area detailed)
Credit: CPTEC-INPE.

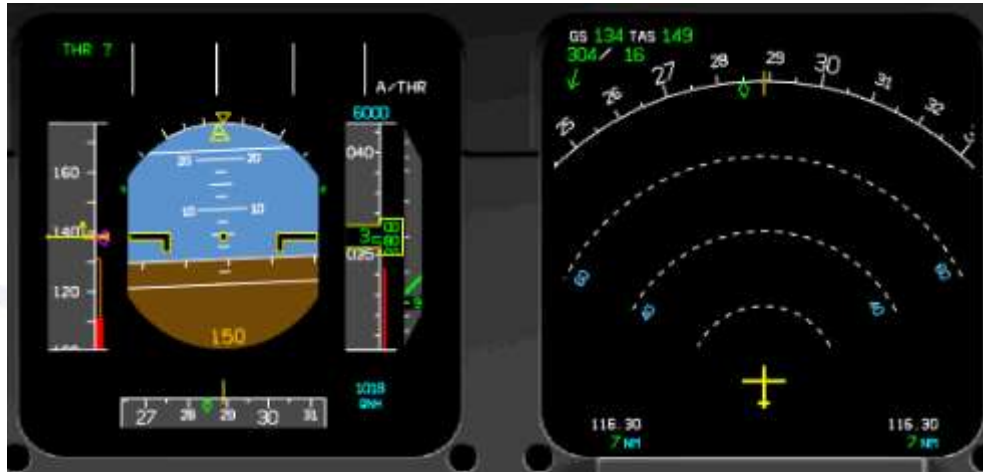
It was also possible to observe GS Mini variations shortly before the landing (Figures 17 to 21).

Figure 17 - FDM data on PFD and ND.

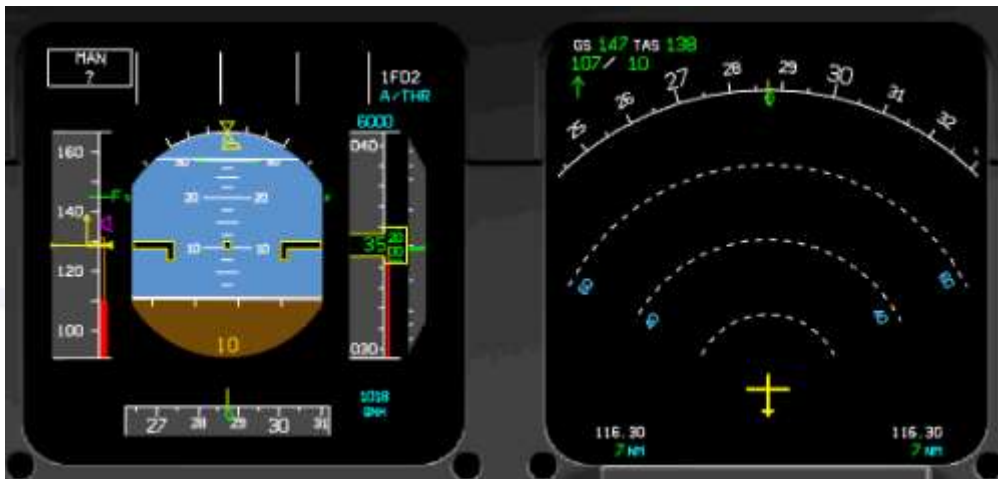
Figure 20 - FDM data on PFD and ND shortly after the aircraft becomes airborne, during the go-around procedure.

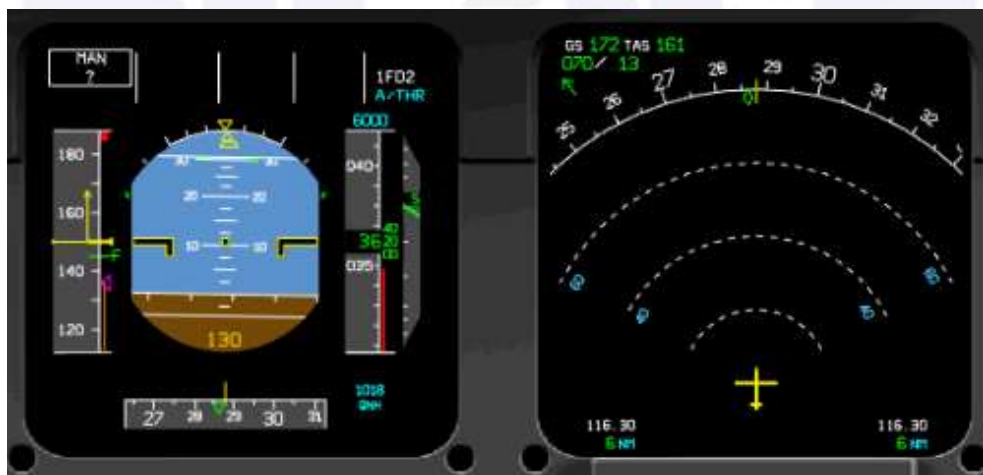
Figure 21 - FDM data during the go-around procedure.
