COMANDO DA AERONÁUTICA
CENTRO DE INVESTIGAÇÃO E PREVENÇÃO DE
ACIDENTES AERONÁUTICOS

FINAL REPORT
A-093/CENIPA/2020

OCCURRENCE:	ACCIDENT
AIRCRAFT:	PR-MJX
MODEL:	AS-350 B2
DATE:	30JUL2020

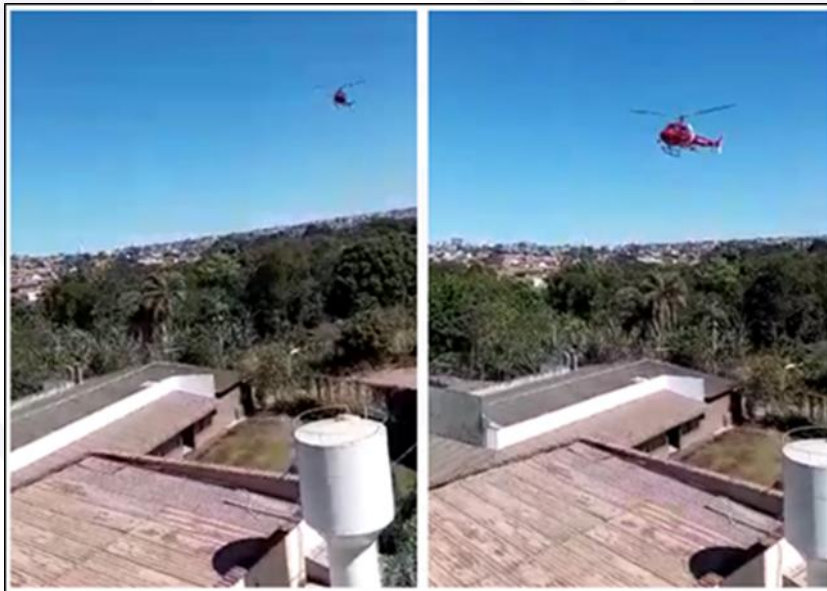
Figure 13 - Initial segment of the PR-MJX's approach.

The PIC performed two orbits to verify the landing conditions, such as: prevailing wind, type of surface, and obstacles. After evaluating the factors that could interfere with a safe landing, he chose to head north, as it was considered the best alternative for a go-around. The landing procedure was then initiated, with the pilot utilizing a high-angle approach.

The sequence of the PR-MJX's approach to landing is shown in Figures 13 and 15.

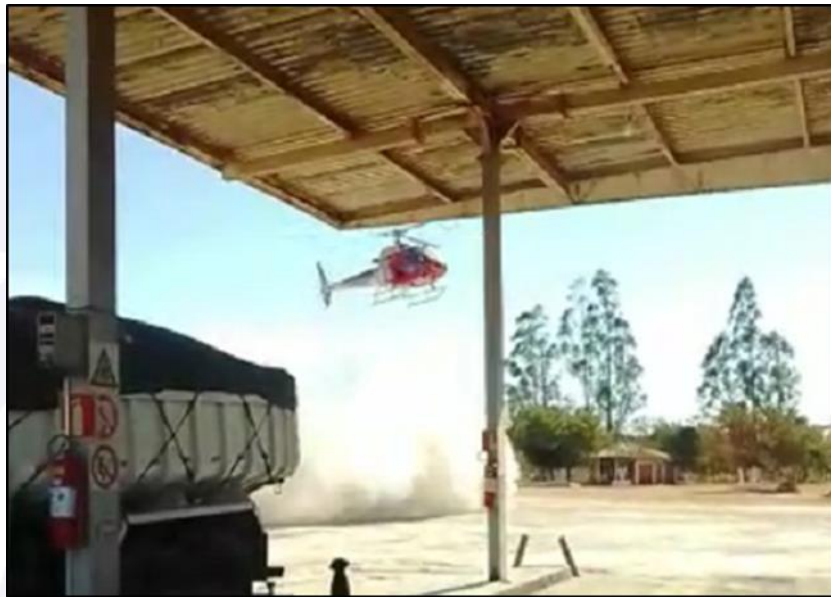
During the landing at the destination, a cloud of dust formed (*brownout*) and the aircraft rolled sideways to the left. The aircraft sustained substantial damage. The pilot, the tactical air-operator, and the nurse were not harmed. The physician suffered serious injuries.

Figures 38, 39 and 40 show the sequence of the final approach for landing of the PT-SUS and shows the formation of the brownout.

Figure 40 – Rise of particles in the landing area caused by the downwash of the main rotor.

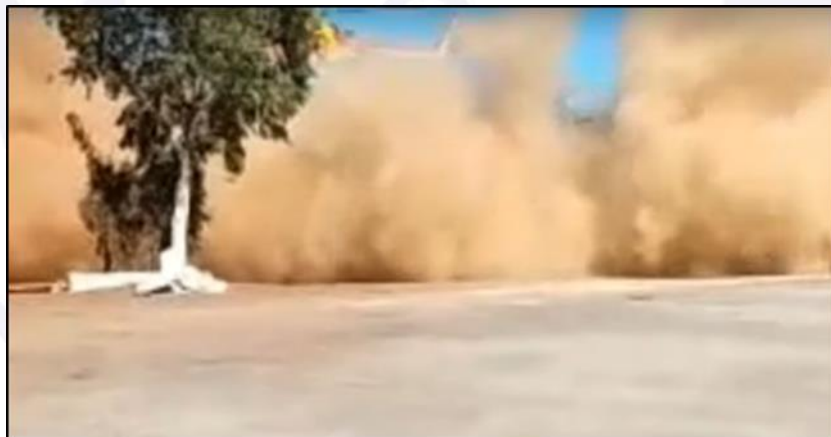
Figure 41 - Helicopter under the brownout effect.
