**COMANDO DA AERONÁUTICA**  
**CENTRO DE INVESTIGAÇÃO E PREVENÇÃO DE**  
**ACIDENTES AERONÁUTICOS**

**FINAL REPORT**  
**A-125/CENIPA/2020**

<b>OCCURRENCE:</b>	<b>ACCIDENT</b>
<b>AIRCRAFT:</b>	<b>PR-MJZ</b>
<b>MODEL:</b>	<b>AS350 B2</b>
<b>DATE:</b>	<b>08OUT2020</b>

This Final Report pertains to the October 8, 2020, accident involving the model AS350 B2 aircraft of registration marks PR-MJZ. The occurrence was typified as “[SCF-PP] Powerplant failure or malfunction.”

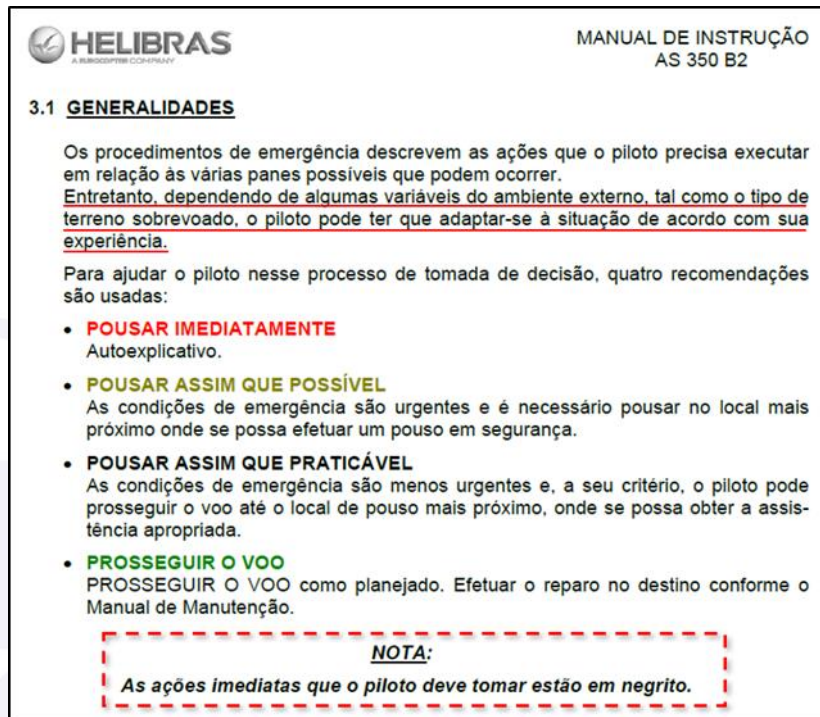
Figure 14 – General Information on Emergency Procedures  
Source: AS350 B2 Flight Manual – HELIBRAS

Regarding Emergency Procedures, the AS350 B2 Flight Manual by HELIBRAS described the actions to be performed by the pilot in the event of various possible failures. The General Information section specified how to identify immediate actions (in bold) within the procedures, adding that depending on external environmental variables, the pilot might need to adapt to the situation based on their experience (Figure 14).

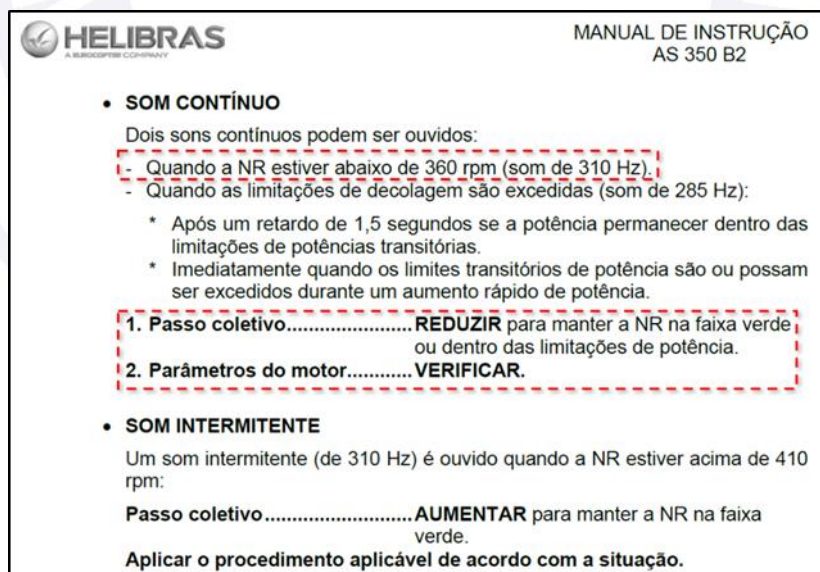
Figure 15 – Aural Warnings Related to NR.  
Highlighted in red: actions to be taken.  
Source: AS350 B2 Instruction Manual – HELIBRAS

This type of helicopter also featured an aural warning system that sounded a buzzer to alert the pilot when NR was outside safe operational limits. When NR dropped below 360 RPM, the pilot would hear a continuous tone. When NR exceeded 410 RPM, an intermittent tone would be heard.

Regarding the aural alerts, the manufacturer's manual specified the procedures to be followed upon detecting such warning tones (Figure 15).

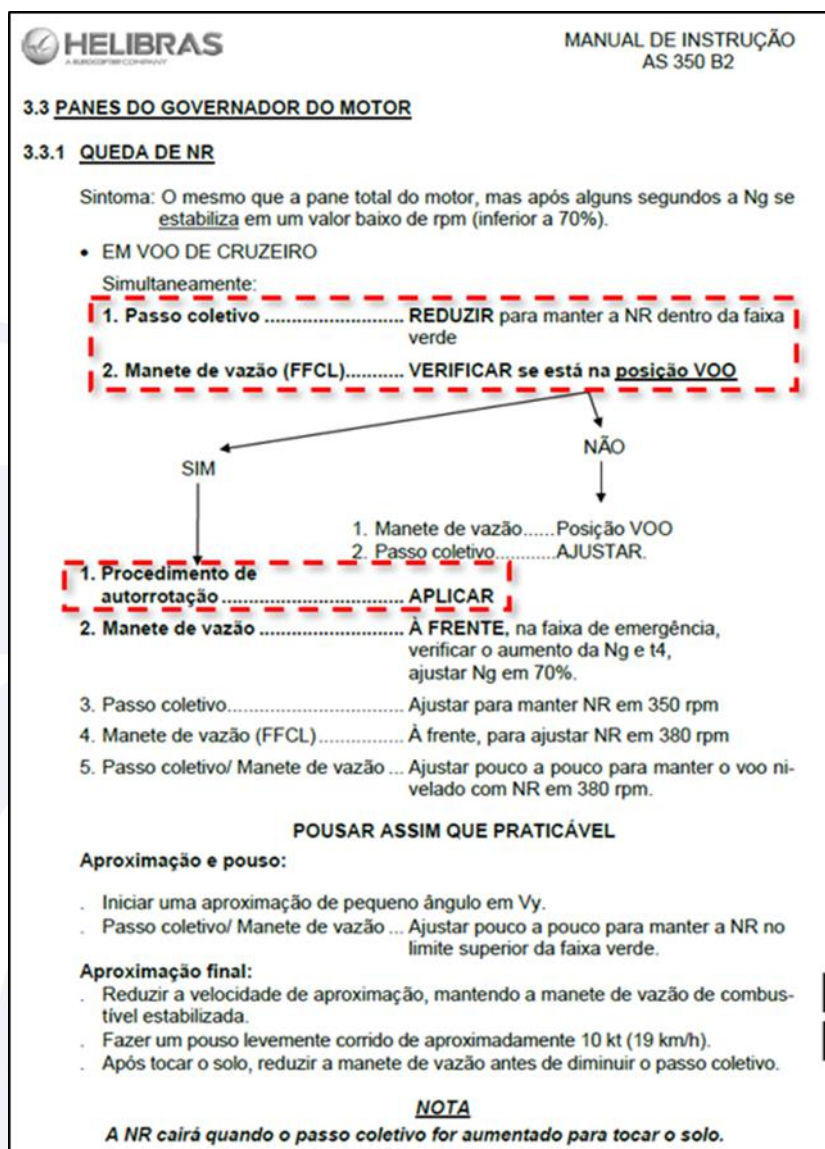
Figure 17 – Procedures for Engine Governor Failures  
Source: AS350 B2 Instruction Manual – HELIBRAS

According to the manufacturer's manual, in Governor Failure situations, the drop in NR would exhibit the same behavior as in the event of a complete engine failure, but after a few seconds, Ng would stabilize. The autorotation procedure was also listed under the specific actions for engine governor failure, although there were additional actions to be taken (Figure 17).

The PIC reported that, following the NR aural warning, the immediate action was to lower the collective control, and that he was unable to observe engine parameters such as oil temperature and pressure. The PIC also stated that the fuel flow lever was not moved to the emergency range, as prescribed in the manufacturer's manual in case of governor failure.
