COMANDO DA AERONÁUTICA
CENTRO DE INVESTIGAÇÃO E PREVENÇÃO DE
ACIDENTES AERONÁUTICOS

FINAL REPORT
A-009/CENIPA/2022

OCCURRENCE:	ACCIDENT
AIRCRAFT:	PR-NEW
MODEL:	R44 II
DATE:	19JAN2022

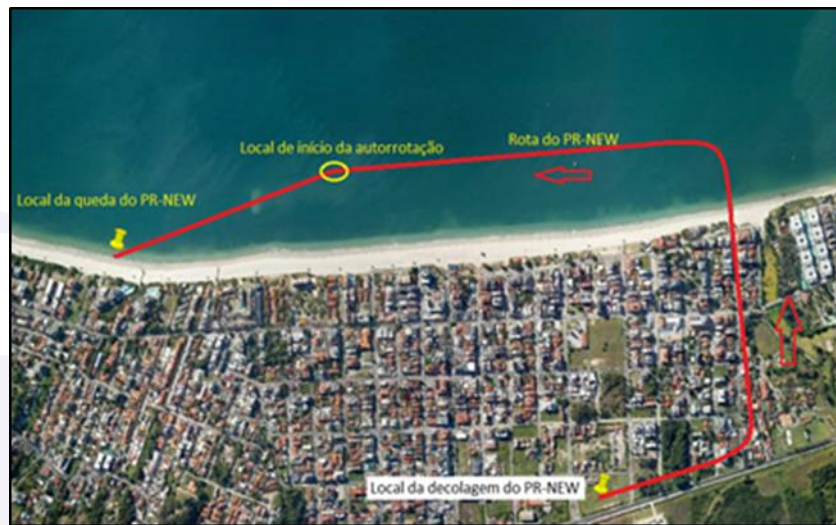
Figure 14 - Croquis indicating the route taken by the PR-NEW.

According to PIC's reports, while flying over the sea at a height of 500 ft. and at a distance of 100 m from the beachfront, he noticed the helicopter's nose yawing to the left, together with a drop of the RPM, illumination of the low-RPM warning light, and activation of the audible alert (horn) indicative of low RPM.
