COMANDO DA AERONÁUTICA
CENTRO DE INVESTIGAÇÃO E PREVENÇÃO DE
ACIDENTES AERONÁUTICOS

FINAL REPORT
A-082/CENIPA/2020

OCCURRENCE:	ACCIDENT
AIRCRAFT:	PR-OFI
MODEL:	BE 58
DATE:	08JUL2020

This is the Final Report of the 08 July 2020 accident with the BE-58 aircraft of registration marks PR-OFI. The accident was typified as “[SCF-PP] Engine failure or malfunction | In-flight engine failure”.

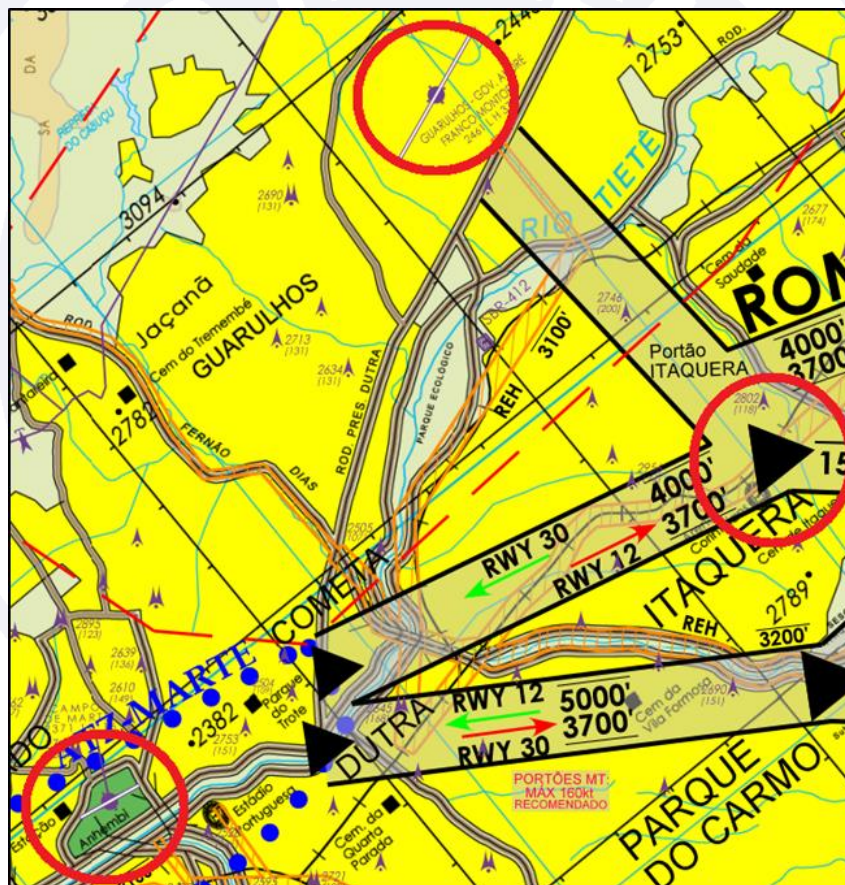
Figure 17 - REA TMA-SP 2 with Itaquera, SBMT, and SBGR positions.

The pilot maintained a single-engine cruise flight from Itaquera position up to SBMT.

Itaquera position was at a distance of 6.7 NM away from SBGR (Governador André Franco Montoro Aerodrome, Guarulhos, SP), which had two runways, one of which measured 3,700 m x 45 m, whereas the other measured 3,000 m x 45 m.

In accordance with the ROTAER, SBGR could not be used as a diversion option by fixed-wing aircraft flying VFR.

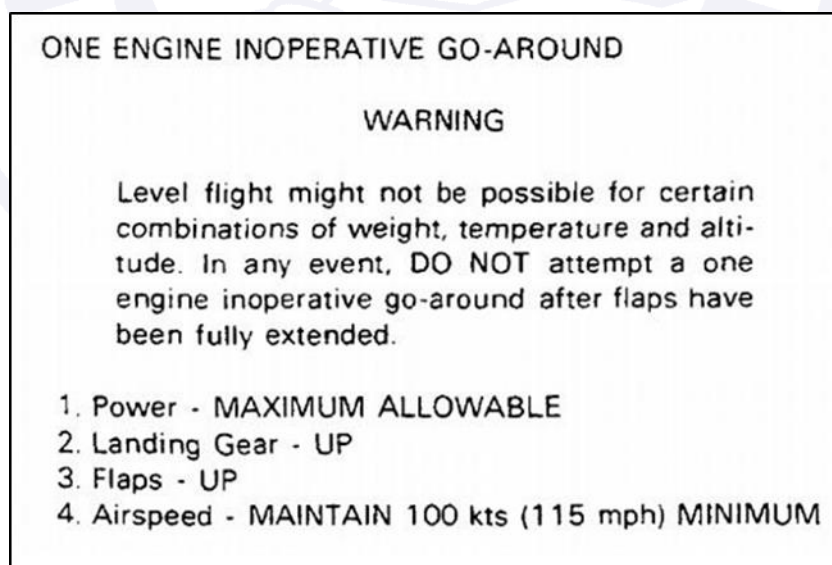
Figure 18 –Procedure for ONE ENGINE INOPERATIVE GO-AROUND.
Source: Aircraft POH.

The go-around procedure with failure in one of the engines (recommended in the Pilot Operation Handbook - POH - of the aircraft) is depicted in Figure 18.

According to the manufacturer's manual, the aircraft would be capable of performing a single-engine go-around, depending on the conditions of weight, temperature, and elevation of the aerodrome. Furthermore, it emphasized that a go-around should not be attempted with the flaps fully lowered.

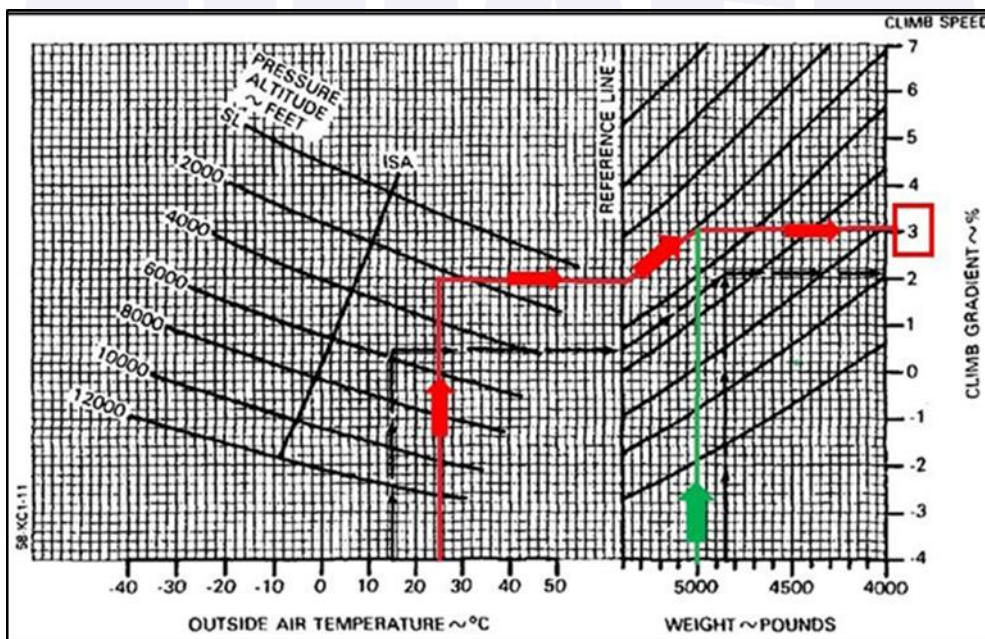
Figure 19 - Extract from the Take-off Climb Gradient – One Engine Inoperative of the aircraft POH.

From the analysis of the communications exchange between APP-SP and the pilot, one found that, shortly before the accident, the aircraft had approximately three quarters ($\frac{3}{4}$) of fuel in the tanks. The temperature at the aerodrome was 25°C, and the aerodrome elevation was 2,371 ft.

Thus, analyzing the Takeoff Climb Gradient - One Engine Inoperative diagram (Section V of the aircraft POH), and estimating an aircraft weight of approximately 5,000 pounds (2,267 kg.), one would obtain a gradient of 3%, according to the projection of the graph in Figure 19.

Considering the only operating engine adjusted for takeoff power, with the aircraft landing gear and flaps retracted, inoperative engine with its propeller feathered, at a speed of 94 kt. recommended by the POH, a rate of climb of 282 ft. /min would be obtained.

Considering that the go-around maneuver would have been initiated at the mid-point of the runway, it is possible to affirm that the aircraft would have a distance of 1.2 NM to the highest obstacle located along the takeoff axis of the runway 30 (i.e. a hill located in the neighborhood of Casa Verde), at an elevation of about 200 ft. (61 m). Maintaining the prescribed speed of 94 kt., the aircraft would travel 1.2 NM to the obstacle in 46 seconds, and would be able to climb approximately 220 ft.

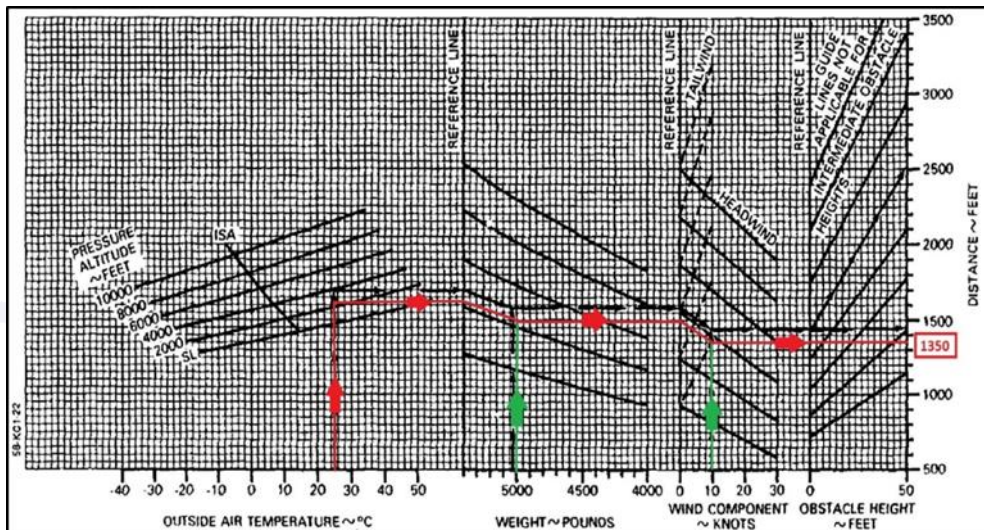
Figure 20 – Extract from the aircraft POH Landing Distance diagram.

If the pilot had chosen to apply the brakes from the mid-point of the runway onwards, and if one analyzes the Landing Distance diagrams in Section V, assuming that the aircraft was subjected to a headwind of 10 kt (as informed via radiotelephony by the control tower) with the landing gear extended and the flaps down, at an approach speed of 91 kt., and fully applying the brakes, the aircraft would be able to stop in 1,350 ft. (412 m), as per the performance diagram illustrated in Figure 20. The length of the runway in SBMT was 1,600 m.

However, it was not possible to determine the speed of the aircraft on the approach, nor the pilot's real motivation in choosing the single-engine go-around.
