**FINAL REPORT**  
**A-078/CENIPA/2021**

<b>OCCURRENCE:</b>	<b>ACCIDENT</b>
<b>AIRCRAFT:</b>	<b>PR-OTF</b>
<b>MODEL:</b>	<b>AW 139</b>
<b>DATE:</b>	<b>02JUN2021</b>

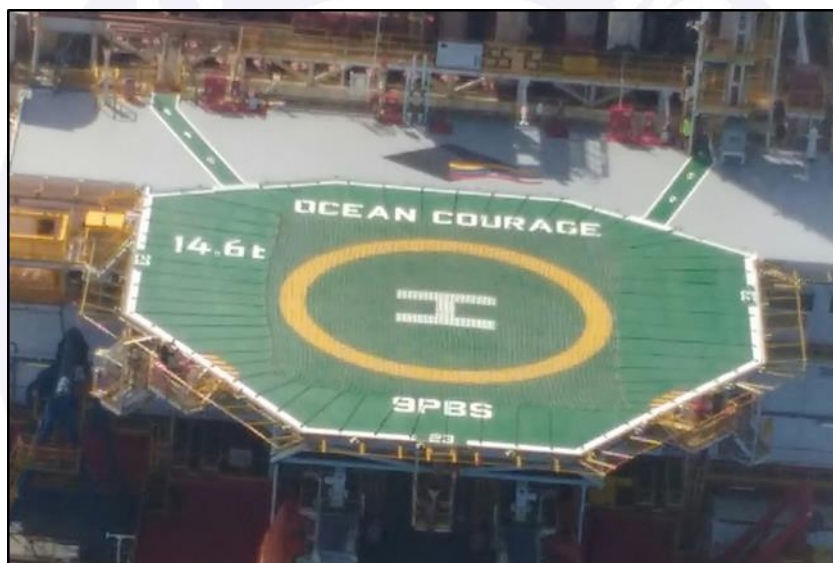
Figure 4 - *Ocean Courage* (9PBS) helideck.  
Source: Brazilian Navy Ports and Coasts Directorate.

The floor was made of metal, with an octagonal shape, and the landing and takeoff area measuring 25.40 m x 24.16 m. It had a pavement resistance of 14.6 tons, and was capable of operating helicopters with a maximum wingspan of 22.8 m (Figure 4).

There was no evidence of any contributions from the maritime unit's infrastructure to the accident.

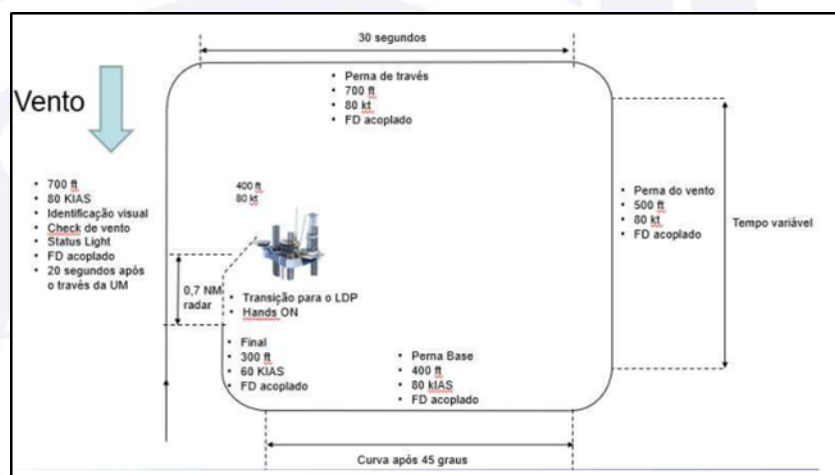
Figure 9 – Traffic pattern for platform and ships.  
Source: SOP 08 LEONARDO AW 139.

The path must follow the legs as shown below (right or left side turns as indicated by wind on UM).

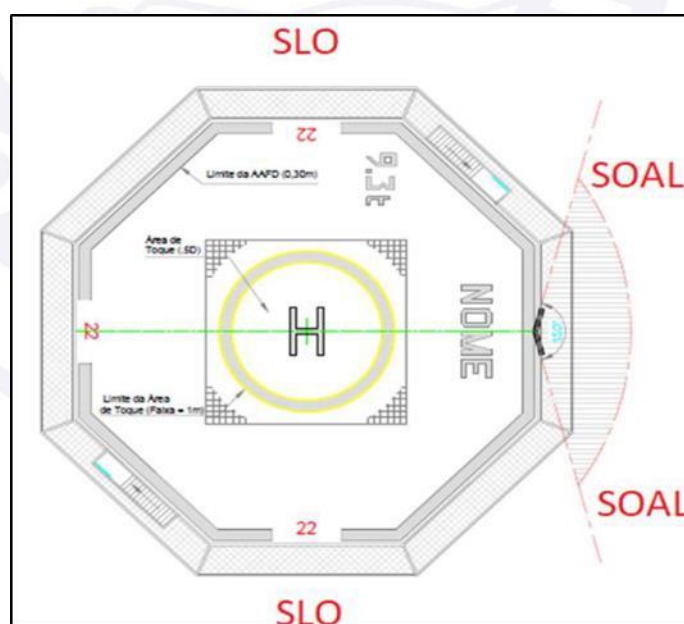
Figure 20 - SLO and SOAL identification.  
Source: Adapted from NORMAM 27 Rev.1

3) Whenever the helicopter is not maneuvered entirely within the SLO on its landing trajectory, the risk of collision with obstacles increases significantly.

4) In an aircraft accident with five fatalities that occurred in Brazil in 2003, the aircraft's tail rotor hit the mast of a vessel because the helicopter was not maneuvered entirely within the SLO during the landing trajectory selected. In 2012 and 2017, two other events involving the tail rotor hitting obstacles outside the SLO and SOAL occurred for the same reason.
