**COMANDO DA AERONÁUTICA**  
**CENTRO DE INVESTIGAÇÃO E PREVENÇÃO DE**  
**ACIDENTES AERONÁUTICOS**

**FINAL REPORT**  
**A - 005/CENIPA/2016**

<b>OCCURRENCE:</b>	<b>ACCIDENT</b>
<b>AIRCRAFT:</b>	<b>PR-PDD</b>
<b>MODEL:</b>	<b>ATR-72-212A</b>
<b>DATE:</b>	<b>09JAN2016</b>

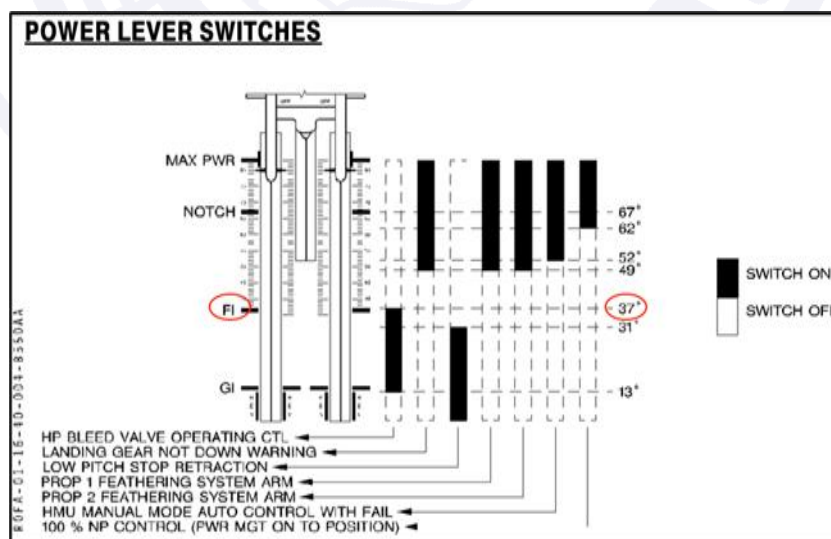
Figure 14 - Engine power levers with TLA angles. (Source: FCOM).

According to the FCOM, Part 1, Chapter 16, Section 40, Page 4, Revision APR 2008, the engine throttle pedestal had certain TLA values for positions corresponding to the power lever. Among these values, we highlight the value of 37° for the Flight Idle (FI) position, minimum power allowed in flight (Figure 14).

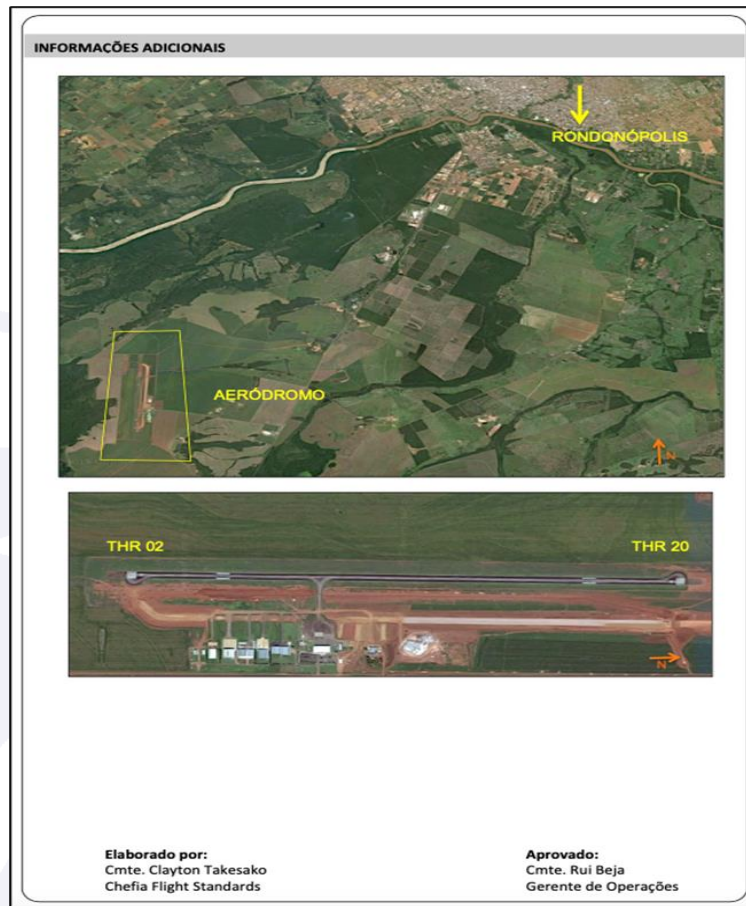
Figure 21 - Airport Briefing to SBRD (Back)

Although the Airport Briefing mentions the term black hole, there was no explanation of the phenomenon in the document, the MGO and the SOP, nor the risks involved when it occurs during approaches.

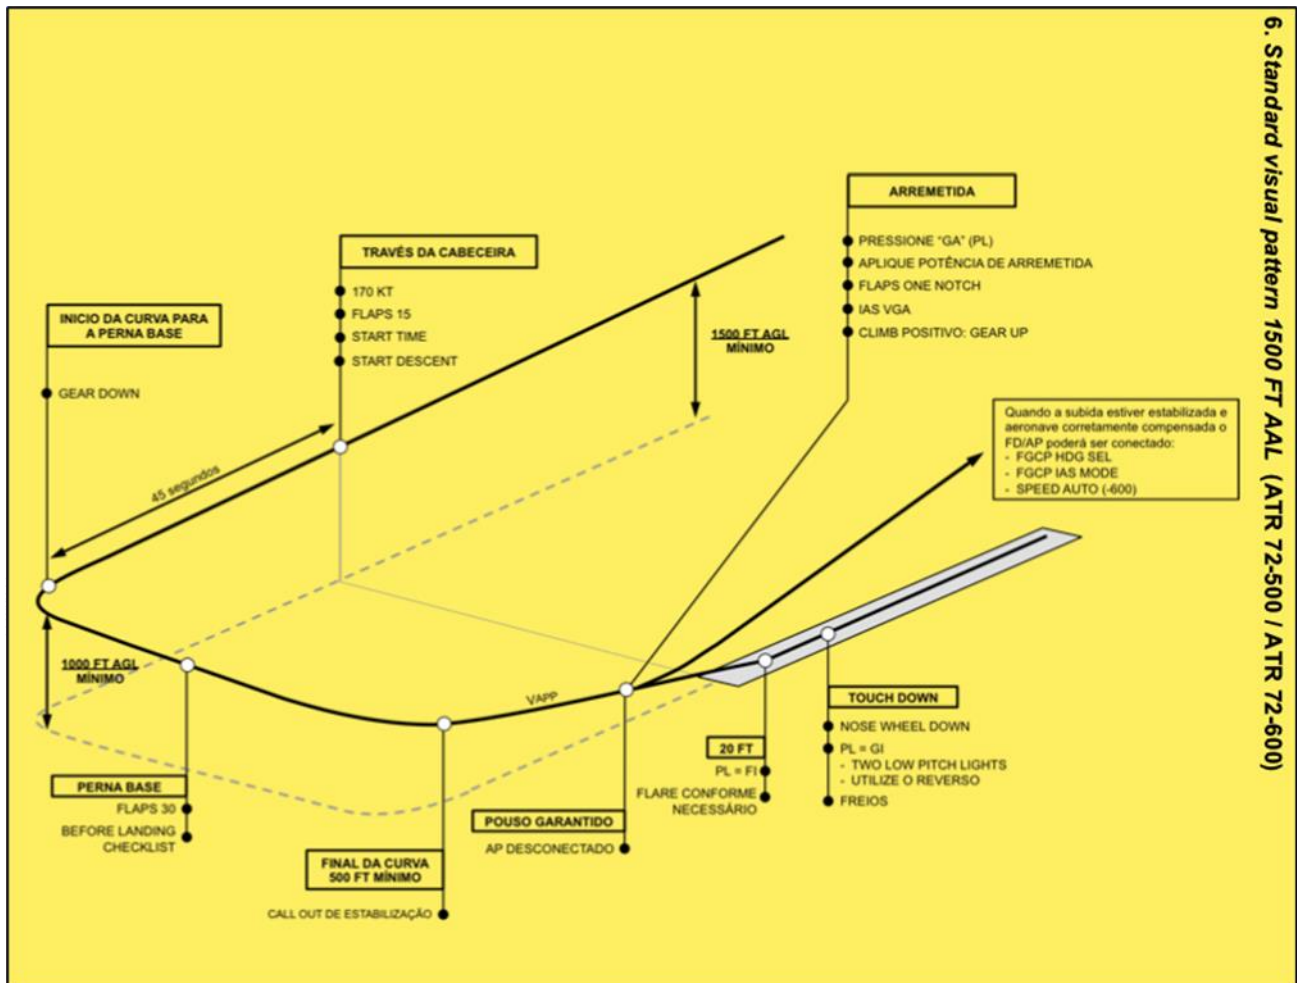
Figure 22 - Approach profile for constant visual landing of the operator's SOP.  
Source: The Operator.

Aligned with the runway axis, the pilots should decide to continue the approach for landing or to start a go-around procedure. If the decision was to proceed with the approach, the pilots should disconnect the autopilot when they were with the landing assured, and proceed to the landing. If they opted for a go-around procedure, they should follow the procedures contained in the SOP for this maneuver (Figure 22).

Comparing Figures 22 and 24, there are some differences between the profile defined by the SOP and the one performed by the crew, mainly with regard to the moment of the aircraft configuration for landing and the moment of disconnection of the autopilot.

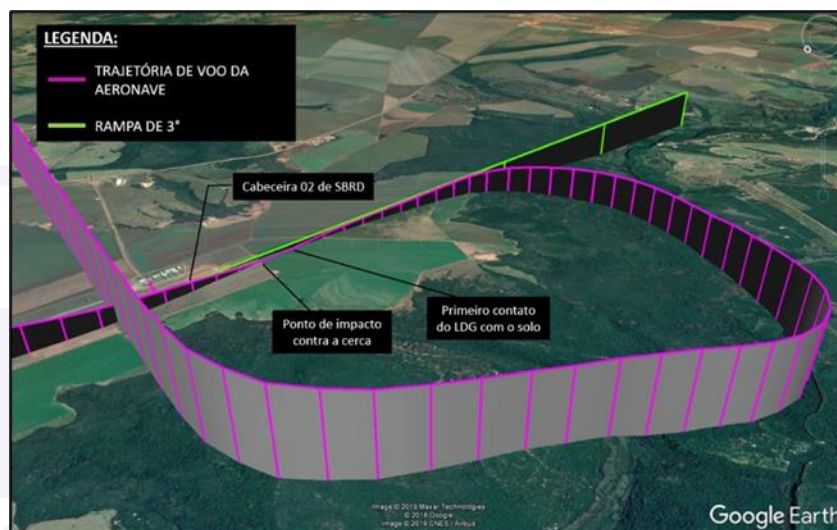
Figure 26 - Top view of the path taken by the aircraft during the traffic circuit.  
Source: Adapted from Google Earth.

For this comparison, a green line with a 3° angle was drawn from the threshold 02 of the SBRD runway. The magenta line illustrates the trajectory developed by the aircraft, based on data collected by the FDR, as shown in Figures 24 and 26.

Figures 26, 27 and 28 illustrate different perspectives of the ramp developed by the aircraft, in comparison with the 3° ramp, drawn from the threshold 02.

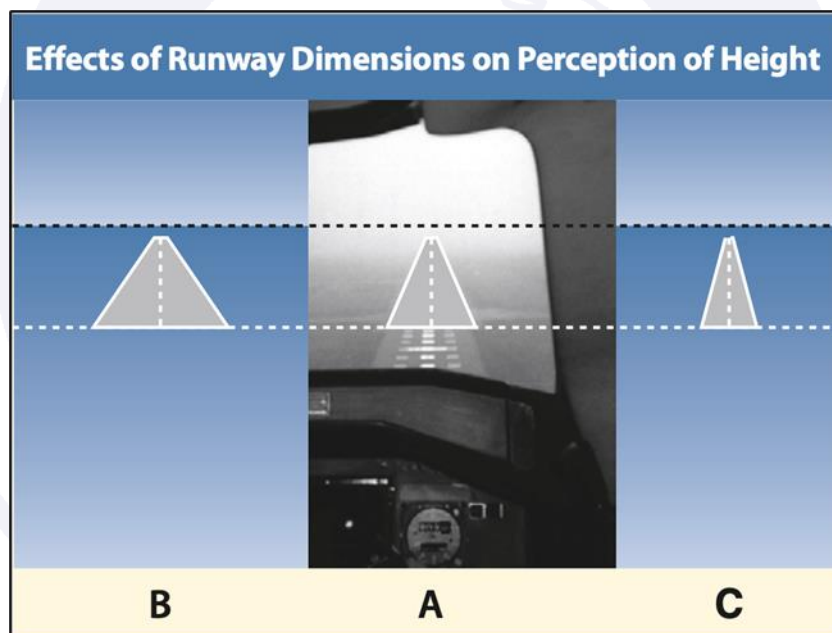
Figure 30 - Influence of the runway width on the pilots' height perception.  
Source: Flight Safety Foundation.

Figure 30, extracted from the ALAR Briefing, Note 5.3, illustrates the effect of the runway width on the pilots' height perception during a visual night approach.

The three panels in Figure 30 show the view from inside the cockpit of an aircraft at 200ft in height, on a 3° approach ramp.
