FINAL REPORT
A-157/CENIPA/2018

OCCURRENCE:	ACCIDENT
AIRCRAFT:	PR-PMT
MODEL:	A109E
DATE:	11OUT2018

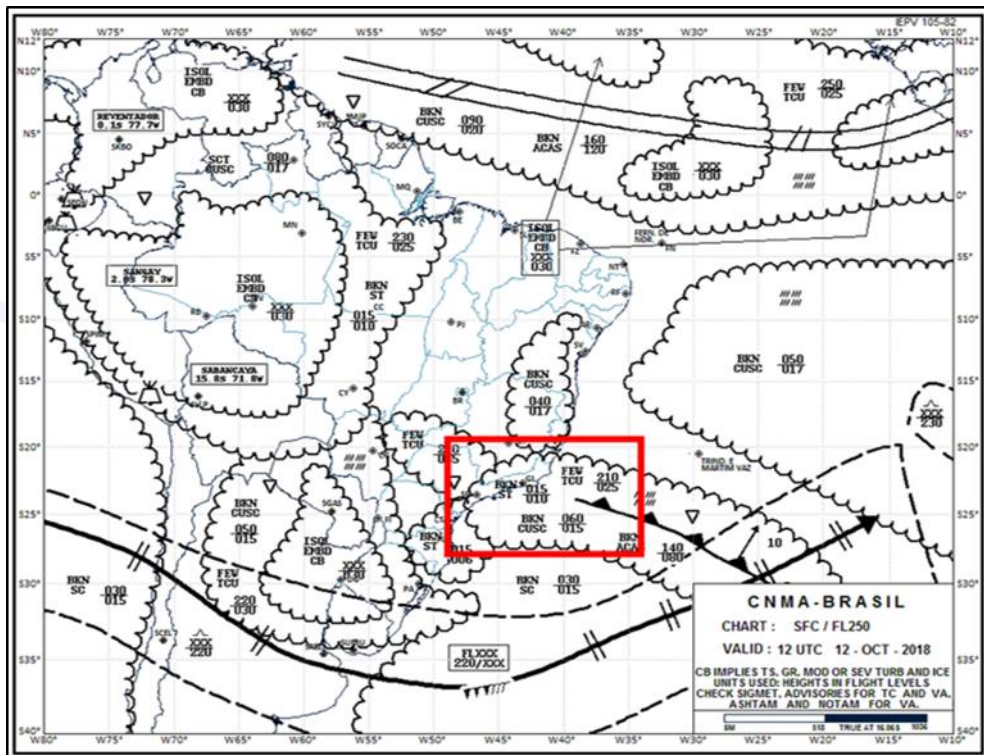
- Stratus cloud layer (ST) with coverage of 5 to 7 oktas (BKN), between levels FL010 and FL015;
- Stratocumulus cloud layer (SC) with coverage of 5 to 7 oktas (BKN), between FL015 and FL060;
- Towering-Cumulus clouds (TCU) with coverage of 1 to 2 oktas (FEW), and developing between levels FL025 and FL210;
- Rain (RA) and Showers (SHRA), among other phenomena (Figure 3).

Figure 3 - SIGWX chart valid until 12 Oct 2018 (12:00 UTC). Source: REDEMET.

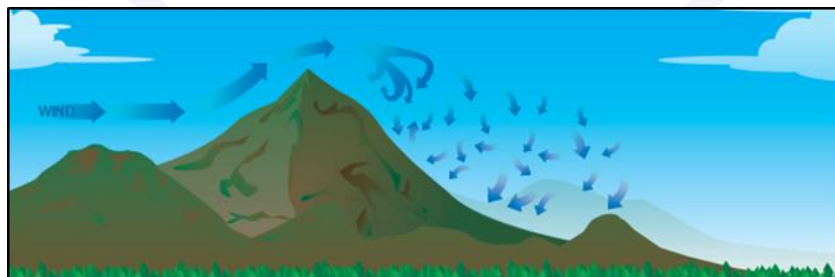
About the subject, the Chapter 12 - Weather Theory of the Federal Aviation Administration (FAA), stated that while the wind flows smoothly through the windward side of the mountain, and the updrafts help to carry an aircraft above the mountain peak, the leeward wind doesn't work the same way. As the air flows to the leeward side of the mountain, the air following the contour of the land is increasingly turbulent. This tends to push an aircraft down. The stronger the wind, the greater the descending rate and the intensity of the turbulence (Figure 4).

Figure 4 - Turbulence in a mountainous region.
Source: adapted from Chapter 12 - Weather Theory - FAA.

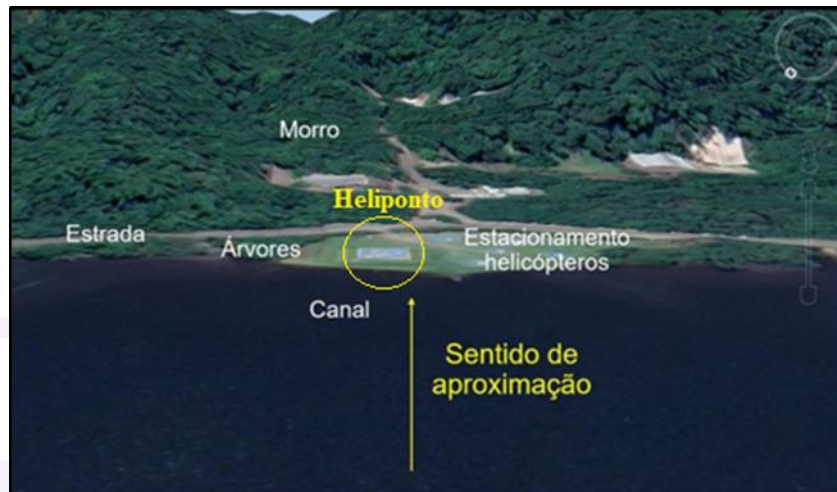
After the road (rear limit), in the extension of the approach axis, there was an elevation approximately 200 meters high (a hill between the helipad and the coastline) (Figure 5).

Figure 5 - View of the obstacles around the helipad, in the direction of approach
Source: adapted from Google Earth.

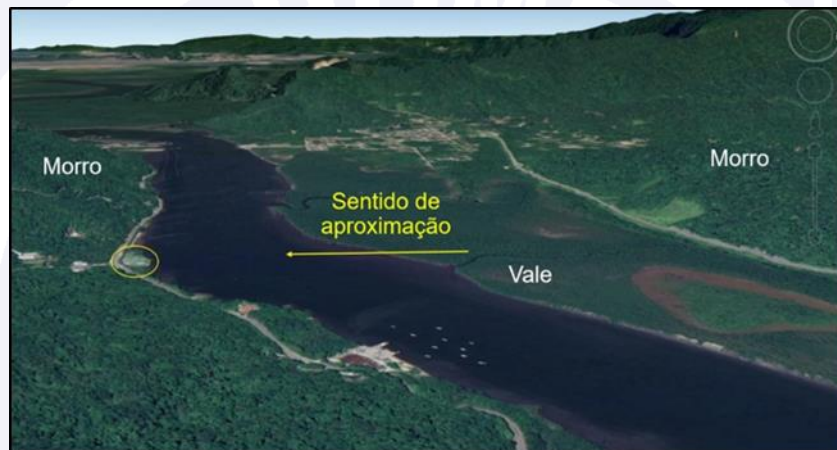
Preceding the canal in the direction of approach, there was high terrain (part of the *Serra do Mar* mountain range), demanding that the approach for landing be carried out from the inside of the valley, but in a direction perpendicular to it (Figure 6).

Figure 6 - Side view of the approach performed by the PR-PMT.
Source: adapted from Google Earth.

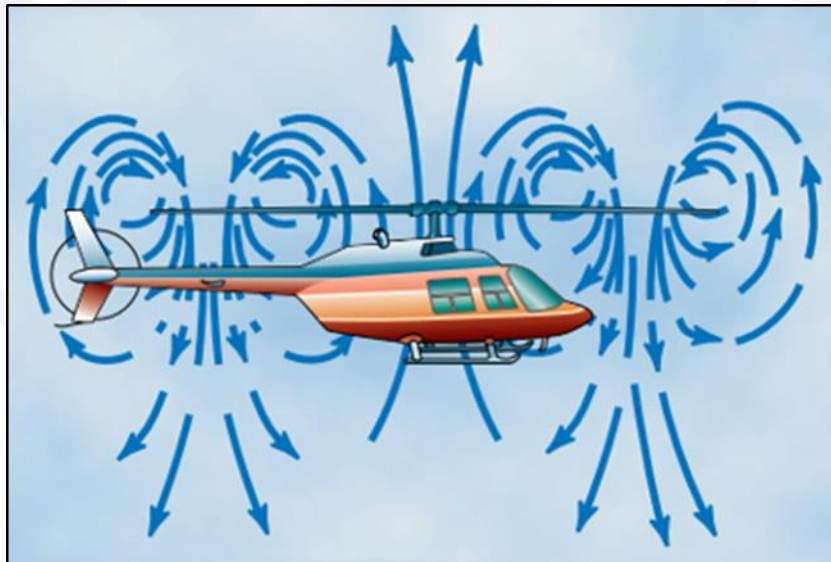
In such condition, most of the energy developed by the engine is wasted in accelerating the air in a "thread pattern" around the rotor. This causes instability of the airflow over a large area of the rotor disk, causing the rotor efficiency to be lost, even though power is still being supplied by the engine (Figure 11).

Figure 11 - Vortex Ring State.
Source: Rotorcraft Flying Handbook (FAA).
