COMANDO DA AERONÁUTICA
CENTRO DE INVESTIGAÇÃO E PREVENÇÃO DE
ACIDENTES AERONÁUTICOS

FINAL REPORT
A - 148/CENIPA/2018

| AIRCRAFT: | PR-RFB |
| MODEL: | C90A |

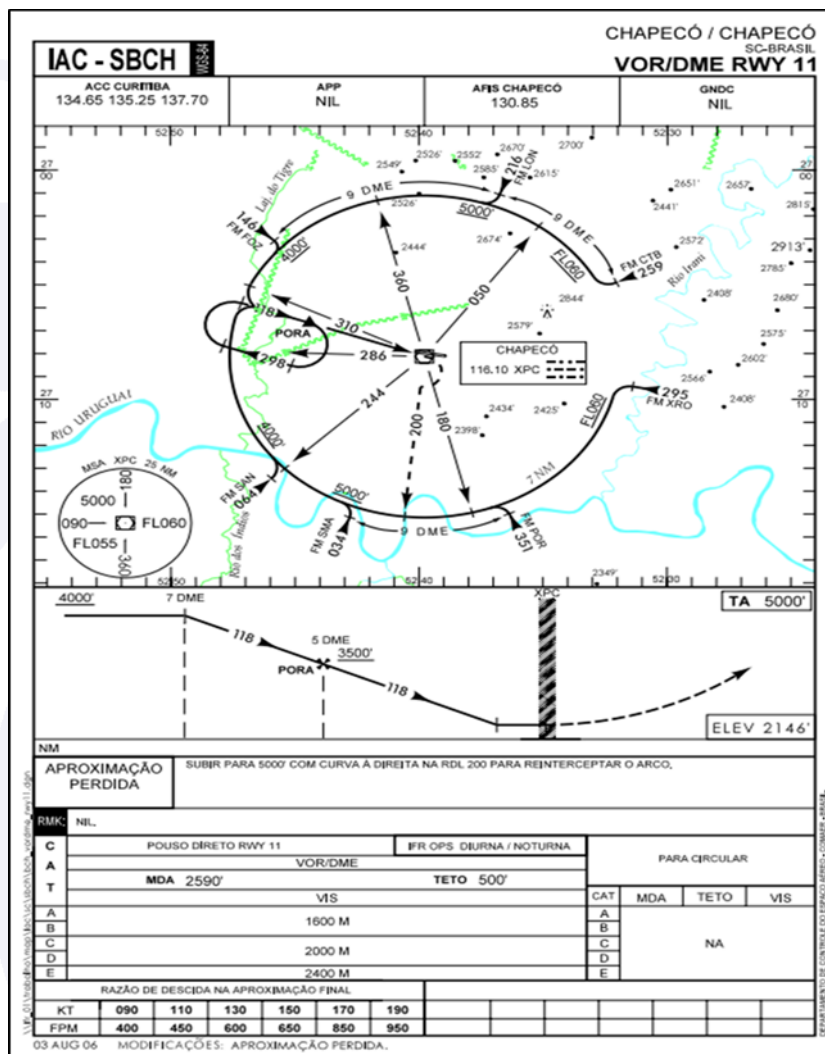
Figure 3 - VOR/DME RWY 11 approach procedure from SBCH.

The SBCH Aerodrome had two instrument approach procedures for runway 11. One of the procedures was marked out by a VOR, as shown in Figure 3.

The VOR/DME RWY 11 procedure prevised its start in an arc marked out by DME at 9 NM, with a minimum flight level of 060 for aircraft coming from SBFL.

Likewise, the MSA, predicted up to 25 NM from SBCH, was FL060.

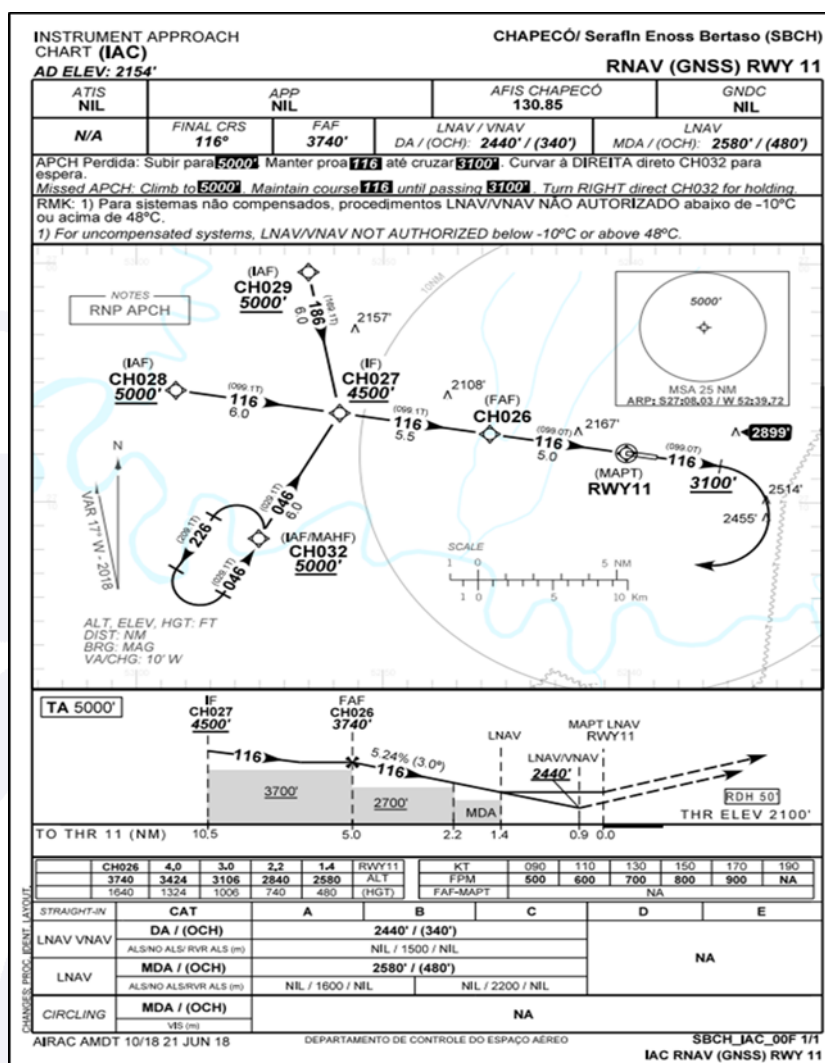
Figure 4 - SBCH RNAV RWY 11 Approach Procedure.

The second procedure was an RNAV, RNAV RWY 11, which prevised its start at the IAF, with a minimum altitude of 5,000 ft. The predicted MSA up to 25 NM of SBCH, for this procedure, was 5,000 ft (Figure 4).
