**COMANDO DA AERONÁUTICA**  
**CENTRO DE INVESTIGAÇÃO E PREVENÇÃO DE**  
**ACIDENTES AERONÁUTICOS**

**FINAL REPORT**  
**A-002/CENIPA/2019**

<b>OCCURRENCE:</b>	<b>ACCIDENT</b>
<b>AIRCRAFT:</b>	<b>PR-RMZ</b>
<b>MODEL:</b>	<b>R44 II</b>
<b>DATE:</b>	<b>01JAN2019</b>

This is the Final Report of the 01 January 2019 accident with the R44 II helicopter, registration marks PR-RMZ. The occurrence was typified as “[SCF-PP] Engine failure or malfunction”.

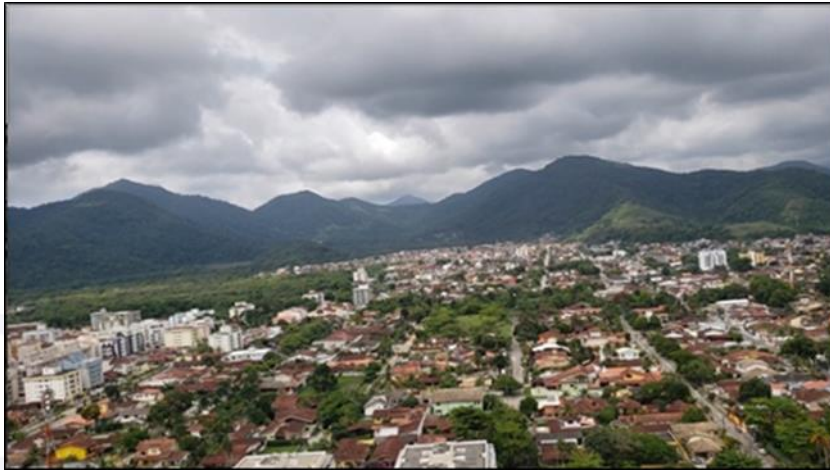
The aerodrome of SDUB did not have meteorological information services. At any rate, as observed in the footage taken by the passengers' cameras, the sky had a layer of clouds above the nearest elevations, that is, at least above 1,000 ft in height, and the visibility was more than 10 km. The temperature in the region was approximately 30°C (Figure 3).

Figure 3 - Panoramic view of *Ubatuba* moments before the accident.

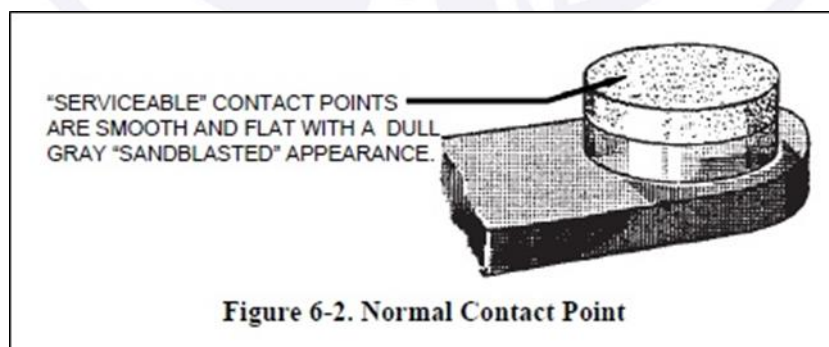
This condition indicated that the points were wearing evenly and fitting properly together. The Item 4 also clarified that the contact assemblies should be replaced if they were “burnt, pitted, peaked, or otherwise damaged”.

Figure 15 - Image taken from the magnetos' manual showing what the appearance of the contact points should be after being removed for inspection.

The Figure 15 shows that contact points in good condition should have a smooth and flat surface, with a dull gray “sandblasted” appearance.

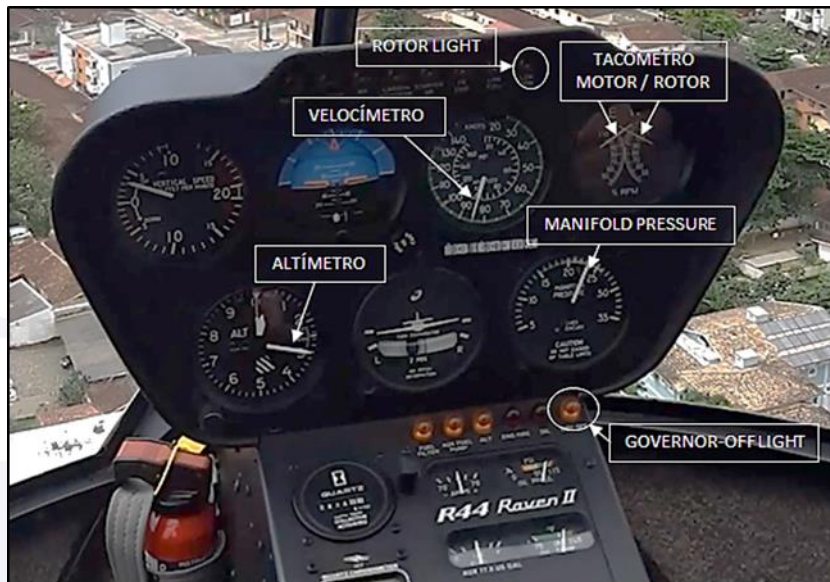
The helicopter then accelerated to about 85 kt, and adjusted the rate of climb to 500 ft/min. From the start-up until that moment, the engine and rotor RPM parameters remained stabilized in the normal operating range (Figure 16).

Figure 16 - PR-RMZ panel, without discrepancies, during the climb after takeoff.

As seen in Figure 16, the governor's alarm light was off, an indication that it was illuminated during the flight in question. Therefore, in accordance with the Section 7 (Systems Description, Warning And Caution Lights), the governor alarm light (*governor-off light*) would only illuminate if the respective switch was turned off.

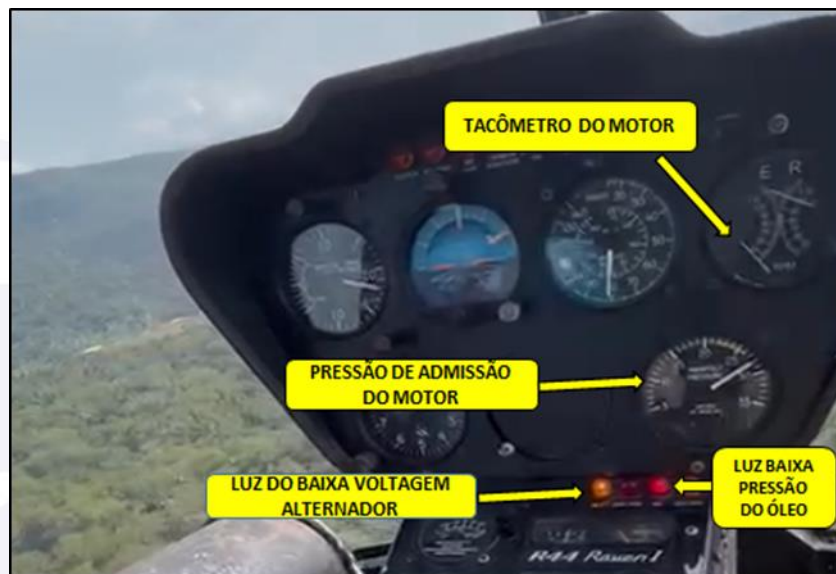
With the engine not operating, the intake pressure would correspond to the local atmospheric pressure, that is, something between 27 and 30 inHg, as can be seen in Figure 26, which captured the image of the panel of an R 44I helicopter during a situation of engine failure in flight.

Figure 26 - Image of an engine failure in flight, involving another R 44 helicopter.

Other aspects observed in the Figure 26 attest to an engine shutdown condition in flight, such as illumination of the low oil pressure lights, low alternator voltage, and engine tachometer indicating 0%.
