COMANDO DA AERONÁUTICA
CENTRO DE INVESTIGAÇÃO E PREVENÇÃO DE
ACIDENTES AERONÁUTICOS

FINAL REPORT
A-112/CENIPA/2017

OCCURRENCE:	ACCIDENT
AIRCRAFT:	PR-RSP
MODEL:	S2R-H80
DATE:	06SET2017

This is the Final Report of the 06 September 2017 accident with the S2R-H80 aircraft, registration marks PR-RSP. The accident received the typification of “[SCF-PP] Engine failure or malfunction”.

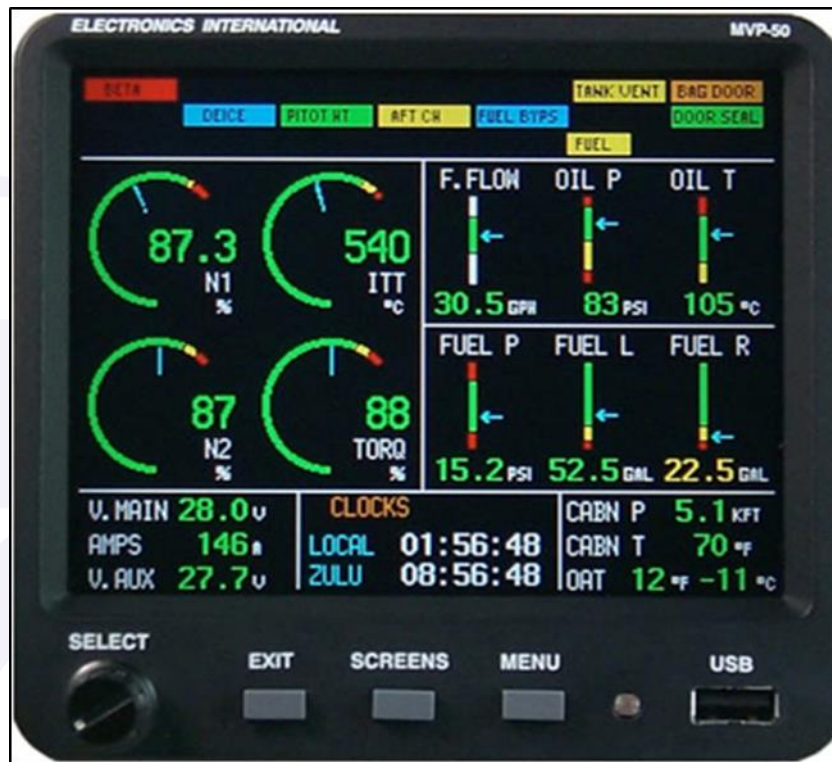
Figure 2 - Panel of the aircraft's MVP-50T.

The MVP-50T's digital screen displayed data of the engine, alarm panel, as well as some information concerning the aircraft's systems, such as the electrical, hydraulic and fuel systems (Figure 2). One of the engine instruments displayed was the torque indicator.

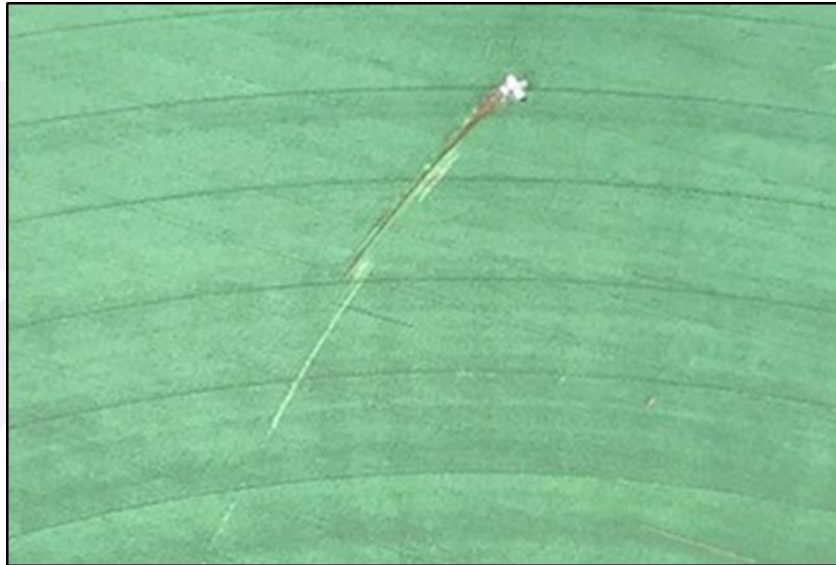
Figure 3 - Aircraft trajectory from the first impact to the complete stop.

The first contact with the ground occurred in a straight attitude (approximately 5°), with a banking of approximately 25° to the left. After this first impact, the plane touched the ground two more times, traveling a distance of 60 m until coming to a complete stop. (Figure 3).

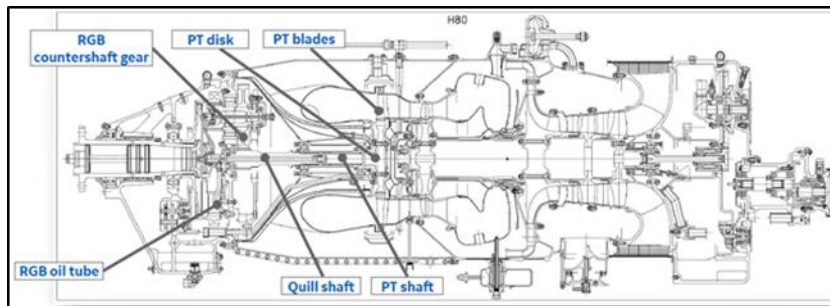
Figure 11 - Schematic drawing of the engine showing the position of the main internal components that were subject to more detailed evaluations.
Source: Investigation Report GEAC.

Figure 11, below, shows the position of the main internal components that were subject to more detailed evaluations.

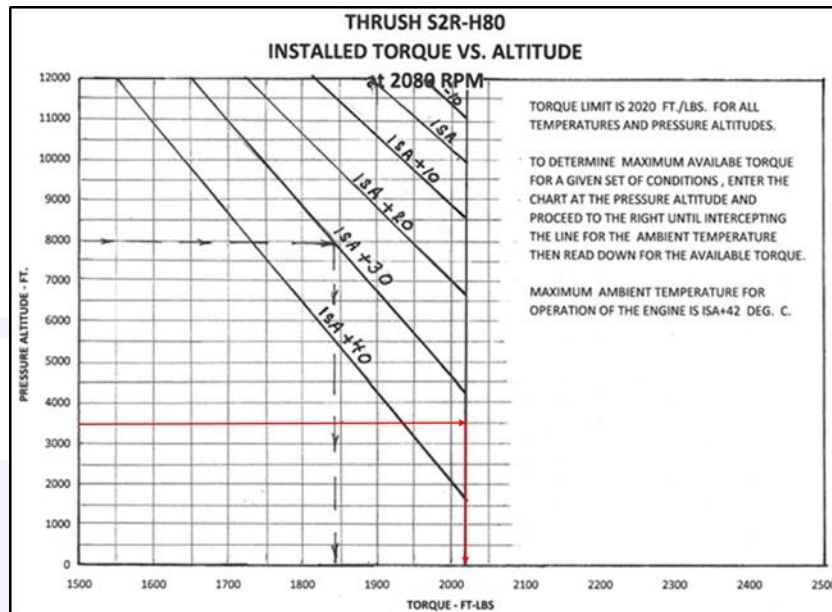
Figure 23 - Diagram of the engine available torque limit as a function of ISA temperature and altitude of the location.

Therefore, by means of the diagram on page 53 of the aforementioned manual, one verified that the available torque would be 2,020 ft-lbs, the maximum value allowed for the engine, which corresponded to 100% under the conditions present during the flight in which this accident occurred. (Figures 23 and 24).

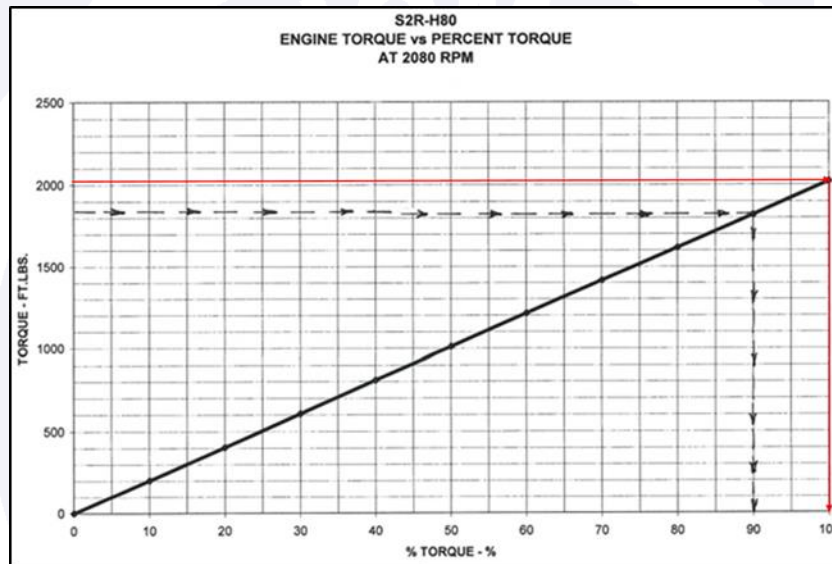
Figure 24 - Torque measurement unit conversion chart from ft-lbs to percentage.

The investigation found out that the PIC did not use the aircraft's performance charts before starting the operation. He made use of the different colors (green, yellow and red) of the MVP-50T's digital arcs as a reference during operation, because, in his understanding, the engine could be operated within the green range regardless of the temperature and altitude of the location.
