COMANDO DA AERONÁUTICA
CENTRO DE INVESTIGAÇÃO E PREVENÇÃO DE
ACIDENTES AERONÁUTICOS

FINAL REPORT
A-013/CENIPA/2017

OCCURRENCE:	ACCIDENT
AIRCRAFT:	PR-SOM
MODEL:	C90GT
DATE:	19JAN2017

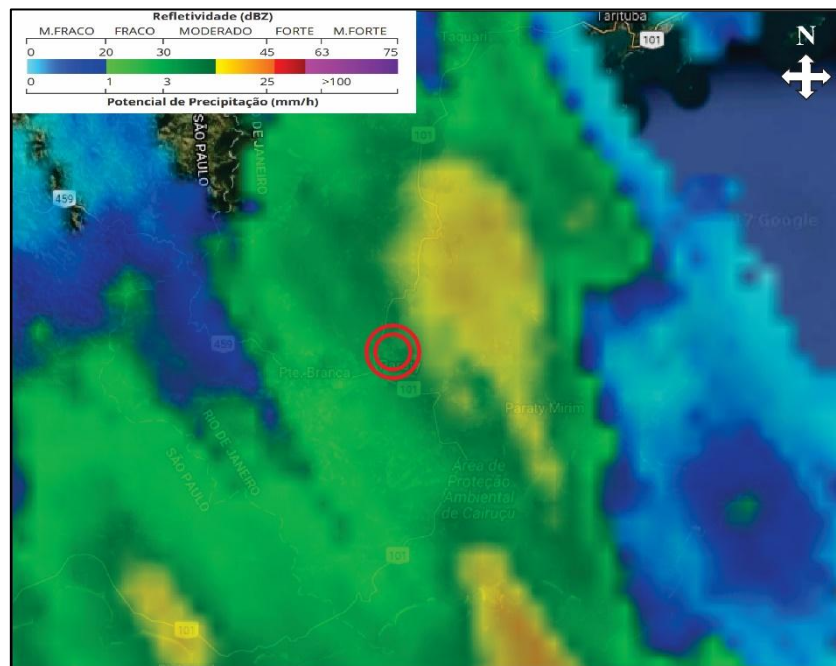
Figure 16 - Meteorological RADAR image of Pico do Couto at 15:46 (UTC).

It stands out the image generated at 15:46 (UTC), about two minutes after the impact of the aircraft, when it is observed a potential rainfall precipitation of 25 mm/h on the Paraty Bay.

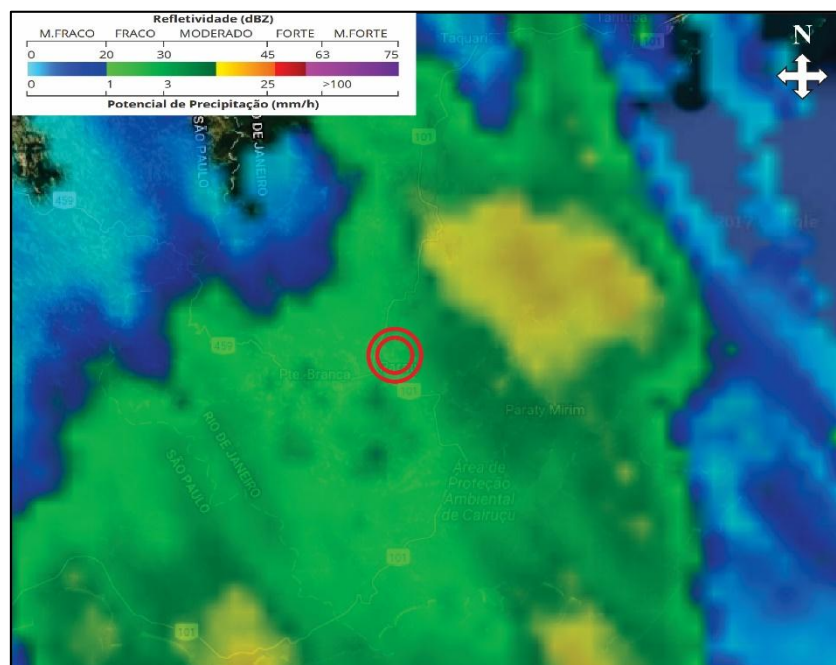
Figure 17 - Meteorological RADAR image of Pico do Couto at 15:56 (UTC).

It was verified the existence of well developed TCU and CB cloud formations on the region of the accident. The convective formations were dynamic and intensified with south-easterly displacement.

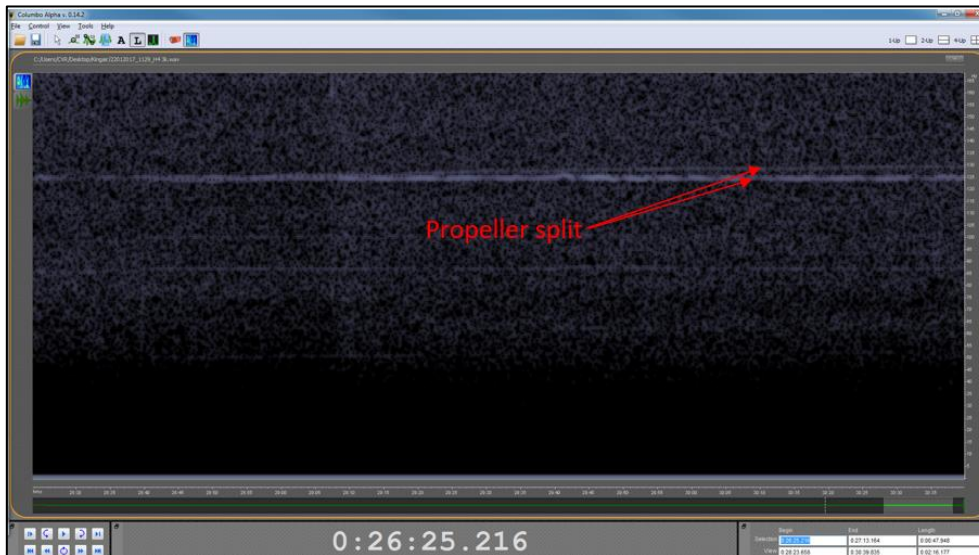
Figure 36 - Small detachment of the frequencies of the propellers rotation indicated in the spectrum.

At 15:42:41 (UTC) the beginning of a small speed differential between the propellers was observed. At the end of the recording, one of the propellers was at 1,875 RPM and the other at 1,950 RPM. The spectral analysis, however, did not allow defining to which engine each rotation was associated with (Figure 36).

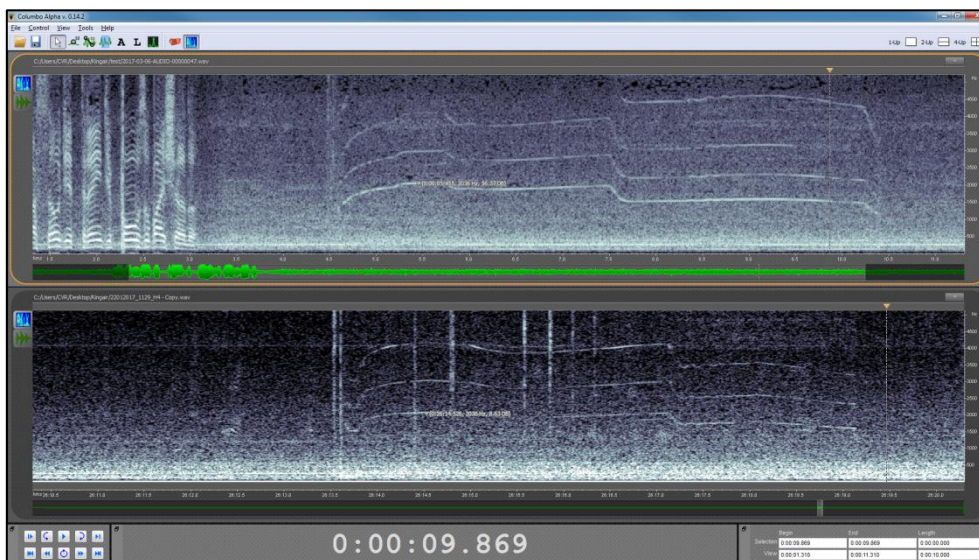
Figure 37 - Comparison between flight spectra with another C90GT aircraft (top image) and crash flight (bottom image).

When comparing the graphical information of the recording of another C90GT aircraft in relation to the information of the accident flight, the parameters of Figure 37 were obtained. Comparison of the data revealed lines that characterized the movement of the landing gear of the PR-SOM aircraft.

Thus, it was possible to identify the landing gear at retraction at 15:40:23 (UTC) and 15:44:12 (UTC).

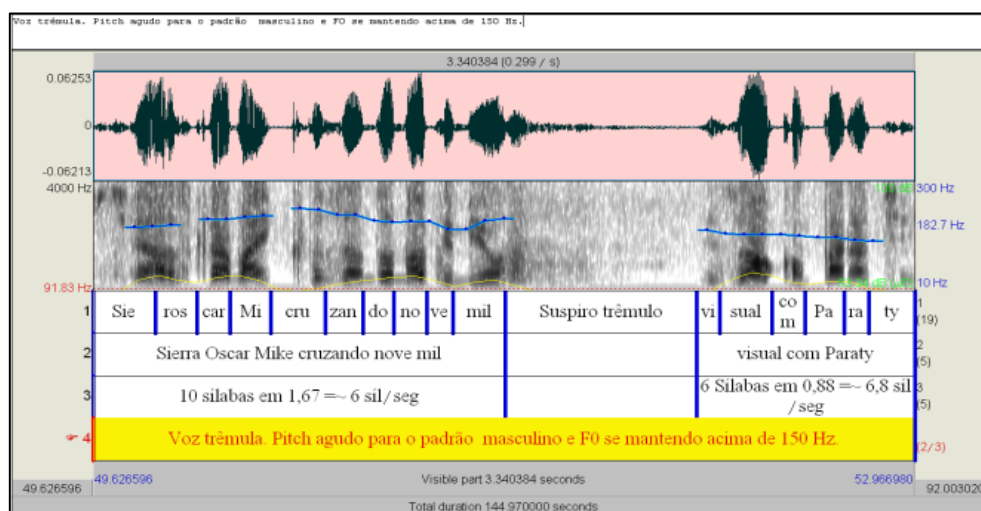
Figure 38 - Excerpt from the pilot's dialog with APP-SP at 15:32:18 (UTC).

In addition to these acoustic parameters, it was observed an acute pitch for the male pattern and in comparison with the pilot's own pattern, incoordination of the pneumophonoarticulatory (alteration in coordination between breathing and articulation). Likewise, vocal quality was tense throughout the flight, accentuating itself in the passage shown, and in this section, the voice was slightly shaky.

It is important to point out that the pilot presented himself breathless during the whole flight, and there was a moment of accentuation in the section of Figure 38

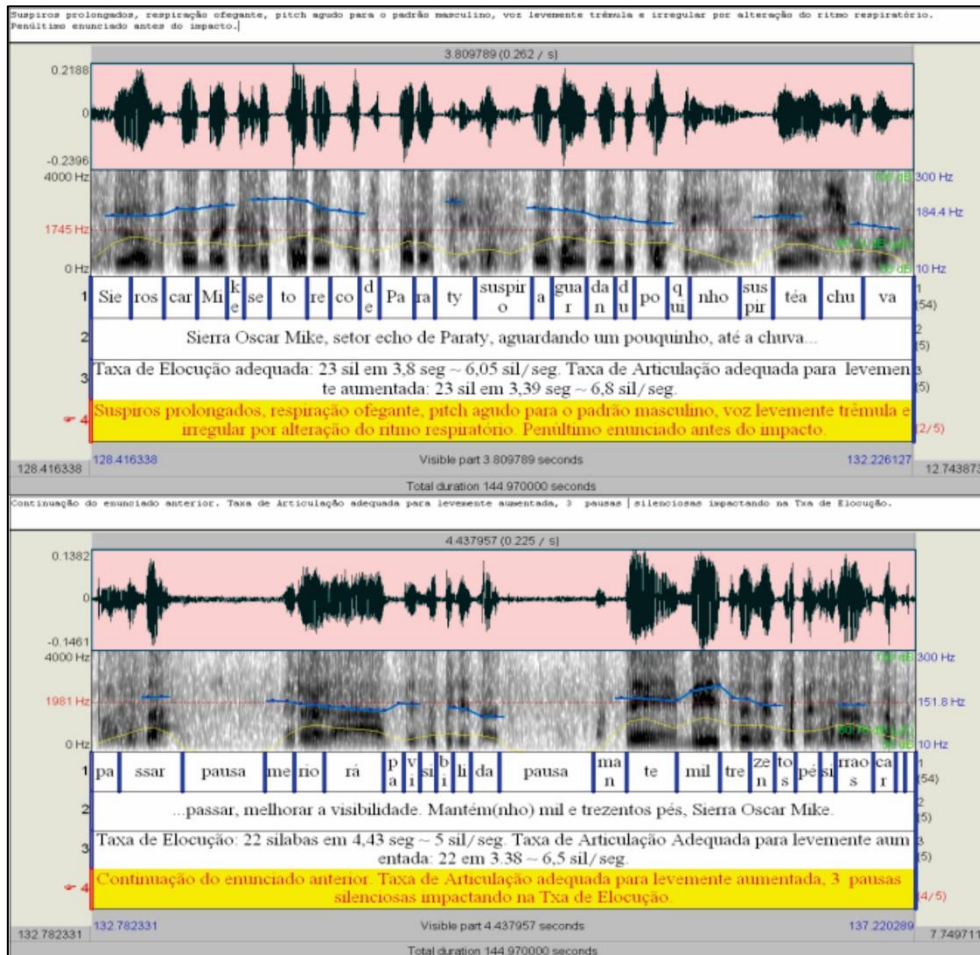
Figure 39 - Excerpt from the pilot's communication on the coordination frequency at 15:40:37 (UTC).

In the penultimate verbalization recorded before impact, it was reported in the phonics that the pilot would wait for the rain to stop, keeping 1,300ft (Figure 39).

At that moment, the pilot presented normal elocution rate, normal articulation rate for slightly increased, high F0, acute pitch, pneumophonoarticulatory incoordination, tense vocal quality, breathless speech, and voice trembling. In this section, these characteristics were more accentuated than previously demonstrated.

Thus, considering the scientific studies on the methodology of acoustic and clinical parameters to evaluate the expression of emotions, it was possible to infer that the pilot had traces of apprehension/worry and anxiety, ranging to fear, especially in the instant immediately before impact.

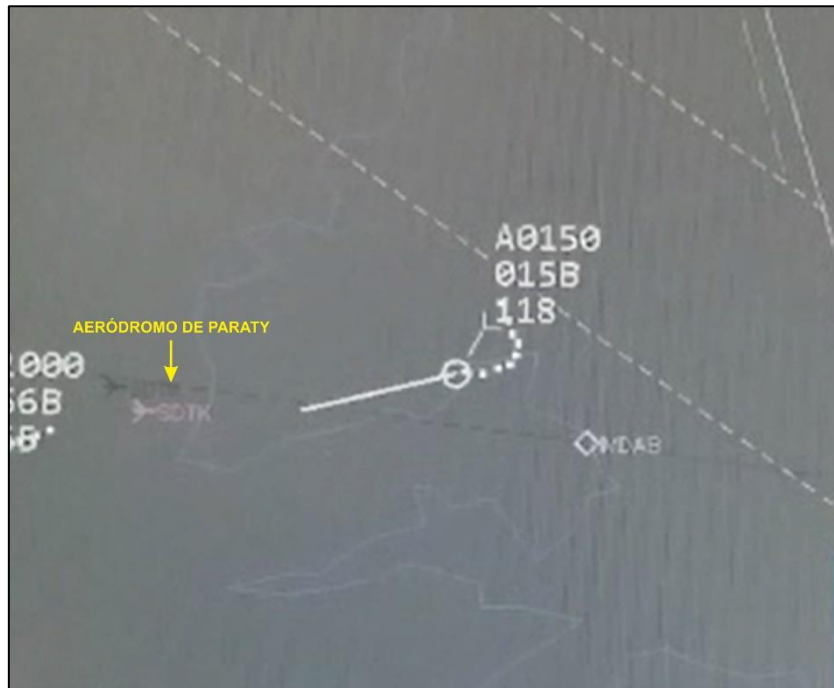
The aircraft then proceeded South and, as it approached the coast, made a right turn until it reached the SDTK Aerodrome, reporting that it was entering the approach to runway 28, crossing 1,500ft (Figure 48).

Figure 48 - APP-SP RADAR image recorded at 15:39:52 (UTC).

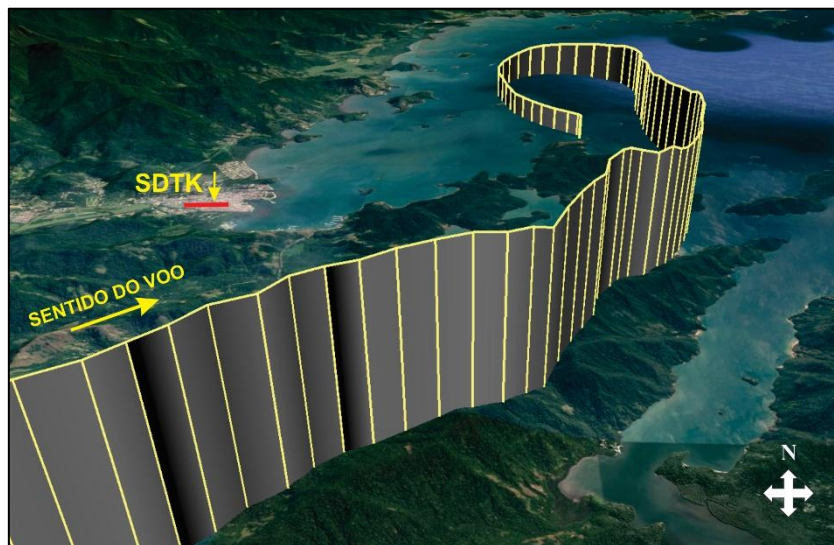
When synchronizing the data provided by APP-SP RADAR with the terrain information of the Paraty Aerodrome region, it was verified that the aircraft followed a descent profile according to the reconstruction shown in Figure 49.

Figure 49 - Reconstruction of the descent profile of the aircraft, according to the RADAR air traffic control data.

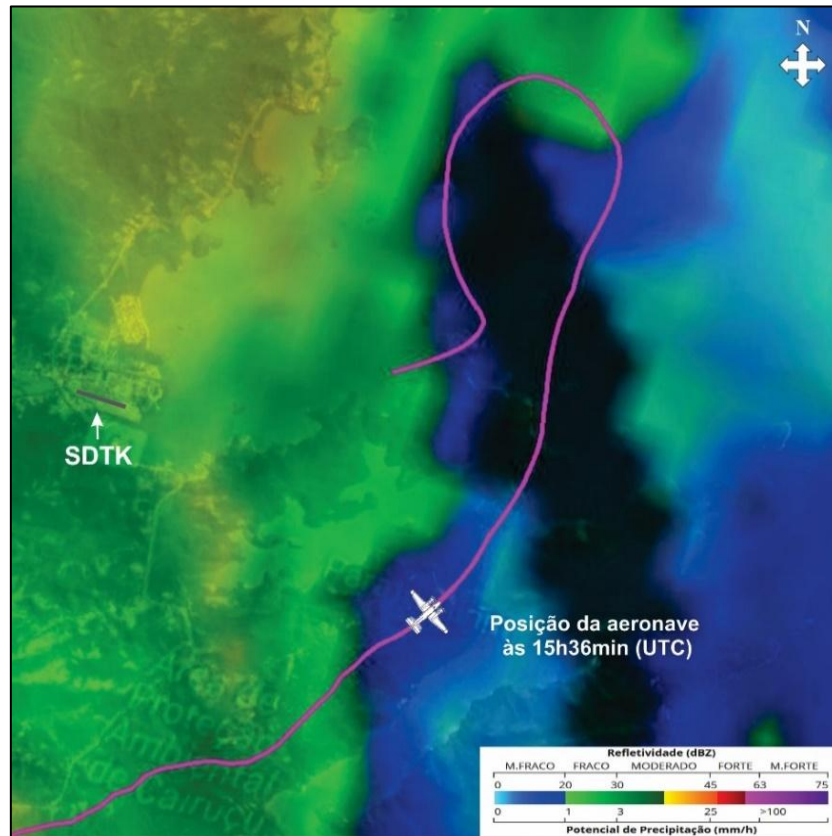
When synchronizing the air traffic control RADAR data with the Meteorological RADAR images from Pico do Couto, it was verified that, at 15:36 (UTC), the aircraft was descending, crossing 6,600ft (Figure 56), and performed a trajectory consistent with deviations from an area of rain located on the Paraty Bay.

Figure 56 - PR-SOM descent trajectory in relation to meteorological formations recorded at 1536 (UTC) by Meteorological RADAR.
