COMANDO DA AERONÁUTICA
CENTRO DE INVESTIGAÇÃO E PREVENÇÃO DE
ACIDENTES AERONÁUTICOS

FINAL REPORT
A - 053/CENIPA/2017

OCCURRENCE:	ACCIDENT
AIRCRAFT:	PR-TTH
MODEL:	ATR-42-500
DATE:	21MAR2017

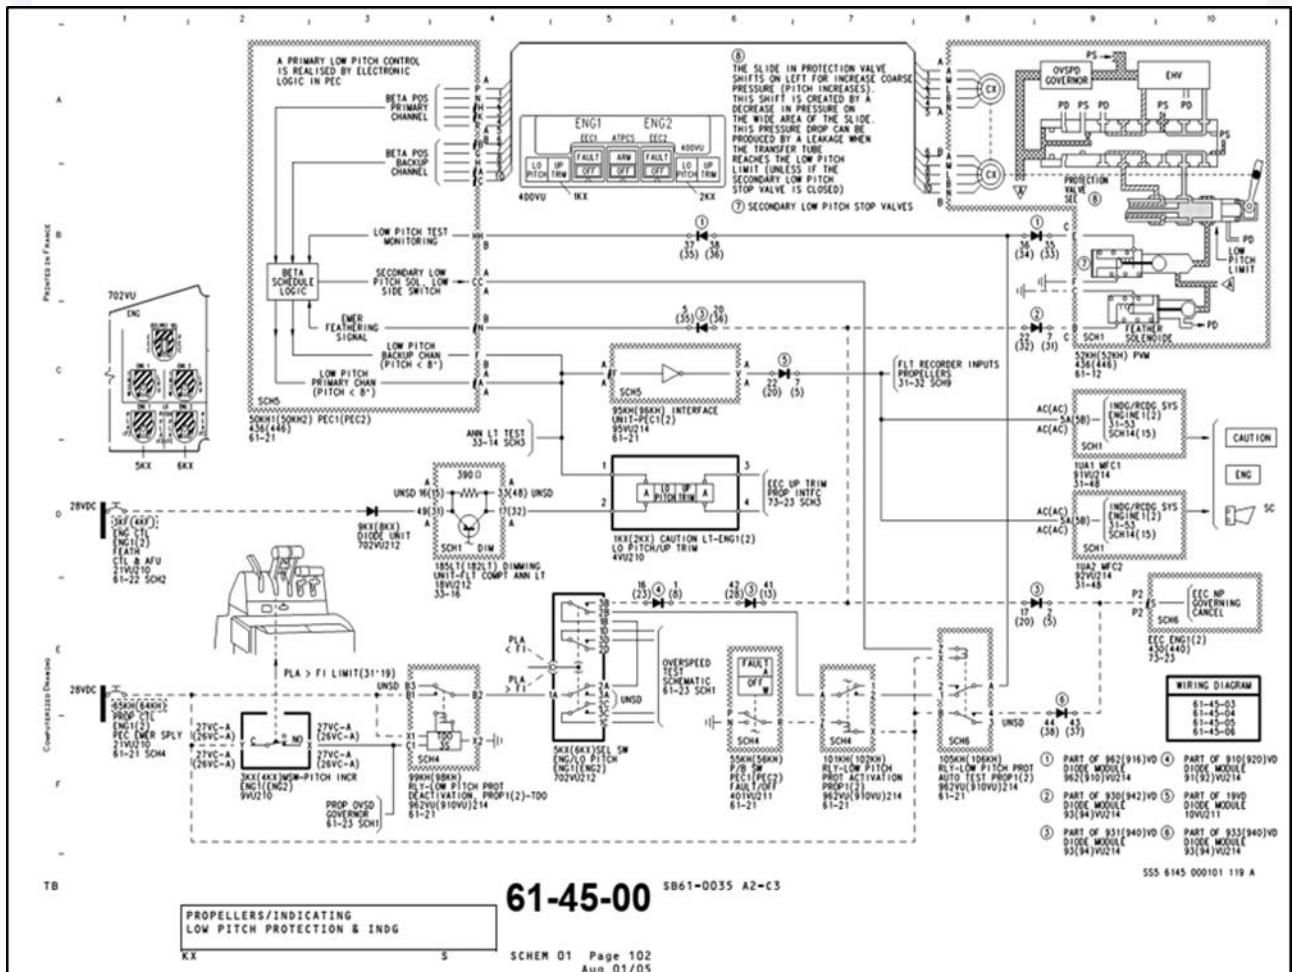
Figure 12 - Schematic drawing of the Low Pitch protection. Source: AMM.

The test consisted of a continuity check of the electrical system regarding the aircraft's Low Pitch protection. The schematic diagram, shown in Figure 12, was used as a reference for carrying out the test.

Failures in continuity were observed at the following points:

- continuity failure between EEC nº2 Connector P2, pin S and Microswitch 30KF pin C (related to the "Np Cancel" logic); and
- continuity failure between Relay 106KH pin B and Microswitch 4KX pin Y (related to the self-test function of the unfeathering logic).

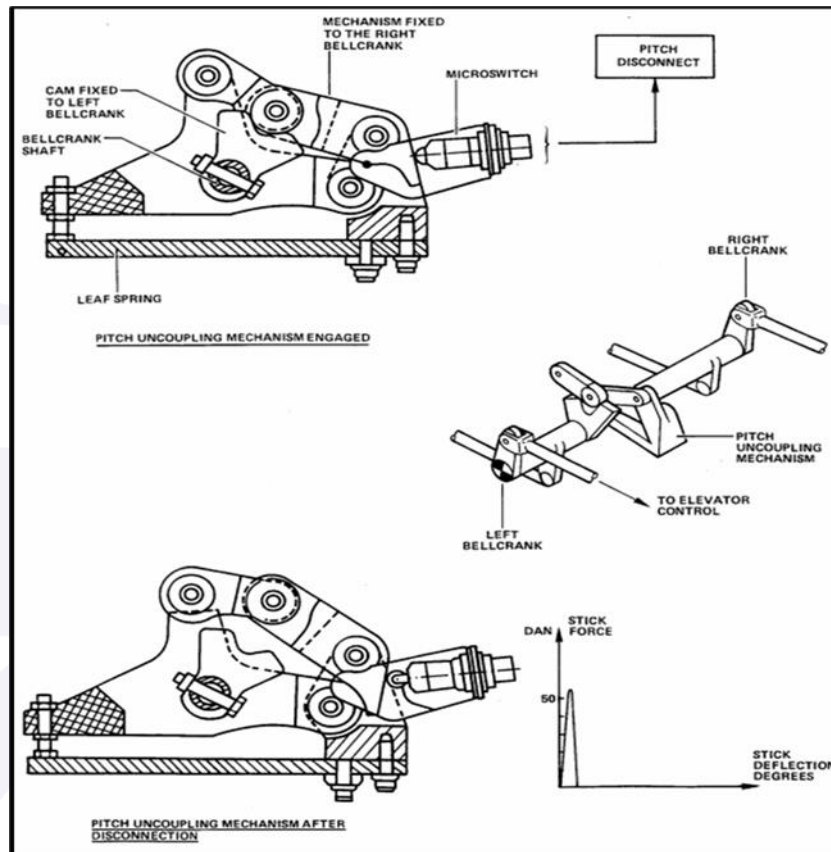
Figure 15 - Pitch Uncoupling Mechanism. Source: AMM.

The intermittent character of the MASTER WARNING observed in the FDR (Figure 17) could be associated with an incorrect adjustment of the Microswitch located in the elevator (Figure 15).

The intermittent character of the MASTER WARNING observed in the FDR (Figure 17) could be associated with the adjustment of the Microswitch located in the elevator (Figure 15).

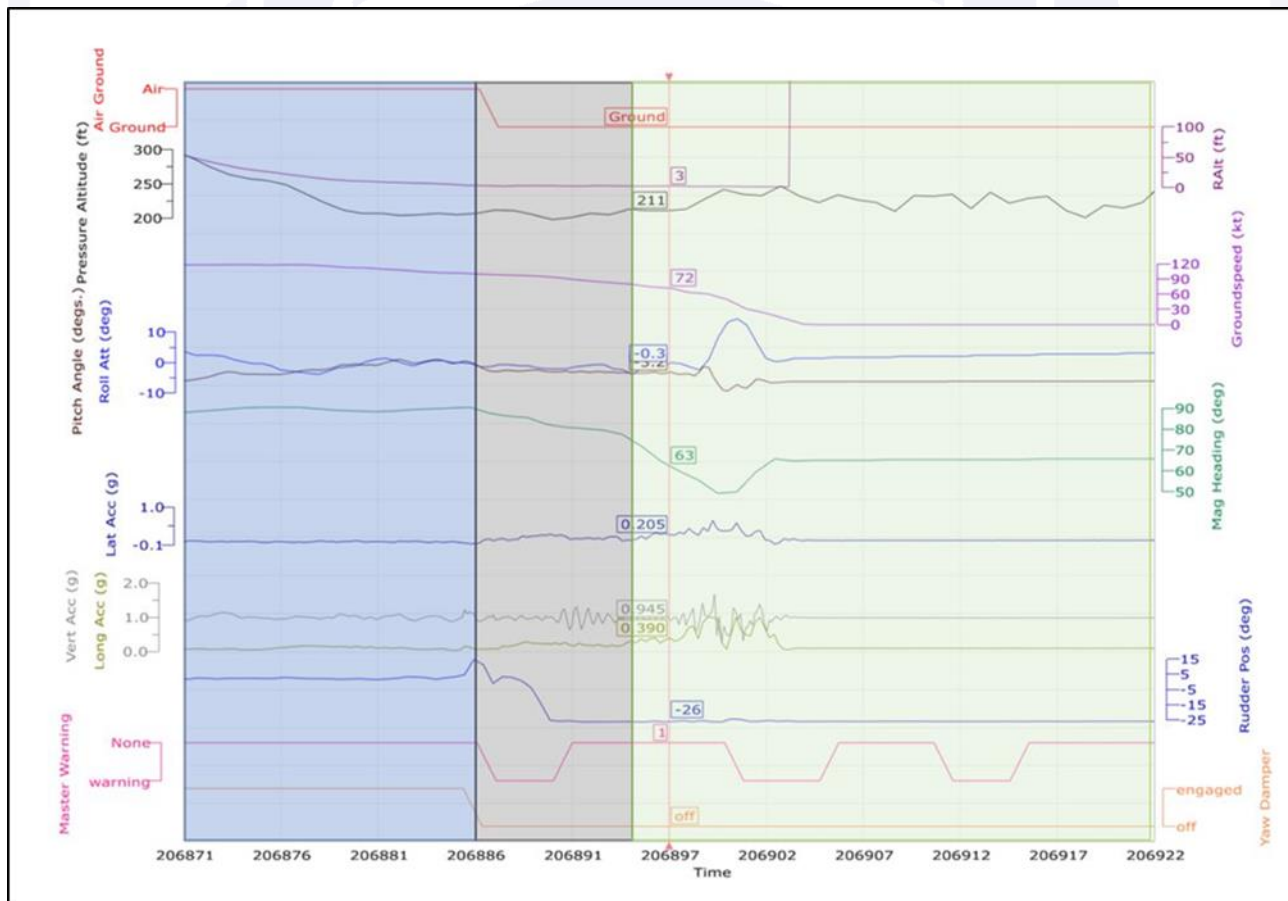
Figure 17 - General event data extracted from the FDR.

At the time of touching the runway, it was not possible to distinguish the Idle Gate and Low Pitch callouts related to the lighting of the respective lights, by the Pilot Monitoring. Simultaneously with the touch, it was possible to hear the MASTER WARNING audible alarm.

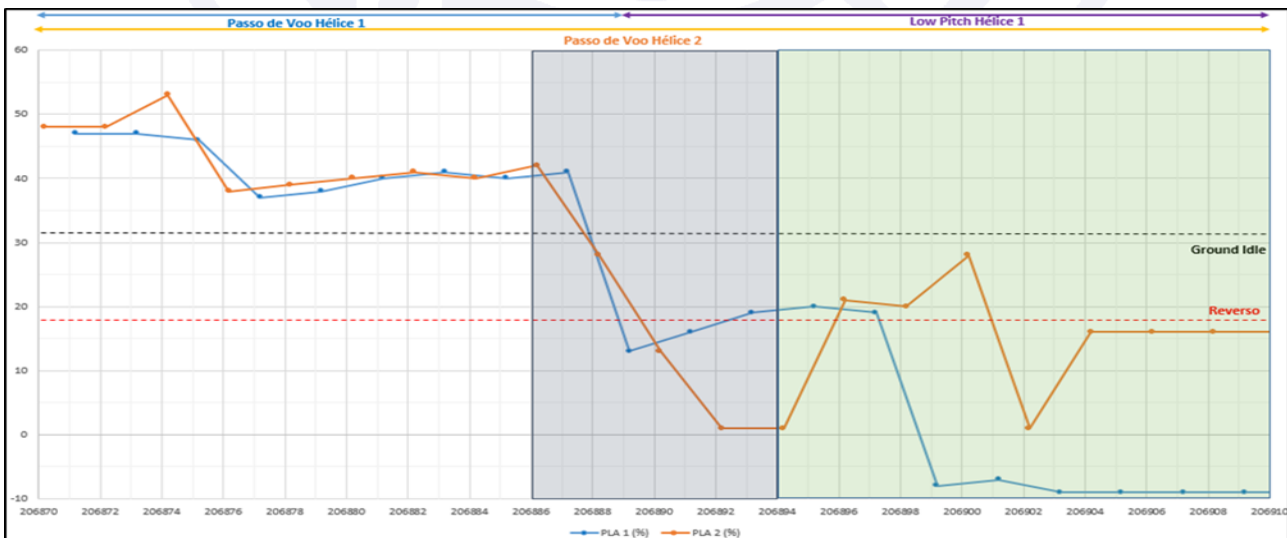
Figure 19 - Recorded parameters of the throttle position.

The position of the two Power Levers is shown in detail in Figure 19. The blue line at the top indicates that propeller n°1 has entered reverse pitch, following the movement of the corresponding lever. The yellow line (upper) indicates that the n°2 propeller remained in flight pitch during the entire trajectory of the aircraft on the ground and did not follow the movement of the respective lever.

Figure 19 highlights that, after the landing gear touched the runway (gray strip of the graph), the two Power Levers left the Flight Idle position for the REV position in a predominantly continuous movement, since the recorded parameters were in a straight line.

The Low Pitch indication of the n^o1 engine was recorded when the Power Levers were already in the reverse range, however the time interval in which the lever was in the position below Ground Idle was less than 1.0 second and there was no recording of the parameter of the Low Pitch condition in that time interval.

to the REV position stop. Lever nº1 mechanically returned to Ground Idle position due to the effect of lever box springs, as can be seen between reference times 206889 and 206895 in Figure 19.

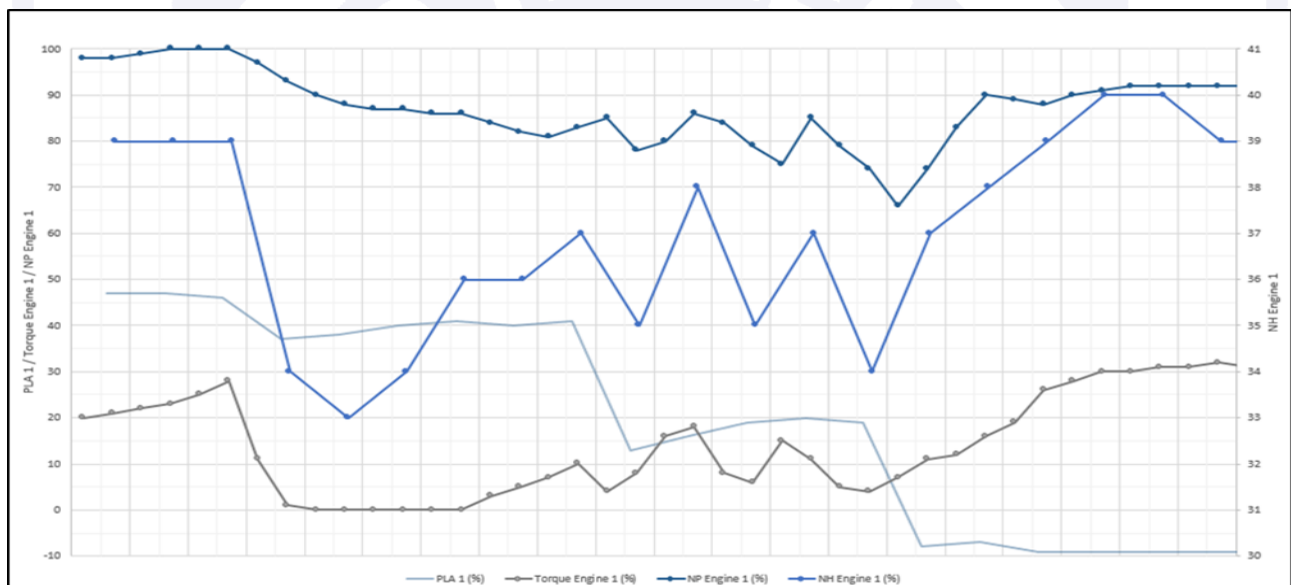
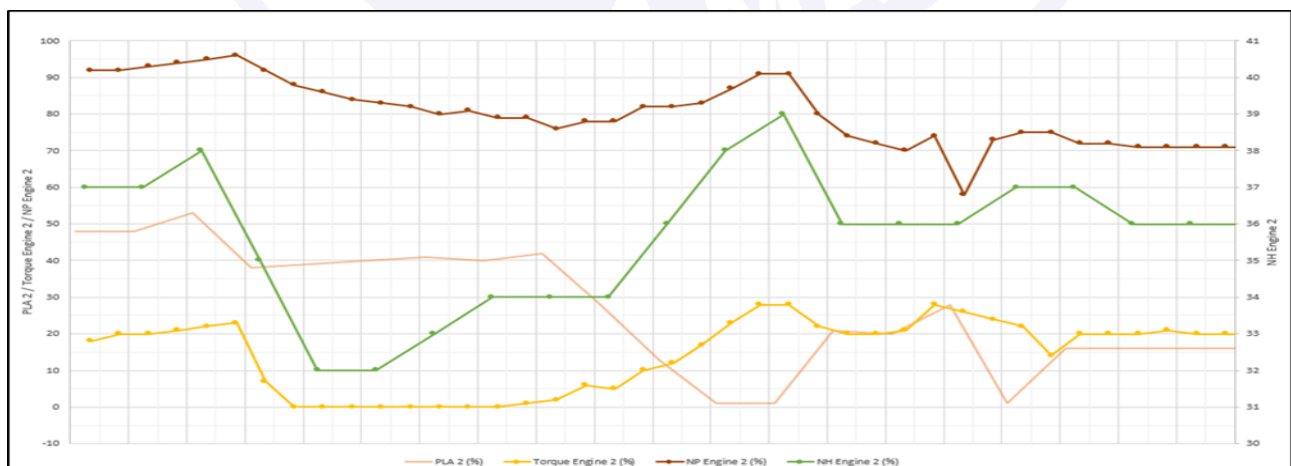
When the engines enter the reverse regime, there was an increase in torque and other related parameters, such as propeller rotation and high-power turbine rotation. This characteristic could be observed in both engines, as seen in Figures 20 and 21.

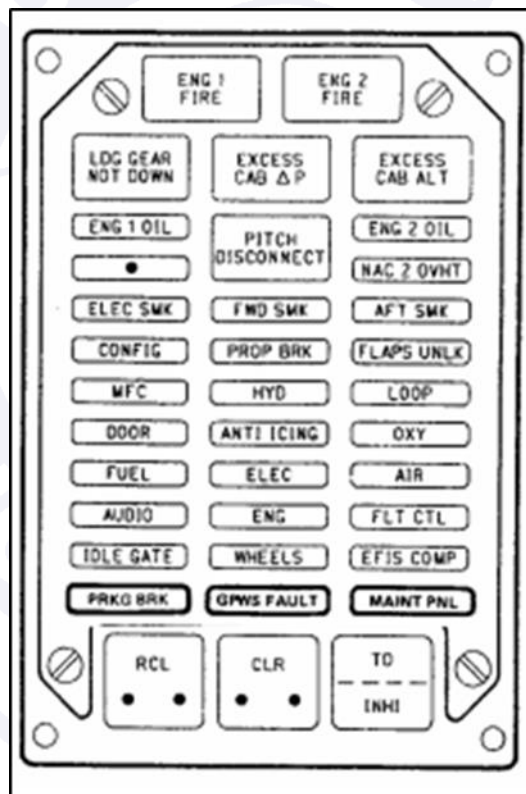
Figure 26 - Alarm Panel Alert Lights. Adapted from the ATR manuals.

The alert messages (red color) that were illuminated were:

- Prkg Brk - Parking brake warning light; and
- Wheels - Warning light concerning the failure or shutdown of the Antiskid system or overheating of the brakes.

In addition to these messages, the Fault light was observed on PEC n°1 (left) and the PWR MGT power selector in the CRZ (Cruise) position.

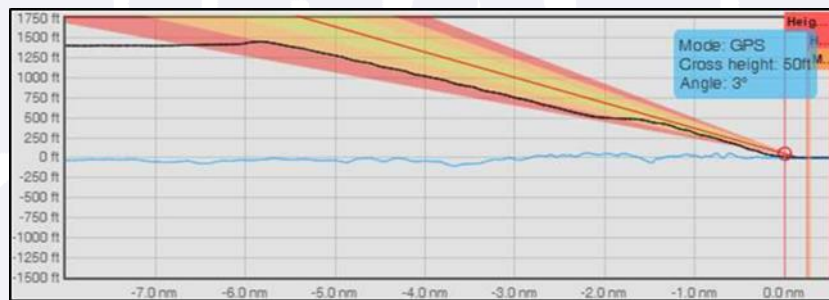
Figure 39 - Vertical trajectory for landing.

According to the perception of the company's crewmembers who operated in that Aerodrome, the proportion of two red lights and two white lights of the PAPI would leave the aircraft with little runway for the accomplishment of the landing.

Figure 39 illustrates the vertical trajectory for the aircraft to land. The black line shows the height of the aircraft above the ground and the red line the standard reference height.
