**COMANDO DA AERONÁUTICA**  
**CENTRO DE INVESTIGAÇÃO E PREVENÇÃO DE**  
**ACIDENTES AERONÁUTICOS**

**FINAL REPORT**  
**A-157/CENIPA/2016**

<b>OCCURRENCE:</b>	<b>ACCIDENT</b>
<b>AIRCRAFT:</b>	<b>PR-TUN</b>
<b>MODEL:</b>	<b>R44 II</b>
<b>DATE:</b>	<b>04DEC2016</b>

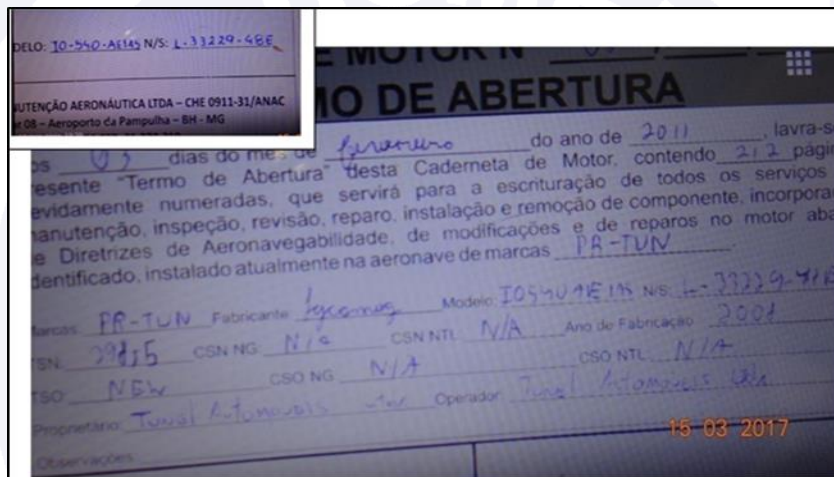
The engine had major breakdowns due to the collision with the ground. One of the consequences was the loss of the nameplate. Its identification was performed through the engine Logbook opening Sheet (Figure 9).

Figure 9 - Identification of the Lycoming IO-540-AE145 engine, S/N 33229-48E.

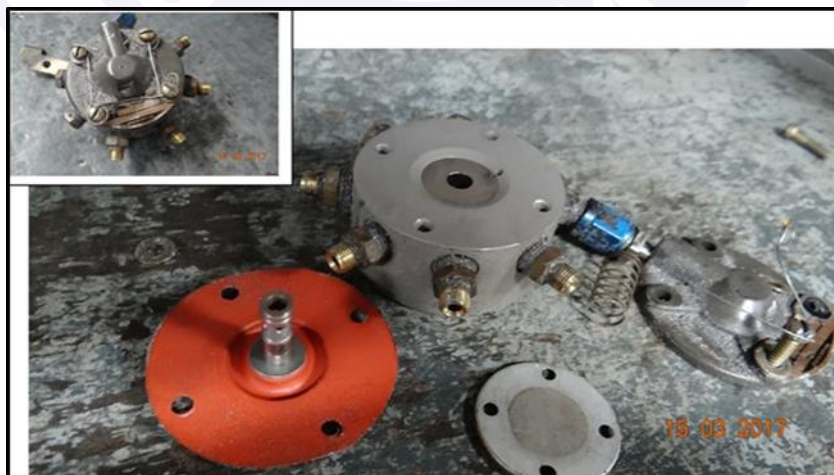
Figure 13 shows the fuel distributor and its components.

Figure 13 - Disassembled distributor view. Highlighted the distributor assembled.

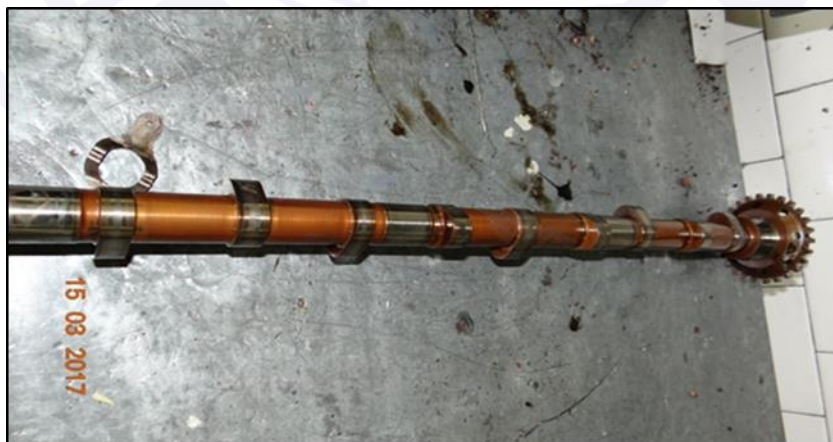
Figure 28 shows a view of the valve control shaft of the engine, which was also intact.

Figure 28 - Overview of the engine valve control shaft.

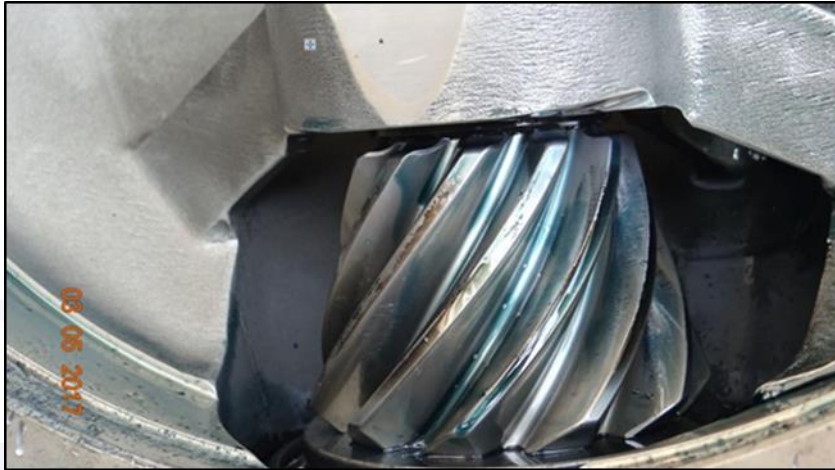
The interior of the transmission case and its components (rack, pinion, hydraulic pump gear, pump housing and bearings) did not present scratches and signs of overheating, due to lack of lubrication (Figures 38 to 46). No evidence of failure was found to compromise its operation.

Figure 44 - View of the gearbox pinion.

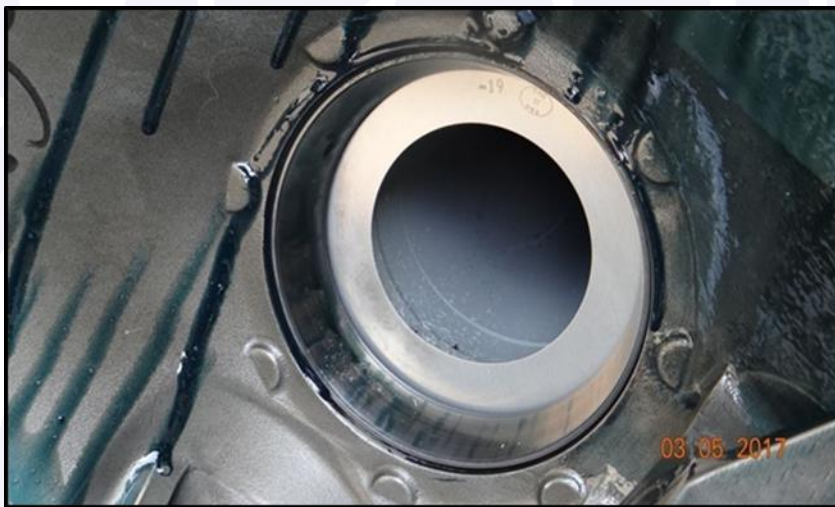
Figure 45 - External track of the upper gearbox bearing.

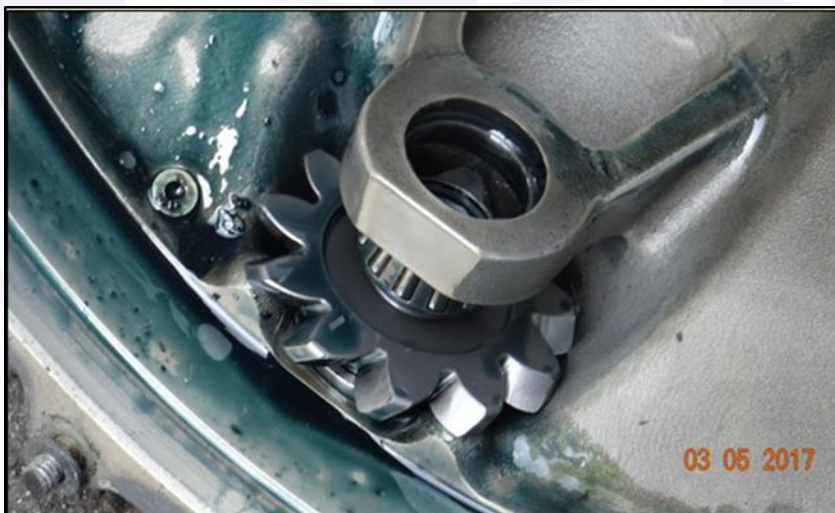
Figure 46 - Gearbox hydraulic pump drive gear.

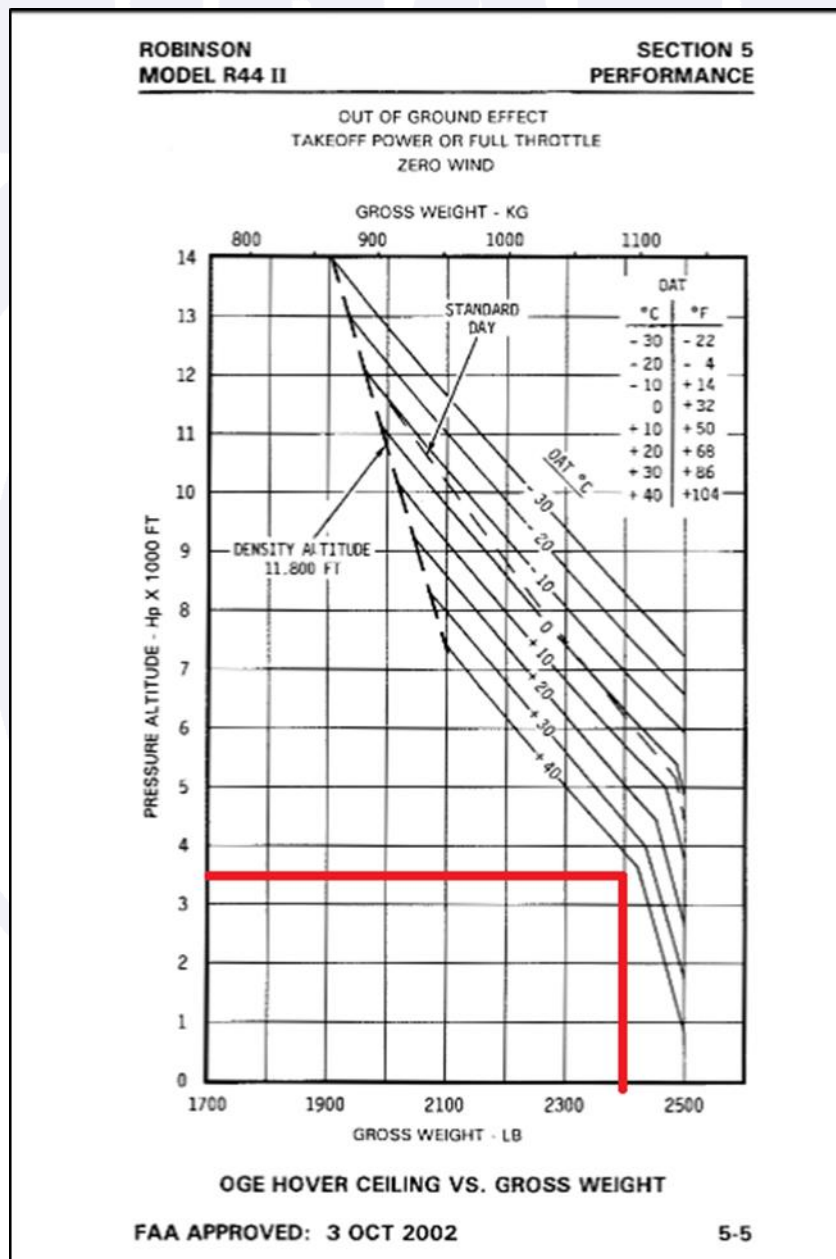
Flight performance hovered out of the ground effect represents the most critical condition as to the power required within the approved envelope for the crashed aircraft model.

The above values were used in the takeoff power chart of the aircraft and the following result was demonstrated in Figure 48.

Figure 48 - Performance of Out of Ground Effect (OGE).

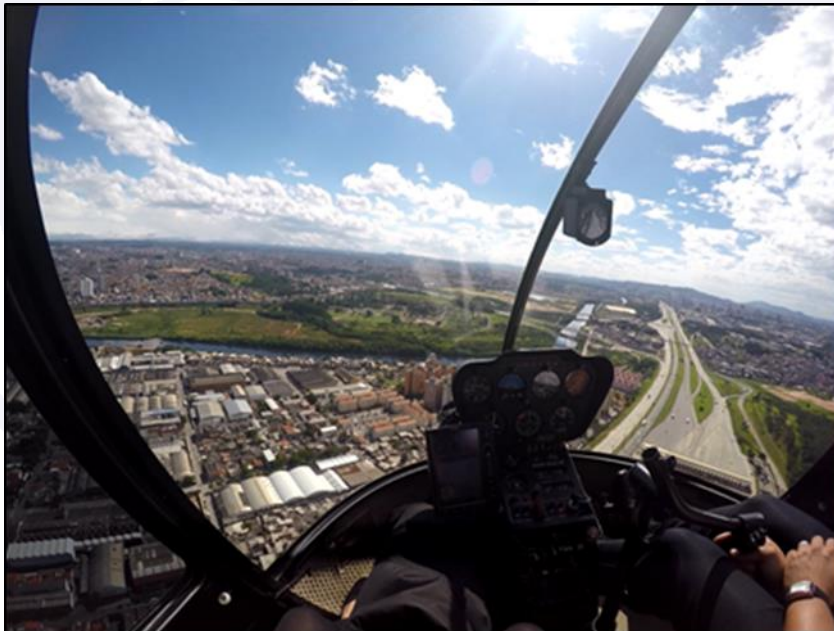
At 18:06:57 (UTC), the aircraft overflew Castelo Branco-Osasco toll, 2.5 NM from the SSUB Helipad. The helicopter had head 260°, altitude 3.030ft, speed 97kt, Manifold Pressure 21.5inHg, Rotor Tachometer 100%, Engine Tachometer 101%, proving to be within the approved limits of operation (Figure 50).

Picture 50 - 18:06:57 (UTC), overpass of the Castelo Branco-Osasco tollbooth.

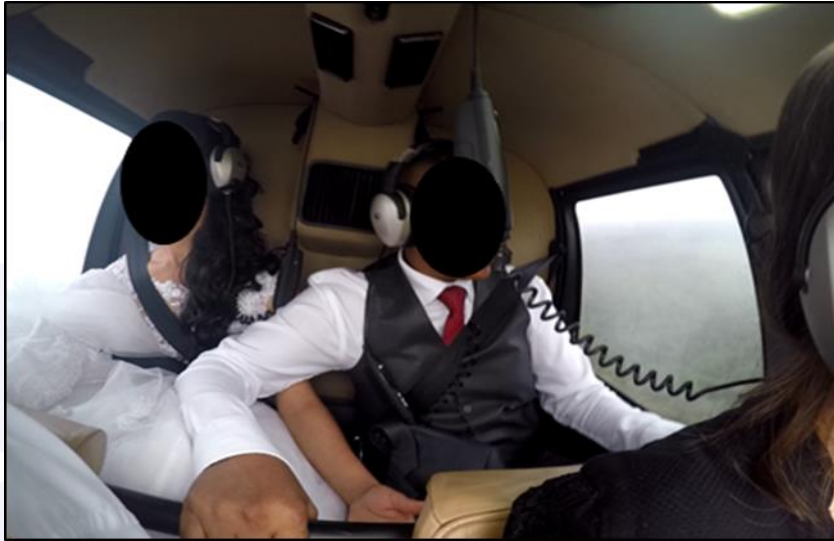
At 18:25:59 (UTC), the aircraft flew over the southern region of São Lourenço da Serra. The pilot turned to the left and began to fly through the clouds, with low visibility and in instrument meteorological conditions (IMC), but it was possible to observe that he still had visual contact with the ground (Figure 55).

Figure 55 - 18:25:59 (UTC), low visibility flight and under IMC conditions.

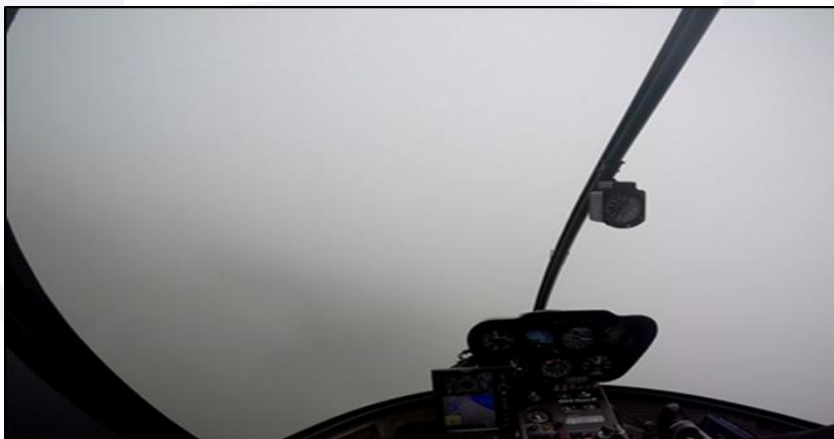
At 18:26:13 (UTC), the weather deteriorated. There was no visual contact with the ground and the visibility ahead was zero. The flight conditions were IMC and it was not possible to define the exact position of the aircraft.

The aircraft turned to the left with 25° inclination, 5° pitched up, 52kt of indicated speed, was passing through 2,940ft, with a rate of ascent of 800ft / min. The Manifold Pressure was 21.5inHg, the Rotor Tachometer was 100% and the Engine Tachometer was 101% (Figure 56).

Figure 56 -18:26:13 (UTC), there was no visual contact with the ground and the visibility ahead was zero.

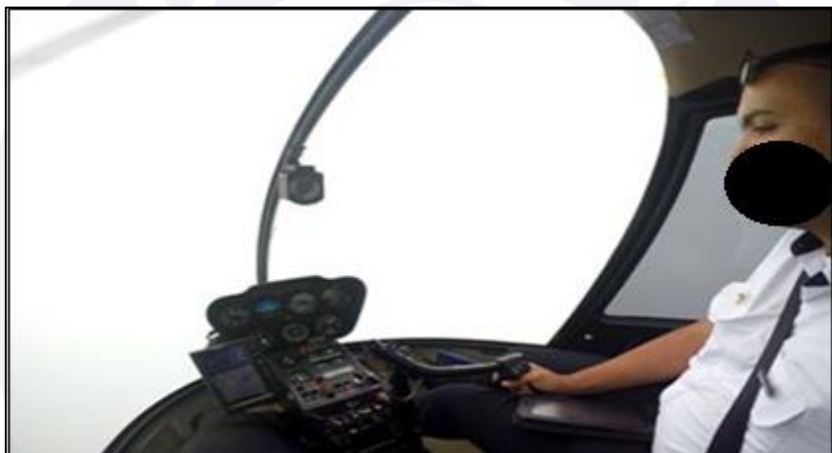
The image recorded at 18:27:32 (UTC) shows that the pilot appeared to be staring only at the aircraft's GPS equipment (Figure 58), but the attitude information from the GPS and the aircraft's original instrument were conflicting, as shown in Figure 59.

Figure 58 - Fixed look, apparently, in the GPS at 18:27:32 (UTC).

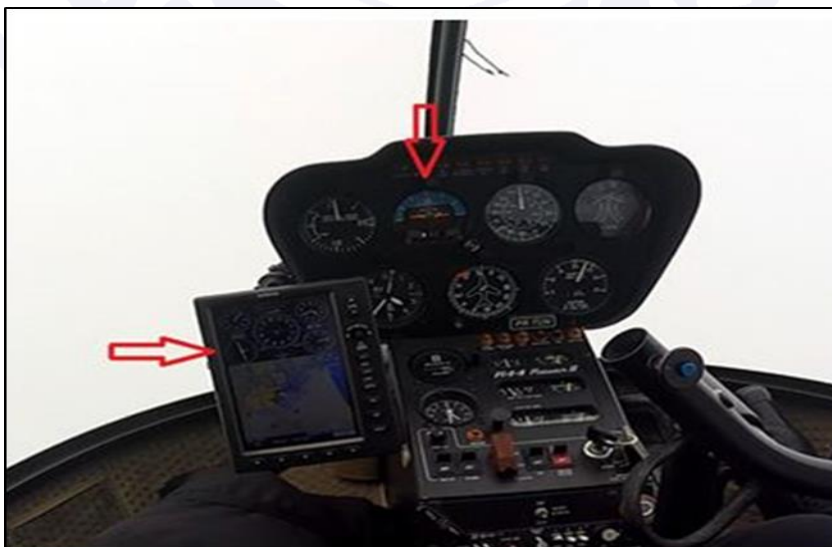
Figure 59 - 18:29:40 (UTC), aircraft attitude indicator and GPS with different indications.

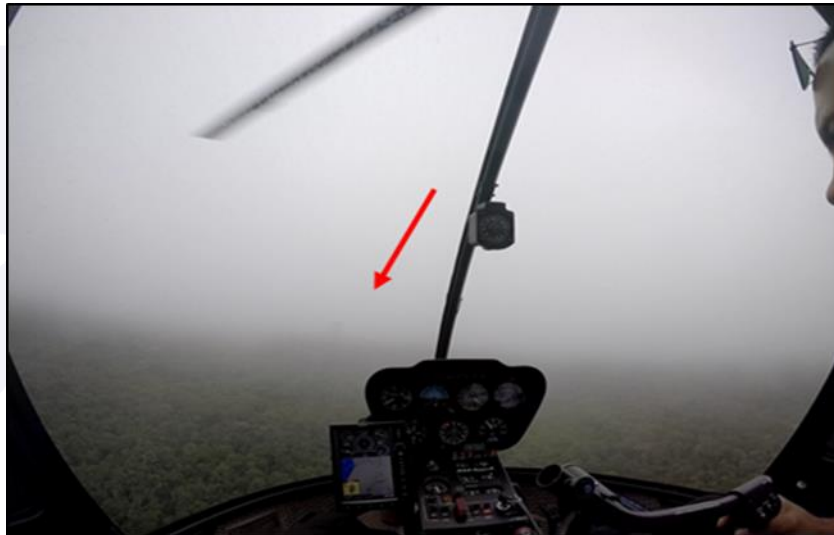
At 18:27:47 (UTC), the pilot saw a power grid network ahead and identified a metallic sound, probably an alert message from the GPS equipment installed on the aircraft. It is still not possible to identify the exact position of the aircraft.

The pilot started a 30° turn to the left. The power was increased to 21inHg, the speed was decreased to 35Kt and the rate of climb reached 400ft / min. The conditions remained IMC, but there was visual contact with the terrain (Figure 60). The following dialogue was established between the passenger and the pilot:

Figure 60 - 18:27:47 (UTC), flight conditions IMC (arrow indicates the power grid).

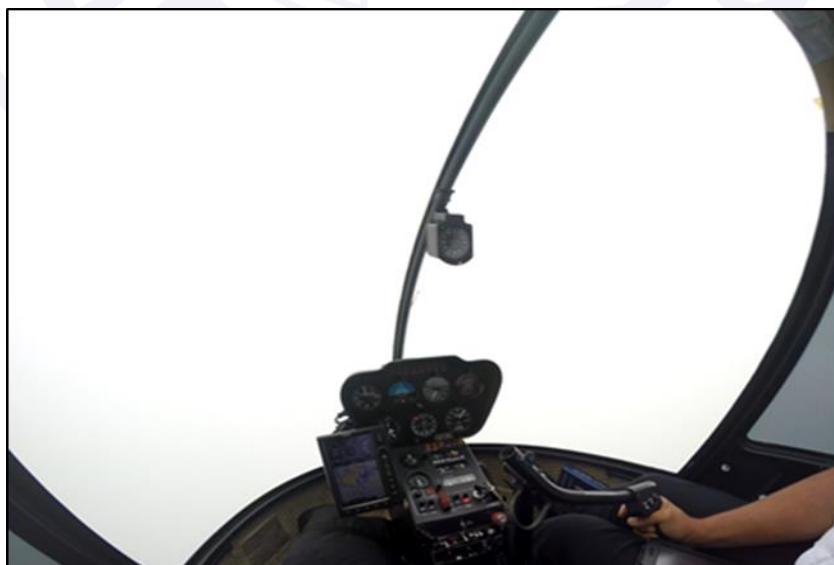
At 18:28:58 UTC, conditions remained IMC and visibility was zero, the pilot constantly looked at the instrument panel (there were no external references). The aircraft had 90kt of indicated speed, passing through 3.500ft of altitude with rate of climb of 800ft / min. The Manifold Pressure was at 25.5inHg, the Rotor Tachometer at 100% and the Engine Tachometer at 101% (Figure 61).

Figure 61 – 18:28:58 (UTC), the visibility was zero.

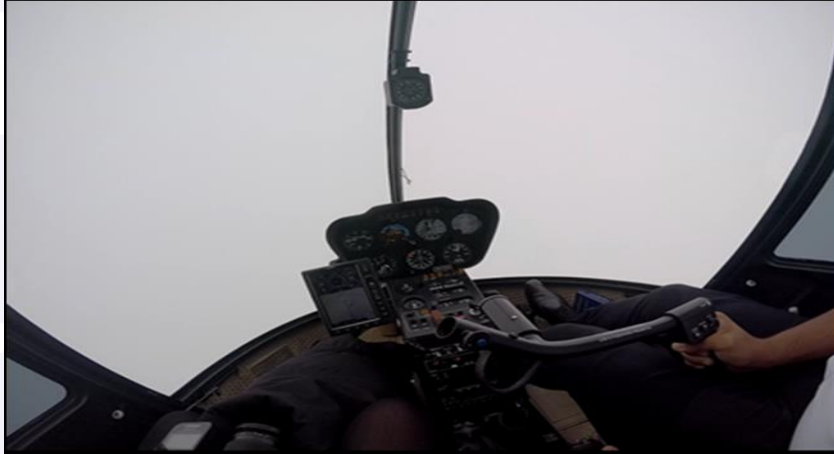
At 18:30:05 (UTC), conditions remained IMC, with no reference to the ground, indicated speed was 0kt, altitude of 3,500ft, Manifold Pressure was at 24inHg, Rotor Tachometer at 100% and Engine Tachometer at 101%. The exact position of the aircraft could not be identified.

The pilot increased the movements of the cyclic. The aircraft tilted to the right, then to the left and reversed again to the right. There were variations in the pitch angle from +30° to -10° and around 45° of banking for each side (Figure 62).

Figure 62 – 18:30:05 (UTC), high pitch and bank angles.

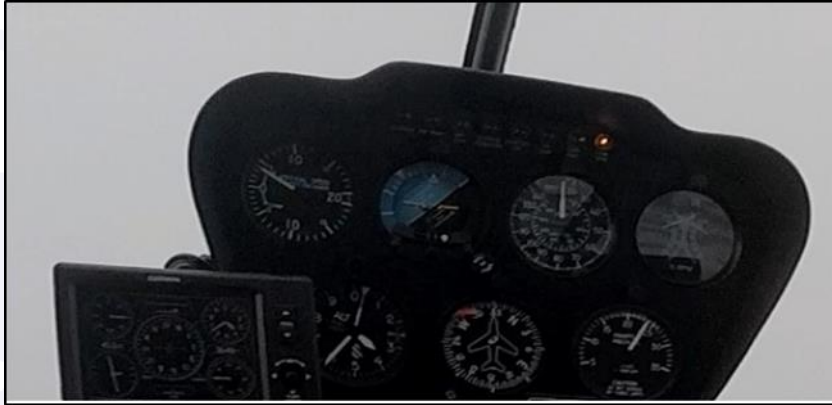
The transmission failure would be indicated by unusual noise and vibration, nose to the right or left, decrease of the main rotor rotation (NR) with increase of the engine RPM. In Figure 64, it was found that engine (Engine RPM) and rotor (NR) rotations were synchronized.

Figure 64 – 18:30:13 (UTC), engine RPM and rotor synchronized (NR).

The illumination of the LOW RPM light in the present case was motivated by an excess load factor caused by the maneuver performed. In Figure 64, it was found that the engine (Engine RPM) and rotor (NR) rotations were synchronized.

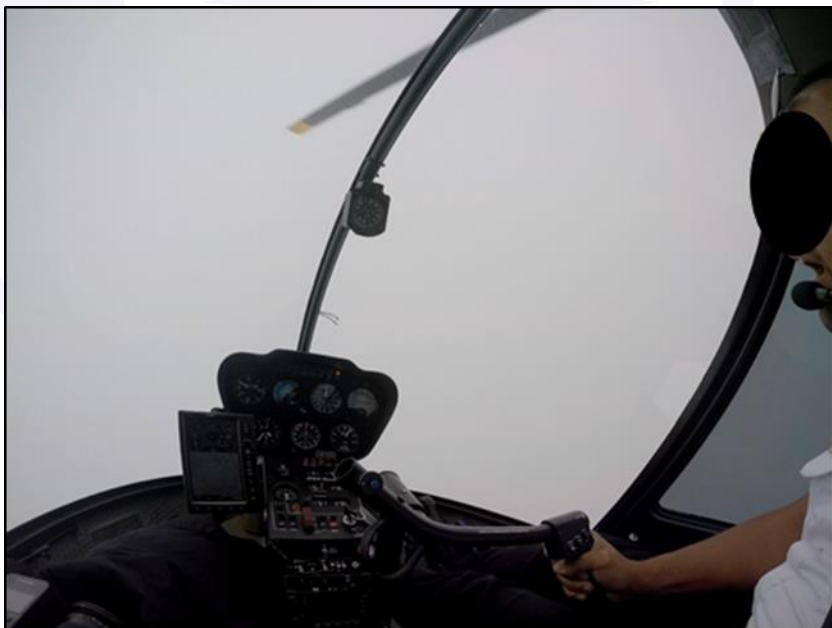
The aircraft entered an abnormal attitude, with an indicated speed of 0kt, a 50° bank to the right, Manifold Pressure was at 24inHg, Rotor Tachometer at 94% and Engine Tachometer at 96% (Figure 65).

Figure 65 - 18:30:13 (UTC), aircraft in a 50° bank to the right.

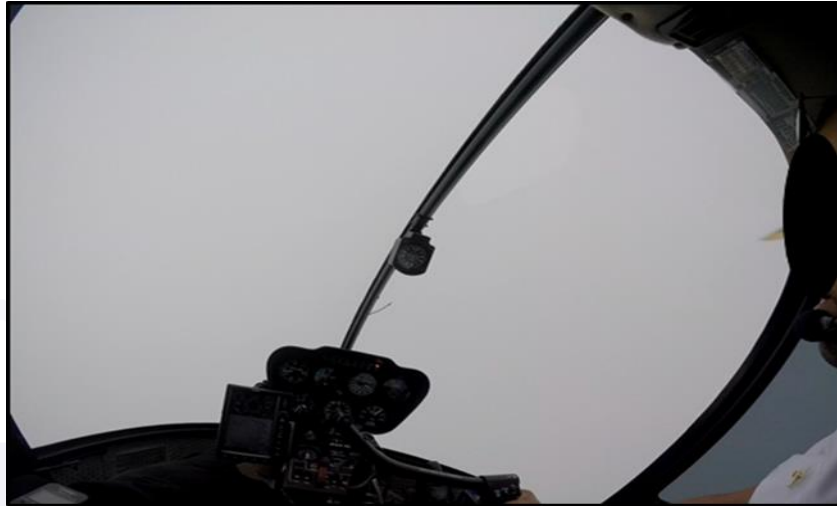
At 18:30:15 (UTC), the aircraft was out of control. The LOW RPM light was still on. The aircraft had an indicated speed of 54kt, in a 75° bank to the right and a 25° pitched down attitude. The altitude was of 3.560ft, the Manifold Pressure was 25inHg, the Rotor Tachometer was 92% and the Engine Tachometer was 94% (Figure 66).

Figure 66 - 18:30:15 (UTC), aircraft with a 75° bank to the right and a 25° pitched down attitude.

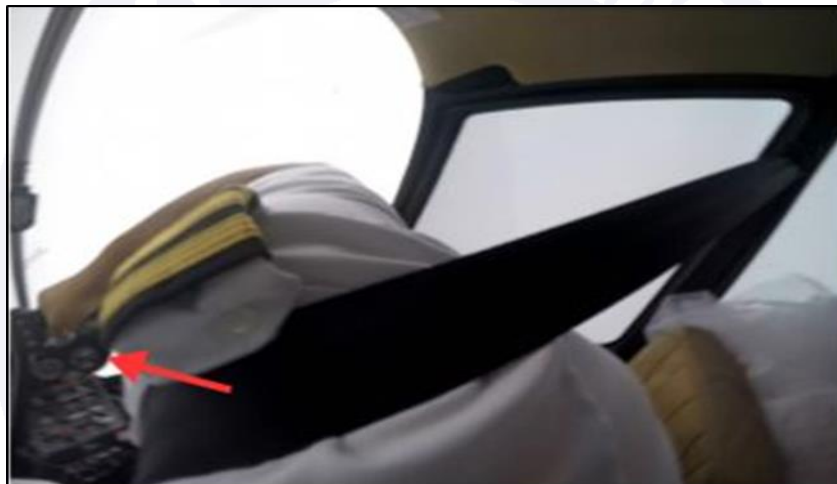
Until that moment, the engine has been in normal operation (Figure 67).

Figure 67 – 18:30:18 (UTC), indication that the engine was still running.

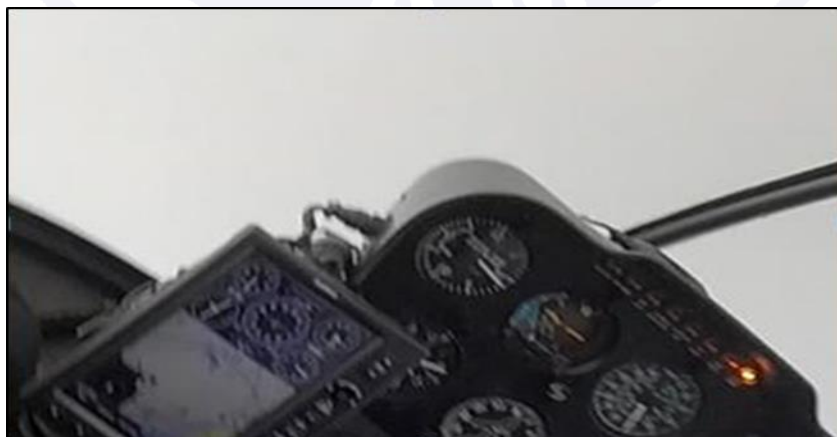
There are indications that the helicopter has reached 140° of bank and 30° of pitch down, already with a high rate of descent (Figure 68).

Figure 68 - Uncontrolled aircraft at 18:30:19 (UTC).

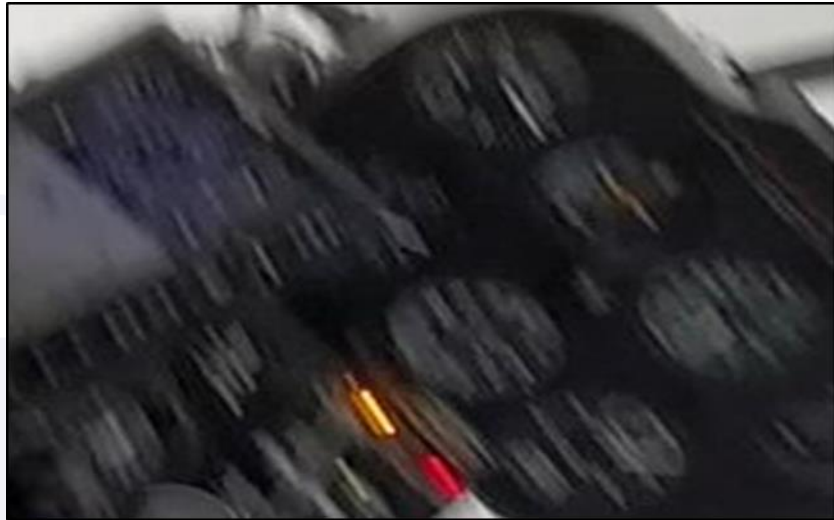
At this time, the OIL PRESSURE and AUX FUEL PUMP alarm lights came on (Figure 69).

Figure 69 - Alarm lights on at 18:30:19 (UTC).

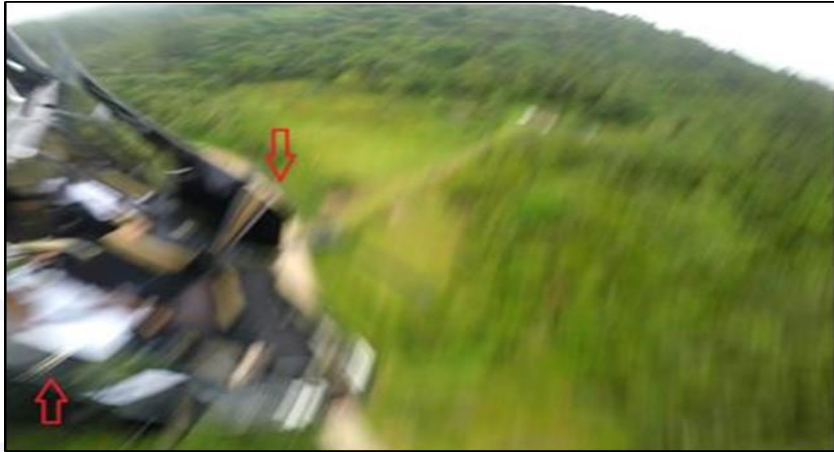
The camera was launched into the air and recorded the image (even if blurred) of the damaged aircraft in the air (Figure 71). In the highlight, one could see the detail of the external painting (three golden bands).

Figure 71 - View of external parts of the aircraft still in the air at 18:30:22 (UTC).

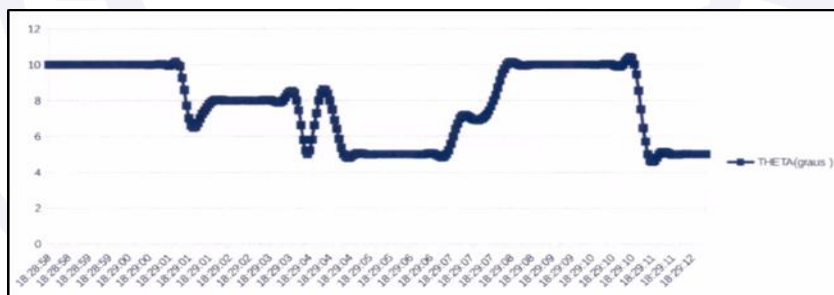
Figure 72-Theta (Attitude in °) up to 18:29:12 (UTC).

On this first moment, the attitude variation in relation to the horizon (Figure 72) and the bank (Figure 73) suggest that the pilot was already showing signs of spatial disorientation, since the parameters were not kept stabilized.

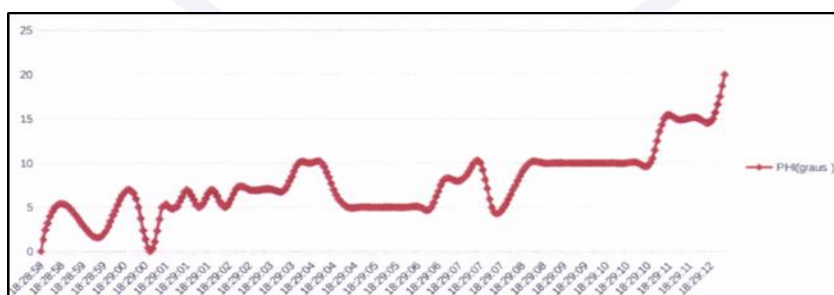
Figure 73 -Phi (bank in °) up to 18:29:12 (UTC).

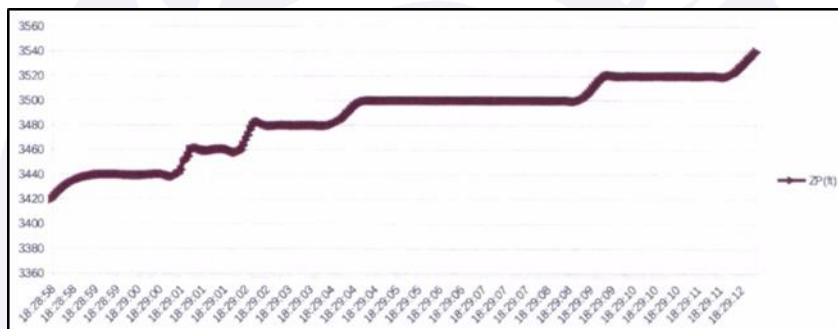
Figure 76 - ZP (Altitude in ft.) to 18:29:12 (UTC).

As shown in the graphs (Figures 72 to 78), the pilot kept high engine power (Maximum Takeoff Power - PMD) and the aircraft kept climbing (Figure 76).

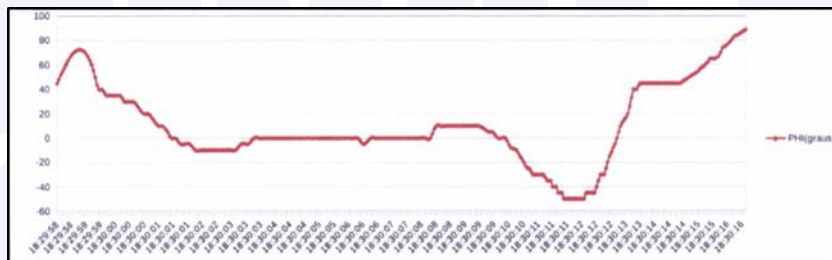
Figure 80 -Phi (bank in °) final moments.

As shown in Figure 80 the pilot commanded the cyclic on the right, reaching 75° of bank at 18:29:59 (UTC). Realizing it, he reversed the command to the left, but in an overly pitched down attitude (-15 ° to -25 °) and finally precipitated an aggressive 90° banking right.

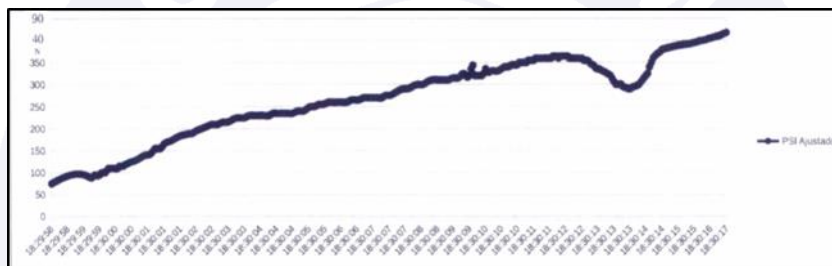
Figure 81 -Psi (Heading in °) final moments.

Figure 81 shows the helicopter's headings at the final moments. If there was a loss of the yaw command there would be no tendency to reverse the heading, which occurred at least twice: at 18:30:09 (UTC) very quickly and at 18:30:12 in a more smooth and clear manner.

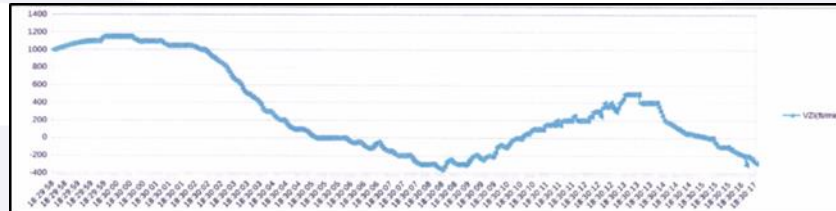
Figure 85 - Vzi (Rate of climb/descent in ft./min) final moments.

Vortex stalls occur in vertical descents with applied power. In Figure 85, it is seen that there has not been a steady descent, but rather an upward sequence interspersed with a rapid descent.
