COMANDO DA AERONÁUTICA
CENTRO DE INVESTIGAÇÃO E PREVENÇÃO DE
ACIDENTES AERONÁUTICOS

FINAL REPORT
A-080/CENIPA/2018

OCCURRENCE:	ACCIDENT
AIRCRAFT:	PR-WBV
MODEL:	PC-12
DATE:	01MAI2018

This is the Final Report of the 01May2018 accident with the PC-12 aircraft, registration PR-WBV. The accident was typified as “[SCF-PP] Engine failure or malfunction | With propeller”.

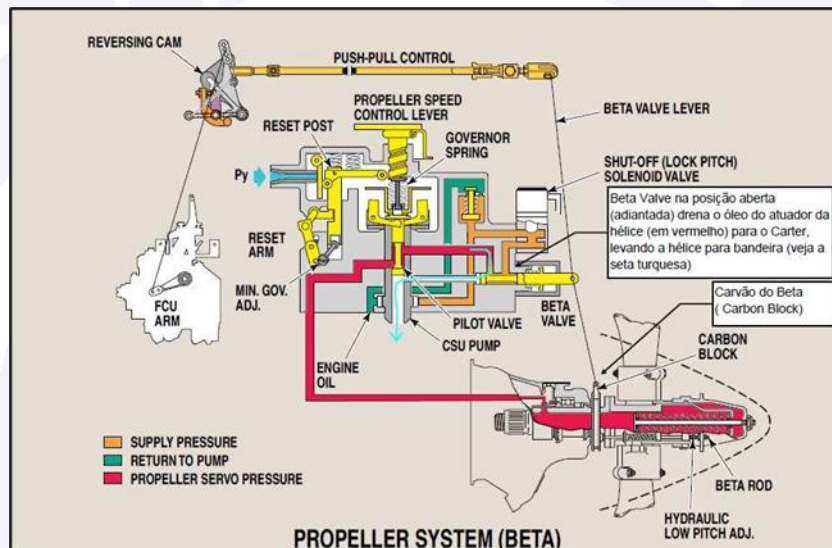
Figure 28 - Pictographic representation of the aircraft pitch control system.

[...] it was found that there was a "culture" of adjusting the Beta Valve clevis in a way that was different from the prescribed in the aircraft Engine Maintenance Manual, leaving the clevis uneven (in this case, ADVANCED) in relation to the front face of the Beta Valve nut. Such procedure, besides being performed without the knowledge of the workshop managers, aimed to meet the request of the pilots, on the grounds that such adjustment would contribute to improving the performance of the CARAVAN aircraft in certain phases of the operation. (RF IG-126/CENIPA/2013).

The adjustment mentioned in the investigation was represented pictorially in the Final Report by means of the Figure 28 below.
