COMANDO DA AERONÁUTICA
CENTRO DE INVESTIGAÇÃO E PREVENÇÃO DE
ACIDENTES AERONÁUTICOS

FINAL REPORT
A - 049/CENIPA/2016

OCCURRENCE:	ACCIDENT
AIRCRAFT:	PR-ZRA
MODEL:	CA-9
DATE:	19MAR2016

This is the Final Report of the 19MAR2016 accident with the CA-9 aircraft, registration PR-ZRA. The accident was classified as “[LOC-I] Loss of Control In-Flight”.

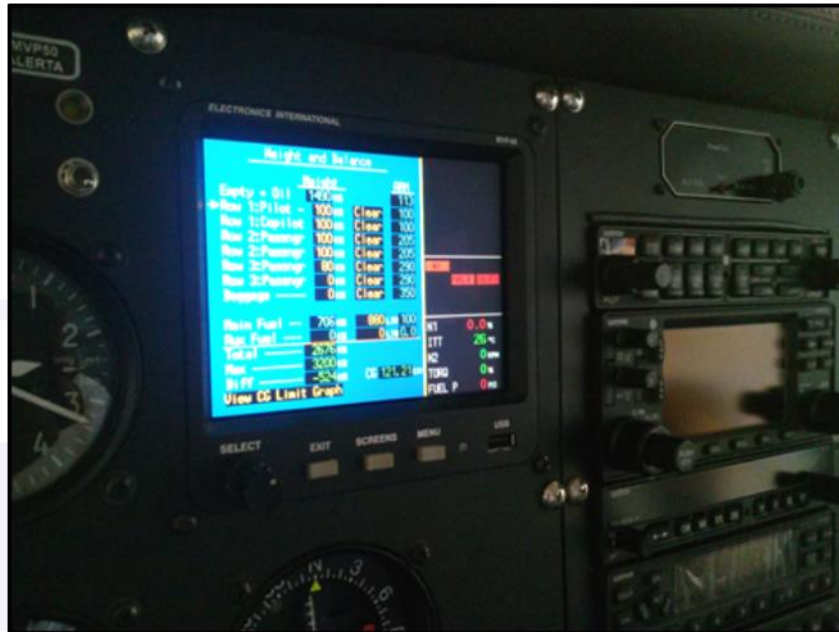
Figure 6 – Aircraft's loading warning system, installed in another aircraft model of the Kit's manufacturer.

There was the prevision of a pilot warning system that would provide inadequate loading information. From the weight and balance parameters entered, the display would show a red stripe when the CG ride was exceeded in the PR-ZRA. It was not possible to confirm if this system (Figure 6) was being used in the aircraft.

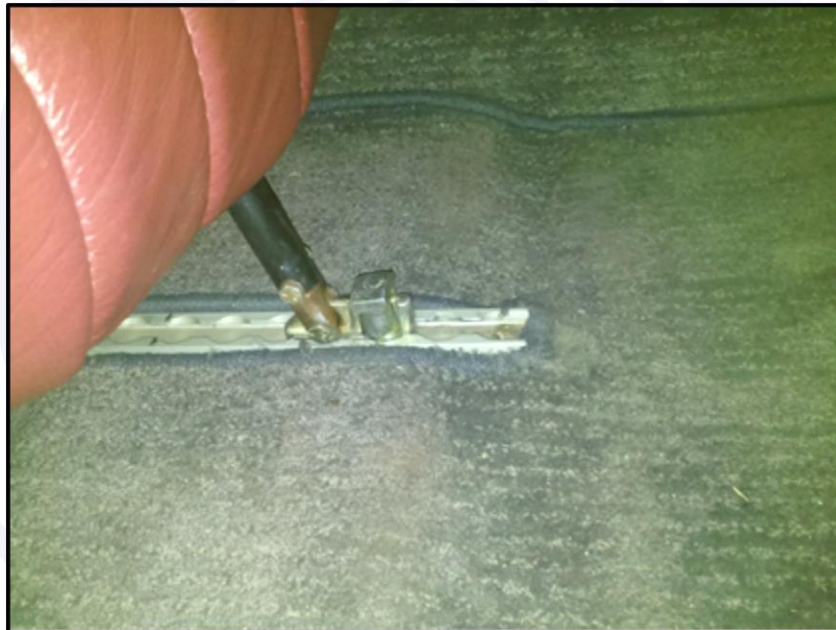
Figure 7 - Aspect of the seats assembly in the floor of the aircraft, in a similar model to the CA-9.

The seats were fixed on rails, allowing more or less space between them, according to Figure 7.

From what was found, the responsible PCA modified these loading parameters. The aircraft was registered with eight seats, one for the pilot and seven for passengers.
