FINAL REPORT IG - 042/CENIPA/2019

OCCURRENCE: AIRCRAFT: MODEL: DATE: SERIOUS INCIDENT PR-AQV ATR-72-212A 12MAR2019

This is the Final Report of the 12MAR2019 serious incident with the ATR-72-212A aircraft model, registration PR-AQV. The serious incident was classified as "[SCF-PP] System/Component Failure or Malfunction Powerplant – Engine Failure on the Ground".

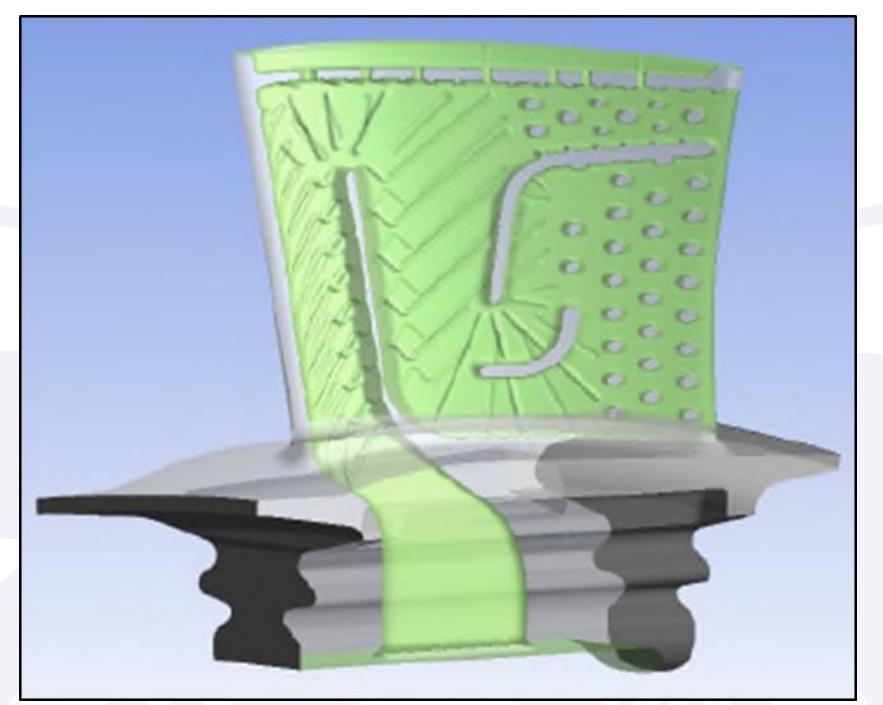
Figure 18 - Visualization of the internal area of an HP blade from a PW100 series engine as a reference for the location of the holes and cavities.

Regarding the design and manufacture of blades, it is important to note that they are produced with the existence of holes and internal cavities for the passage of air, which, among other functions, are dedicated to the cooling of its structure during the cycles of operation of the engines. The direction of displacement of this air current is from the blade root, through the platform, through the airfoil cavities and out through the trailing edge (Figure 18).

That said, the finding that was most present in the cases investigated by the manufacturer was the obstruction of the cooling holes and cavities. There have been cases of obstruction due to the deposit of material foreign to the engine, such as sand and other solid particles present in atmospheres with industrial waste.
