COMANDO DA AERONÁUTICA
CENTRO DE INVESTIGAÇÃO E PREVENÇÃO DE
ACIDENTES AERONÁUTICOS

FINAL REPORT
A – 066/CENIPA/2014

OCCURRENCE:	ACCIDENT
AIRCRAFT:	PR-OAF
MODEL:	F28MK0100
DATE:	28MAR2014

This is the Final Report of the 28MAR2014 accident with the F28MK0100 aircraft, registration PR-OAF. The accident was classified as “[SCF-NP] System/Component Failure or Malfunction Non-Powerplant / With Landing Gear”.

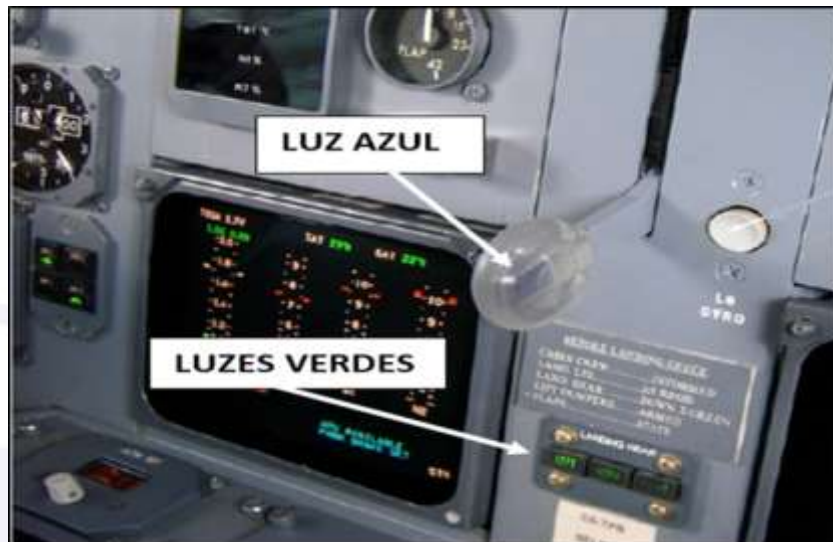
In normal operation, a blue light, incorporated into the selector lever, turned on during the landing gear retraction and stayed on until all landing gear doors were closed and locked. During the lowering of the landing gears, the light turned on and stayed on until all the landing gears were lowered and locked.

In an alternating system operation, the blue light turned on and stayed on until the selector lever was set to the down position and until all landing gears were down and locked.

Figure 6 - Location of the blue light and the green ones.

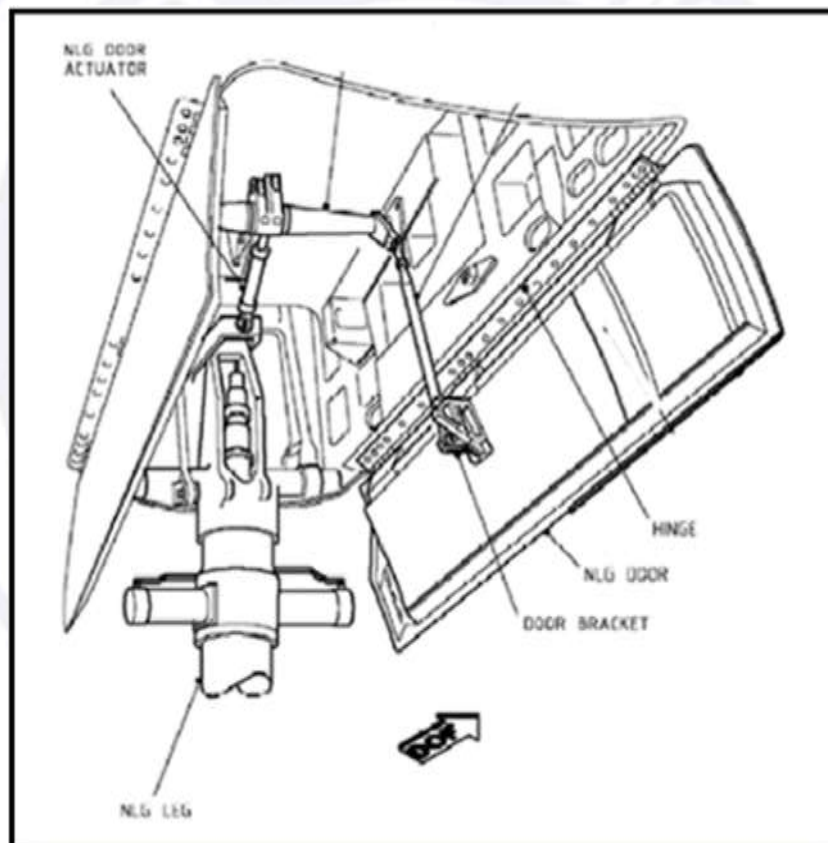
The doors were built, internally, with honeycomb panels aluminum alloy-covered and exterior coating panels. The panels were stiffened by reinforcing plates. A bracket was installed inside the door to connect the door bracket. There was a hinge assembly installed on the outer lateral end of the door.

Figure 7 – Landing gear doors, bracket and hinge.

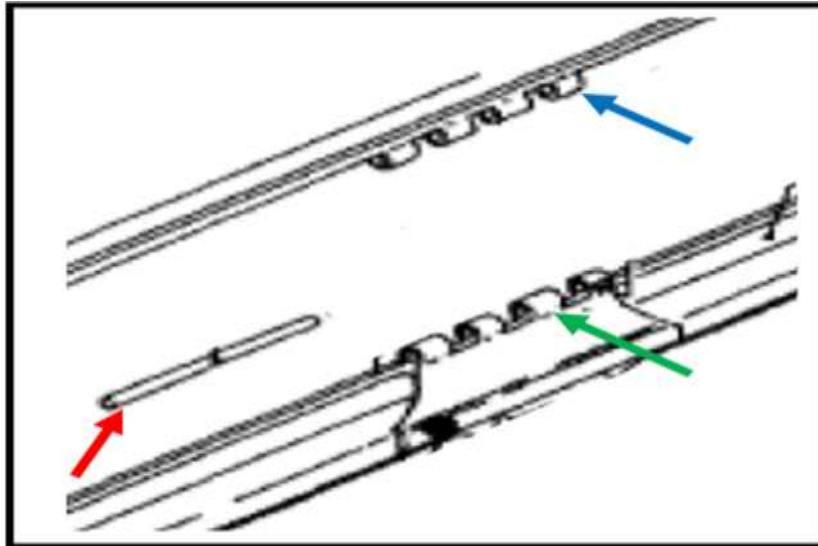
In the aircraft maintenance history, specifically with regard to the services performed in the landing gear door area, it was found that in September 2012, the right door hinges were repaired by incorporating larger radial pins and enlargement of the lobe holes. This service was performed at Fokker Services B. V. base in Hoofddorp, the Netherlands.

In Figure 8, the pin can be identified through the red arrow, the hinge lobe connected to the fuselage through the blue arrow and the hinge lobe connected to the door through the green arrow.

Figure 8 - Detail of the hinges.

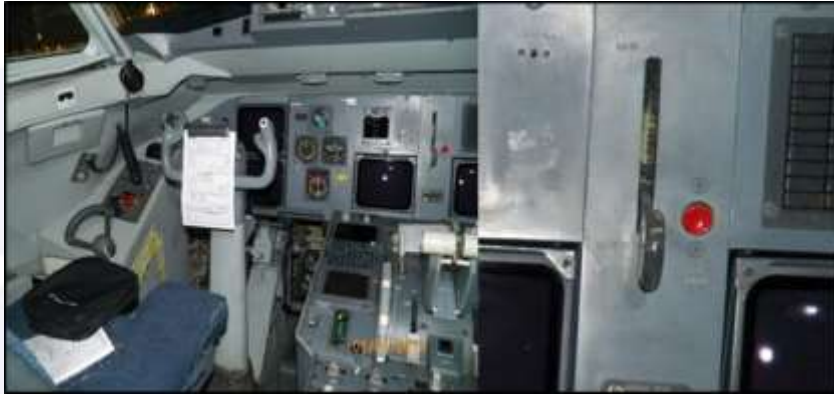
About an hour after the accident, the field investigation action team verified in the cockpit that the landing gear selector lever was in the landing gear down position, LG DOWN.

Figure 10 - Landing gear lever in the down position, LG DOWN.

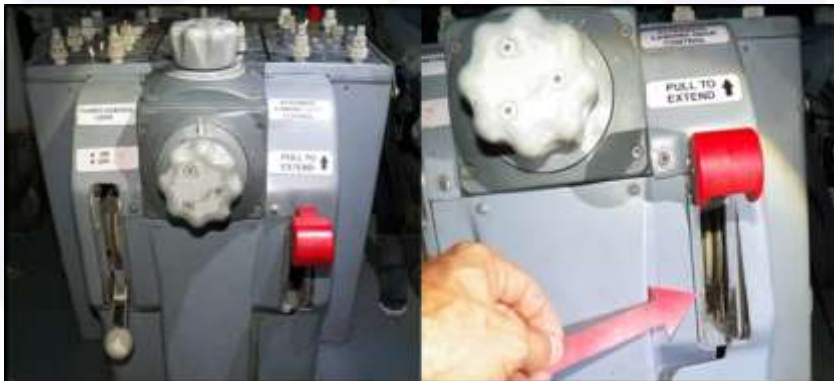
The landing gear alternative control lever was in the extend position.

Figure 11 - Landing gear alternative control lever in the extend position.

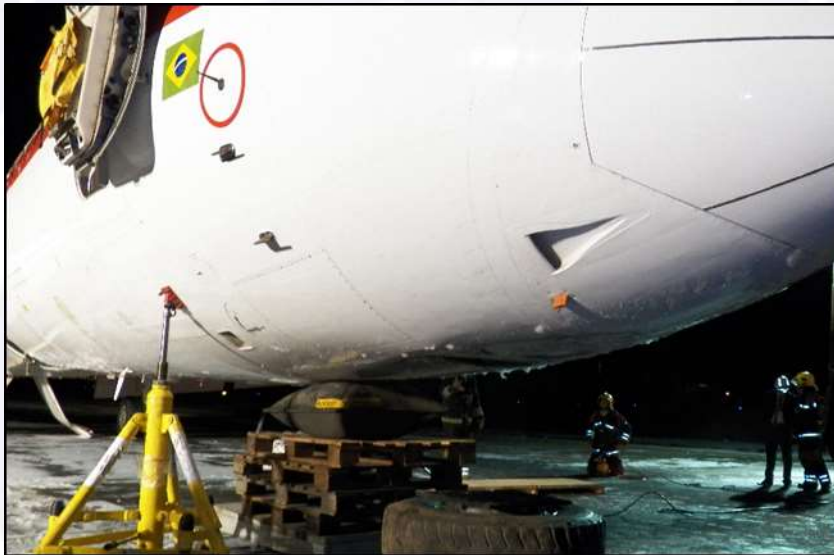
Figure 14 - Aircraft lifted by platforms, inflatables and jacks.

The nose landing gear was found unlocked and had started the lowering course. The wheels were propped on the inside of the doors, which were unlocked and had begun to open.

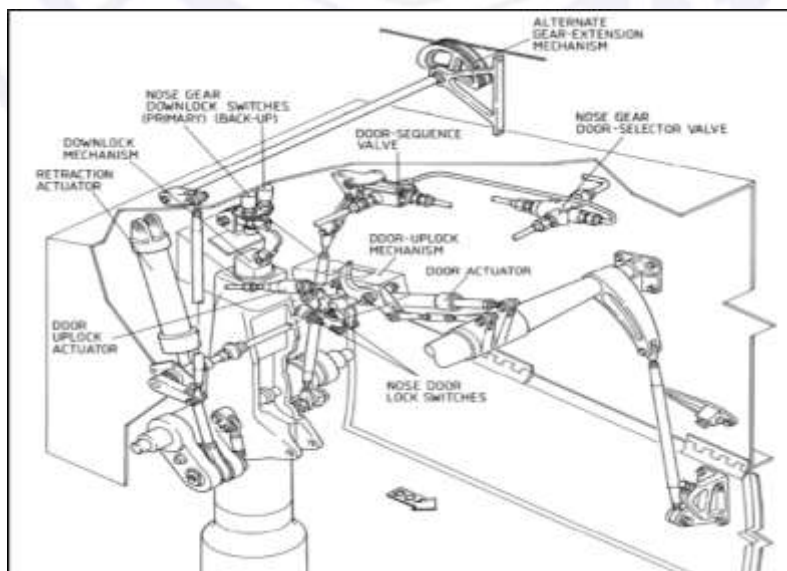
The locking and unlocking mechanisms were checked, up and down positions, as well as the mechanism responsible for lowering and retracting the nose landing gear, and also the opening and closing mechanism of the doors. There was no hydraulic fluid leakage in the actuators, all control cables and pulleys were properly positioned and connected. The selector valve switches were free of mechanical interference.

Figure 18 - Mechanisms of the nose landing gear and doors.

In these mechanisms conditions were not identified that could impose restrictions on the unlocking of the up position of the landing gear and the proper functioning of the lowering mechanism.

It was found that the rods responsible for opening and closing the landing gears doors suffered plastic deformation, caused by buckling, due to an axial compression effort. After lowering the nose landing gear, the rods separated into two sections each with slight manual effort.

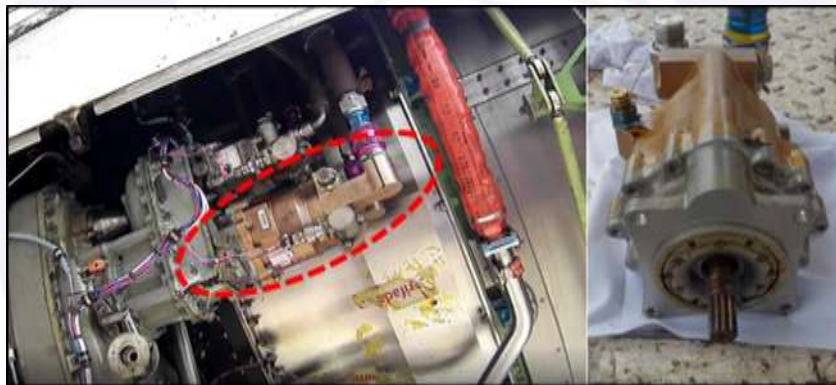
The EDP1 was removed and it was found that there was fluid leakage through the pump body, specifically by the gasket between the sections that make up the pump body, called mounting flange and housing.

Figure 22 - EDP1 installed and after removal.

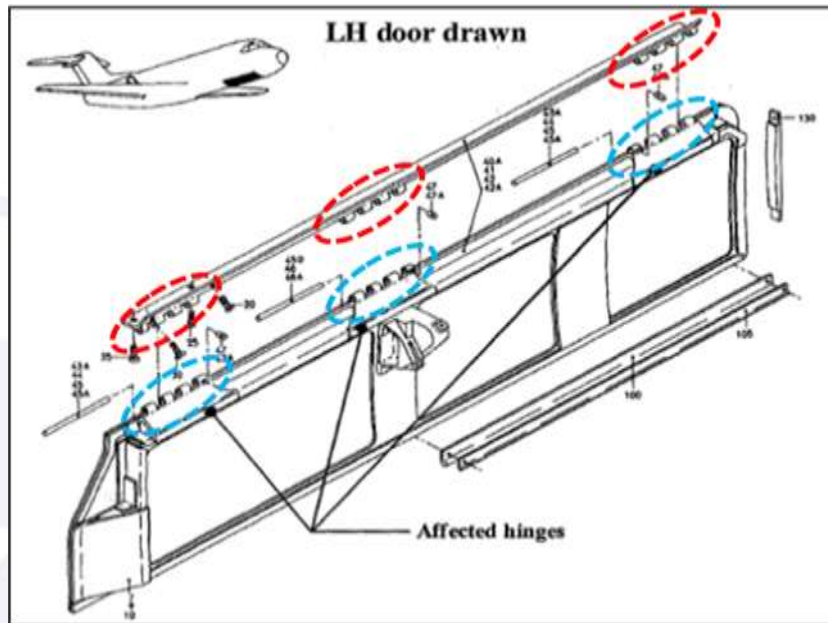
Figure 25 below illustrates a left nose landing gear door where red hinges that were attached to the aircraft structure can be identified and in blue detail, the hinges that were

attached to the aircraft structure doors. A pin through the lobe holes of each of the hinges promoted the union of the two frames, door and fuselage.

Figure 25 - Drawing of the left door and detail of the hinges.

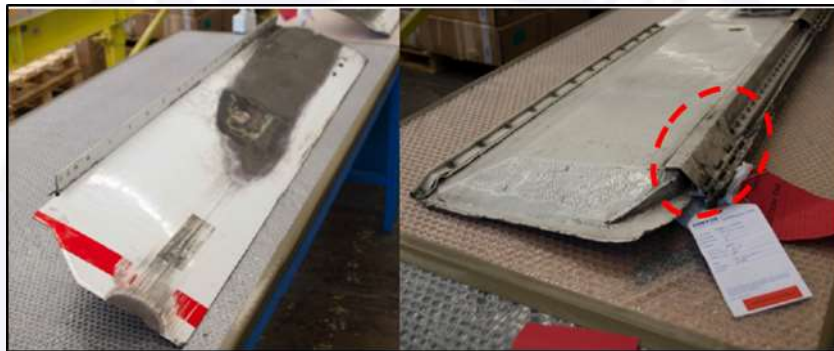
Figure 26 - Left door and front hinge detail.

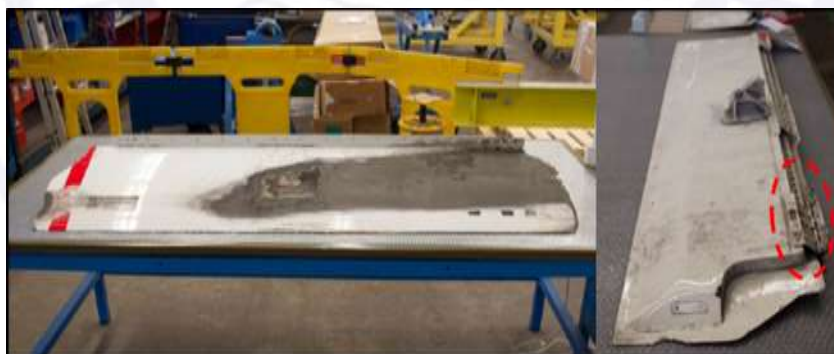
Figure 27 - Right door and rear hinge detail.

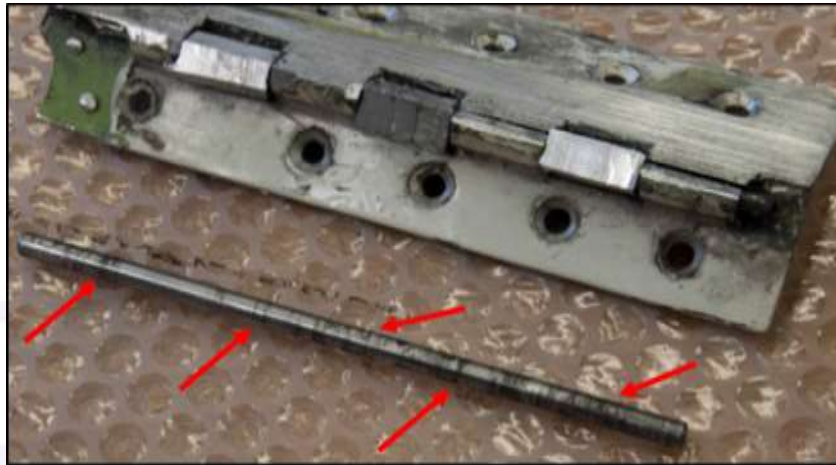
Figure 28 - Right front door hinge and pin detail.
