**COMANDO DA AERONÁUTICA**  
**CENTRO DE INVESTIGAÇÃO E PREVENÇÃO DE**  
**ACIDENTES AERONÁUTICOS**

**FINAL REPORT**  
**A - 036/CENIPA/2019**

<b>OCCURRENCE:</b>	<b>ACCIDENT</b>
<b>AIRCRAFT:</b>	<b>PR-OCW</b>
<b>MODEL:</b>	<b>A320-214</b>
<b>DATE:</b>	<b>03MAR2019</b>

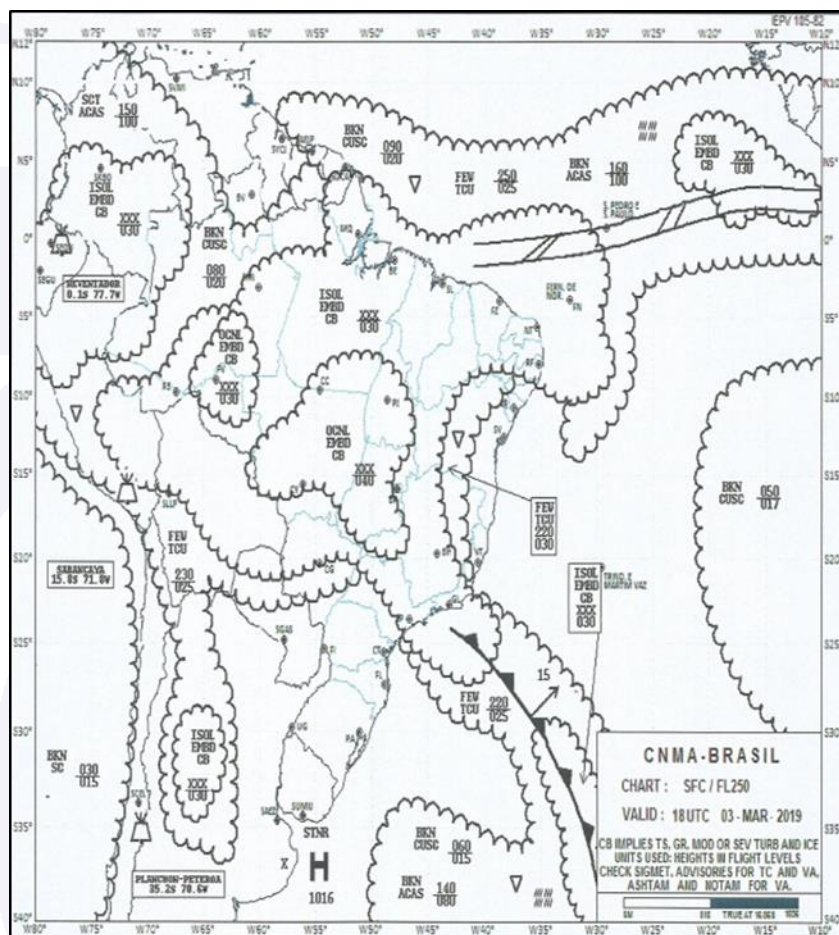
According to Opinion nº 04 / CVM / 2019, the synoptic situation presented a frontal system moving across the Atlantic Ocean in the state of Rio de Janeiro, as shown in Figure 1.

Figure 1 - SIGWX chart, from surface to FL250 - 03MAR2019 at 1800 (UTC).

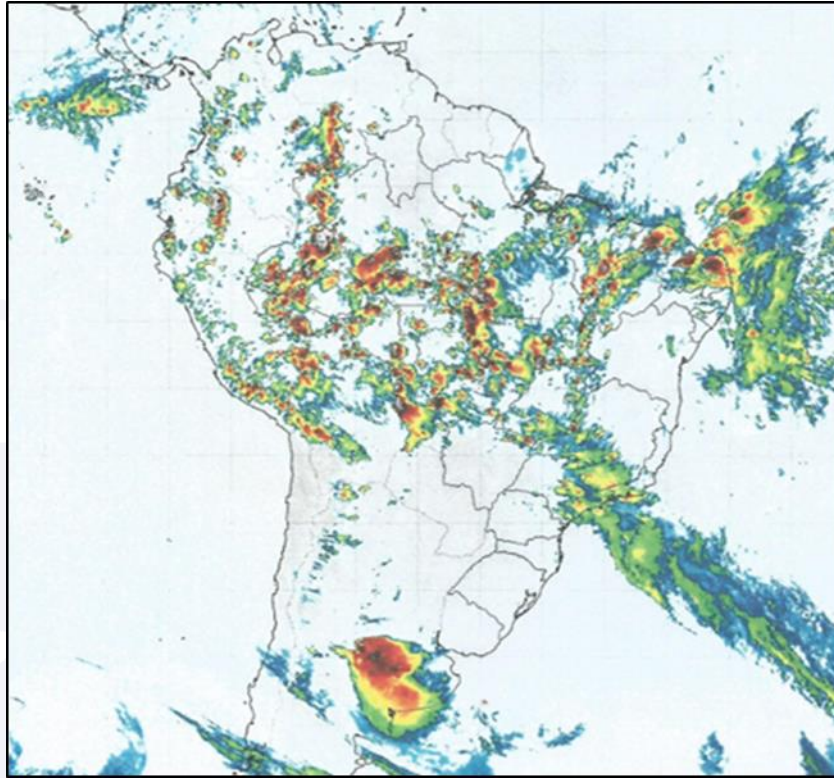
Figure 2 - Satellite image (Infrared) from 2030 (UTC) on 03MAR2019.

The opinion concluded that the weather was unstable with rain and thunderstorms forecast. The sky was covered with cloudiness in the form of CB and TCU. At 2000 (UTC), there was already an atmospheric discharge in SBGL.

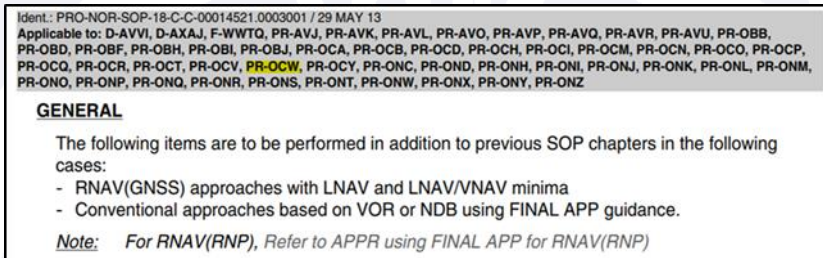
The DA was previously selected during the preparation of the cabin to perform the RNAV - GNSS - approach with minimal LNAV / VNAV procedure, as described in the company's SOP.

Figure 15 - FCOM - Approach Using Final APP Guidance - PRO-NOR-SOP-18-C P 6/30.

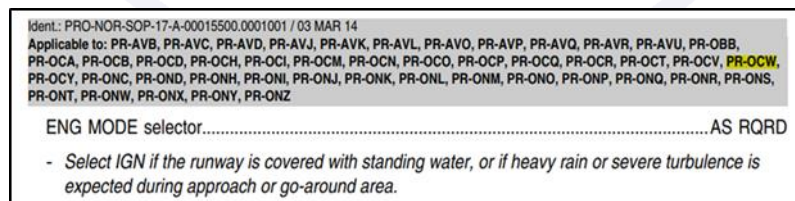
- At 20h24min50s, the commander selected the ENG MODE selector in Ignition mode, as prevised in the SOP;

Figure 16 - FCOM - ENG MODE - PRO-NOR-SOP-17 P 4/6.

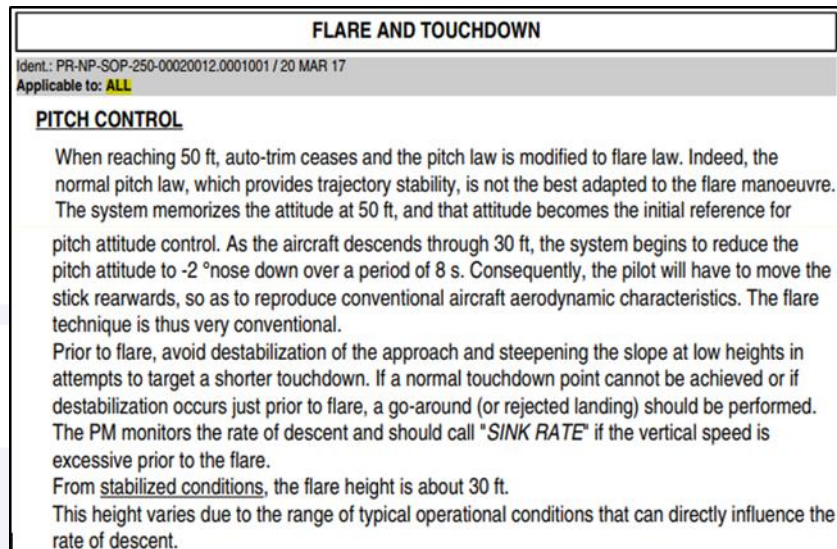
According to the FCTM, in stabilized conditions, the altitude of the flare was approximately 30ft, at which point the aircraft system started to reduce the pitch by -2° nose down for a period of approximately eight seconds.

At this point, the commander should move the side stick backwards, in order to reproduce the conventional aerodynamic characteristics of the aircraft. Thus, the flare technique on this aircraft was absolutely conventional.

Figure 20 - FCTM - PR-NP-SOP-250 P 1/10, 2/10.

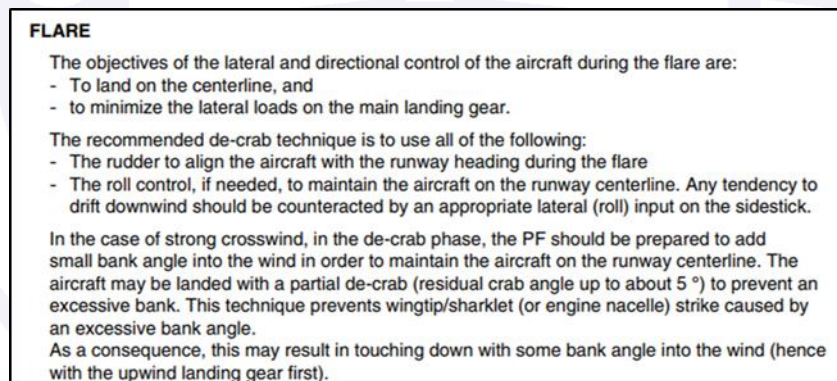
The FCTM reported that, if the aircraft had a tendency to drift from the centerline of the runway, caused by crosswinds, the de-crab technique was also recommended, applying the appropriate roll command.

Additionally, in case of strong crosswinds, during the application of the de-crab technique, the commander should prepare to apply a small bank angle towards the wind, in order to assist in maintaining the center of the runway.

Figure 21 - FCTM - Lateral and Directional Control/Flare - PR-NP-SOP P 3/10.
