FINAL REPORT
A - 137/CENIPA/2016

OCCURRENCE:	ACCIDENT
AIRCRAFT:	PR-STN
MODEL:	A300-B4-203
DATE:	21OCT2016

This is the Final Report of the 21OCT2016 accident with the A300-B4-203 aircraft model, registration PR-STN. The accident was classified as “[LOC-G] Loss of Control on the Ground” and “[RE] Runway Excursion”.

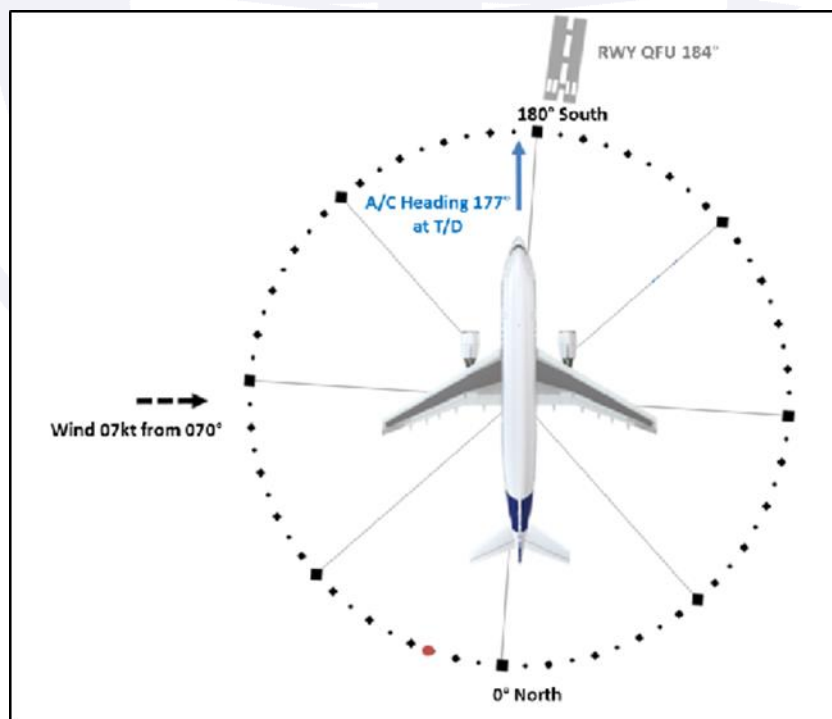
Figure 20 - Wind direction and head of the aircraft at the moment of landing.

The METAR of the Gilberto Freyre Aerodrome, at 0900 (UTC) indicated that the wind direction was of 070° with 07kt intensity, which would result in a left crosswind as illustrated in the figure below.
