COMANDO DA AERONÁUTICA
CENTRO DE INVESTIGAÇÃO E PREVENÇÃO DE
ACIDENTES AERONÁUTICOS

FINAL REPORT
A-104/CENIPA/2021

OCCURRENCE:	ACCIDENT
AIRCRAFT:	PS-CSM
MODEL:	B200GT
DATE:	14SET2021

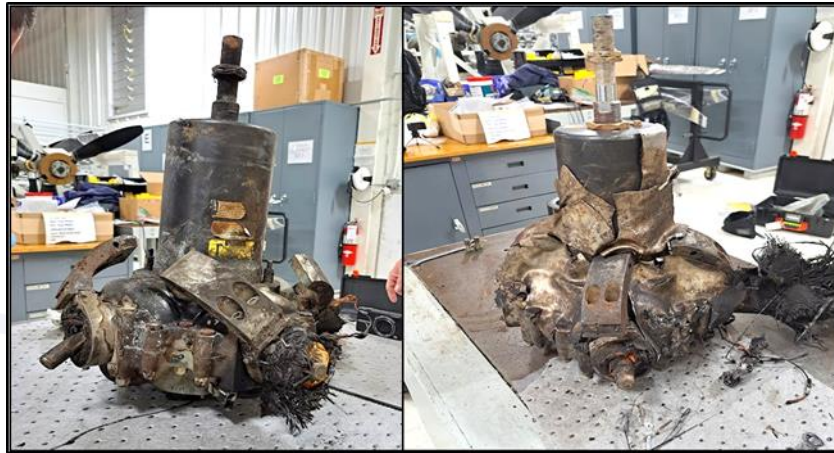
Figure 16 - NR511 (left) and NR505 (right) propeller hubs shown at the beginning of the analyses.

The left- and right-hand propellers equipping the PS-CSM aircraft were of the HC-E4N-3A model with NC9208K propeller blades and had serial numbers NR511 and NR505, respectively.

The hubs of these components and a fractured, unnumbered propeller blade were analyzed at the Hartzell Propeller Engineering Test Lab, located in Piqua, Ohio, USA (Figure 16).

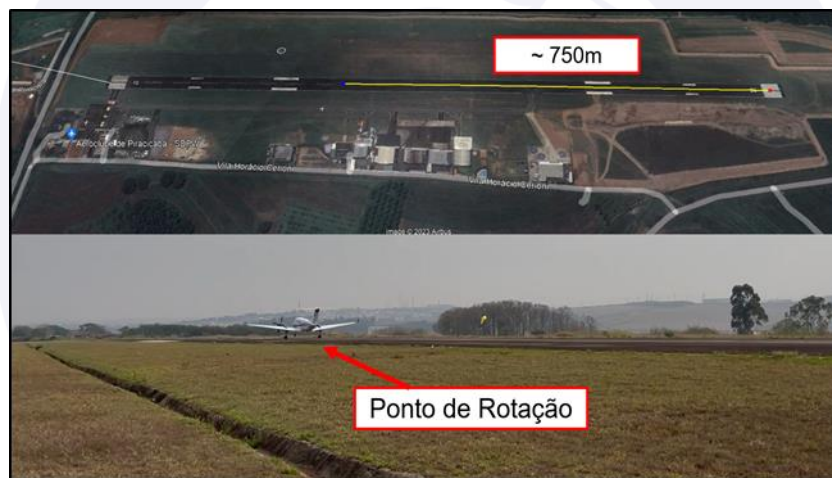
Figure 26 - Estimated distance traveled during the takeoff run.

By means of a video recording made with the cell phone of a witness watching the takeoff near the runway, it was possible to estimate that the aircraft got airborne at a distance of 750 meters from the point where the brakes were released (Figure 26).

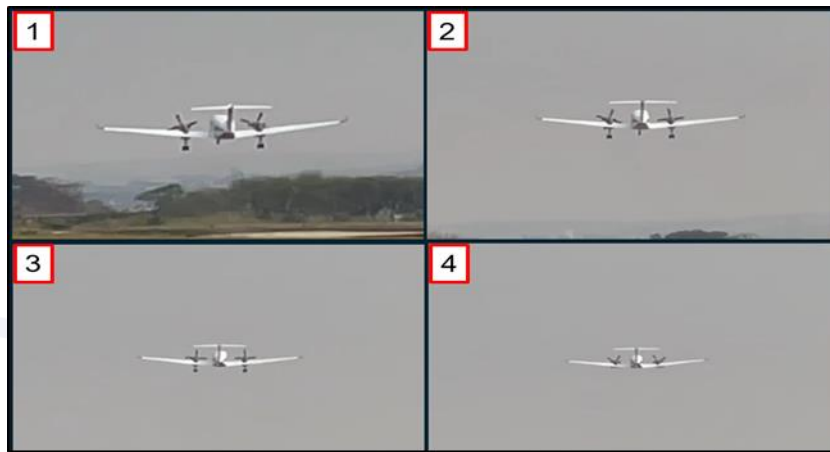
Figure 27 - Sequential images of the aircraft during takeoff, progressively ordered in relation to the time of recording

Shortly after rotation, the images showed that the aircraft commenced a right turn, which progressively increased until the end of the video, as illustrated in Figure 27, with sequential video excerpts numbered 1 to 4.

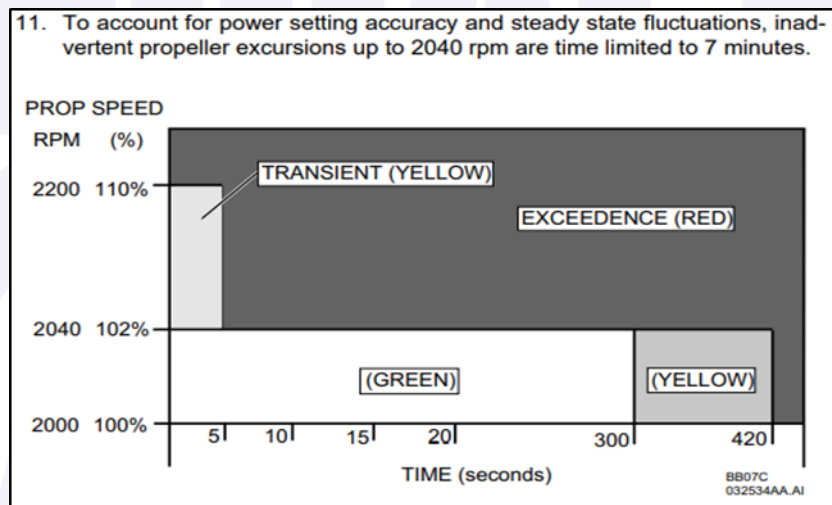
Figure 30 - Alarms and warnings related to the rotation speed of the propellers (AFM).

As for potential visual and aural alarms that could warn the pilots of the overspeed condition, the manual read that if the speed of one of the propellers exceeded 2,040 RPM, the corresponding indicator (N2) would turn yellow, and could become red if this condition persisted for more than 5 seconds. If the RPM remained above 2,000 RPM for more than 300 seconds, the indicator would also turn yellow (Figure 30).

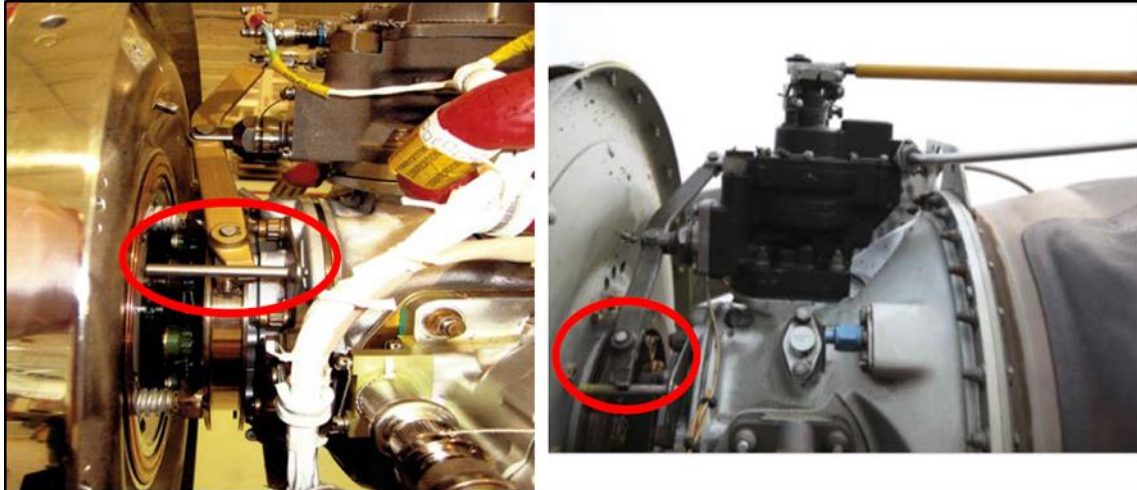
Figure 31 - Examples of correct (on the left) and incorrect (on the right) installation of the beta arm. Source: ASR-16-007, NTSB.

During an investigation conducted by the NTSB, it was found that the beta arm (reverser lever) and related components in PT6A engines could be positioned incorrectly. If the beta arm was not positioned so as to be locked under its guide pin, the insecure connection could release oil pressure at the beta valve and cause uncommanded movement of the propeller toward the feathered position (Figure 31).

The recommendation was accepted by the Federal Aviation Administration (FAA), which issued the 20002 Safety Alert for Operators (SAFO) on 27 February 2020, establishing actions concerning the PT6A engines.
