COMANDO DA AERONÁUTICA
CENTRO DE INVESTIGAÇÃO E PREVENÇÃO DE
ACIDENTES AERONÁUTICOS

FINAL REPORT
IG-029/CENIPA/2025

SERIOUS INCIDENT

737-8 MAX

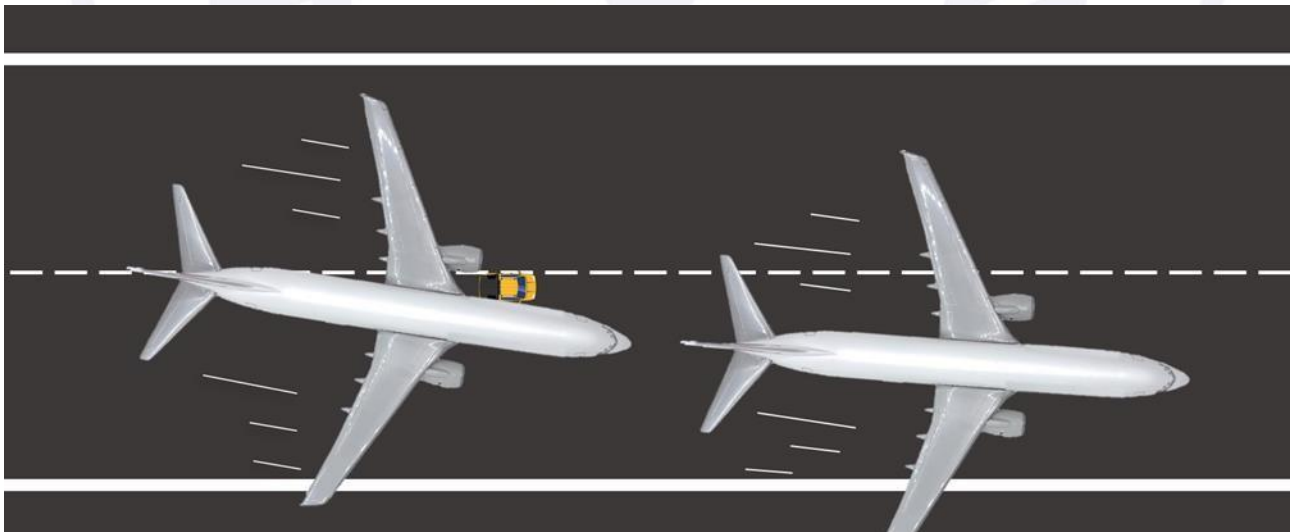
The maintenance vehicle passed underneath the aircraft fuselage, between the nose landing gear and the left main landing gear (Figures 20 and 21). The collision occurred as the aircraft approached rotation speed, at 156 kt.

Figure 20 - Overhead view of the collision dynamics between the aircraft and the vehicle. Despite the evasive maneuver to the right, the aircraft remained within the runway lateral limits.

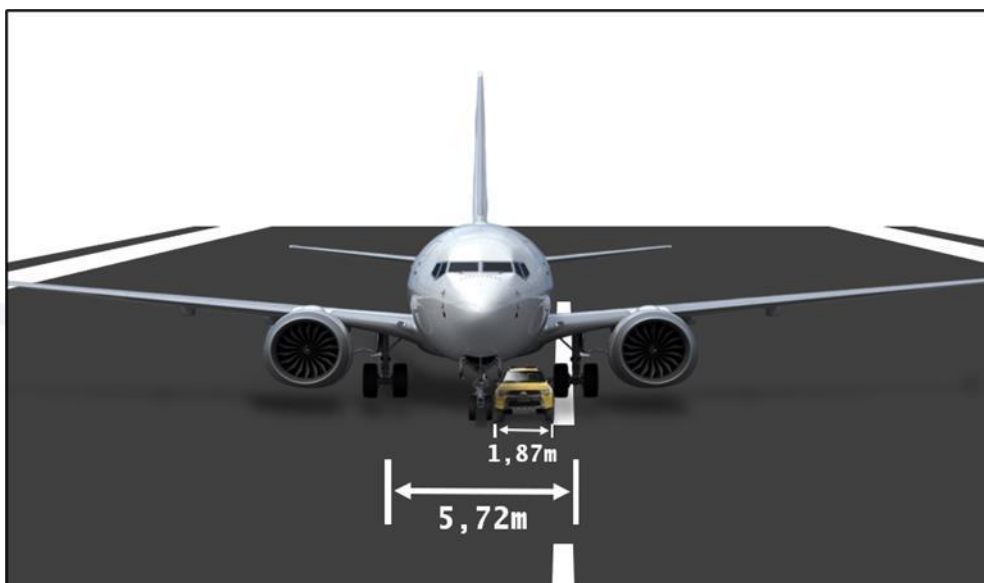
Figure 21 – Frontal view of the dynamics of the collision between the aircraft and the vehicle. The maintenance vehicle passed underneath the aircraft fuselage, between the nose landing gear and the left main landing gear.

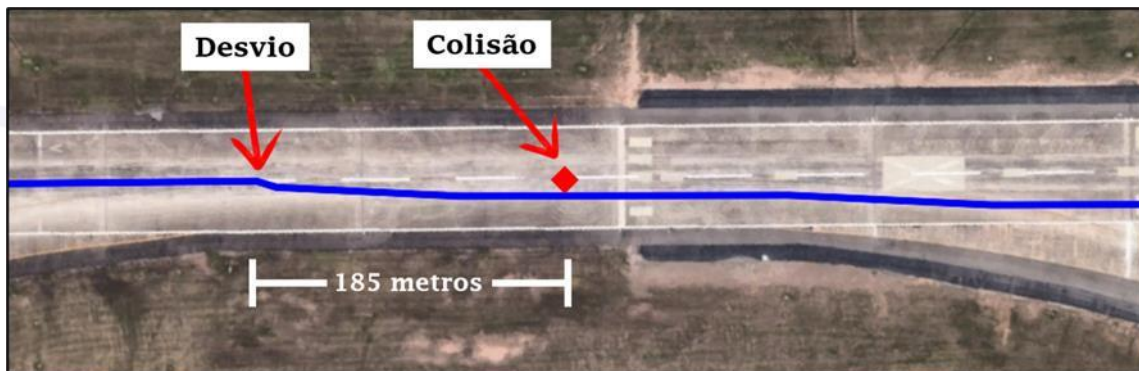
The PF's pedal input - 0.5 seconds before the collision - prevented a direct impact of the nose landing gear with the rear of the vehicle, significantly reducing damage to the aircraft and the severity of injuries to those involved. According to FDR data, the pilots spotted the vehicle at a distance of approximately 185 meters (Figures 23).

Figure 23 – Moment when the pilots sighted the vehicle and initiated a right turn, at a distance of 185 meters short of the collision point. At that moment, the aircraft had an indicated airspeed of 153 kt. The blue line indicates the approximate trajectory of the nose landing gear. Source: adapted from the *Google Earth/FDR*

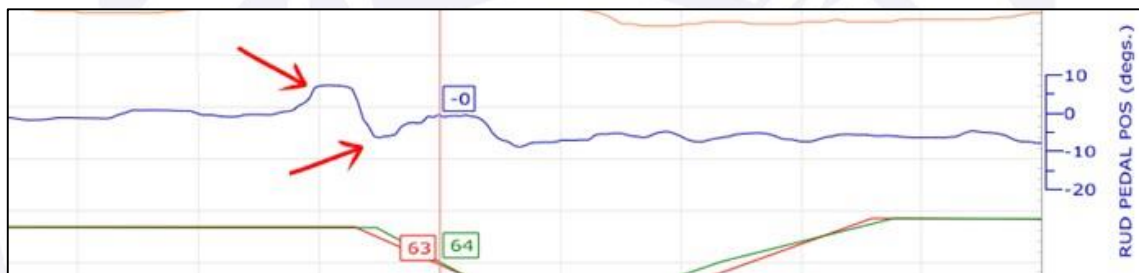
Figure 24 - Pedal input amplitude used by the PIC prior to impact with the vehicle. Source: FDR.

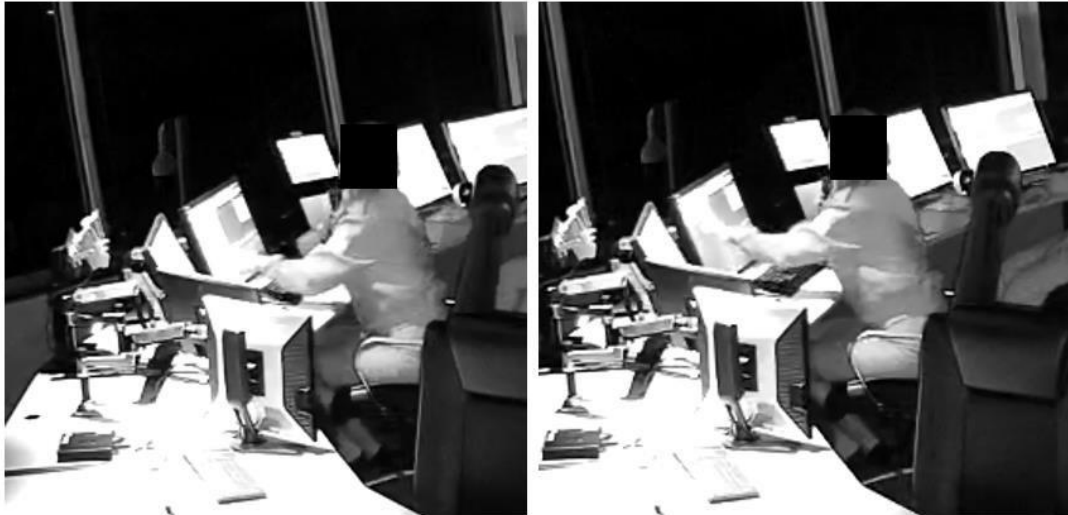
At 01:07:03 UTC, the ATCO at the TWR Control position unlocked the TATIC screen without verifying whether the vehicle had vacated the runway. Immediately afterward, the ATCO called aircraft PS-GPP, authorizing takeoff on runway 10, without visually scanning the runway.

Figures 34 - Moment at which the TATIC screen was unlocked.

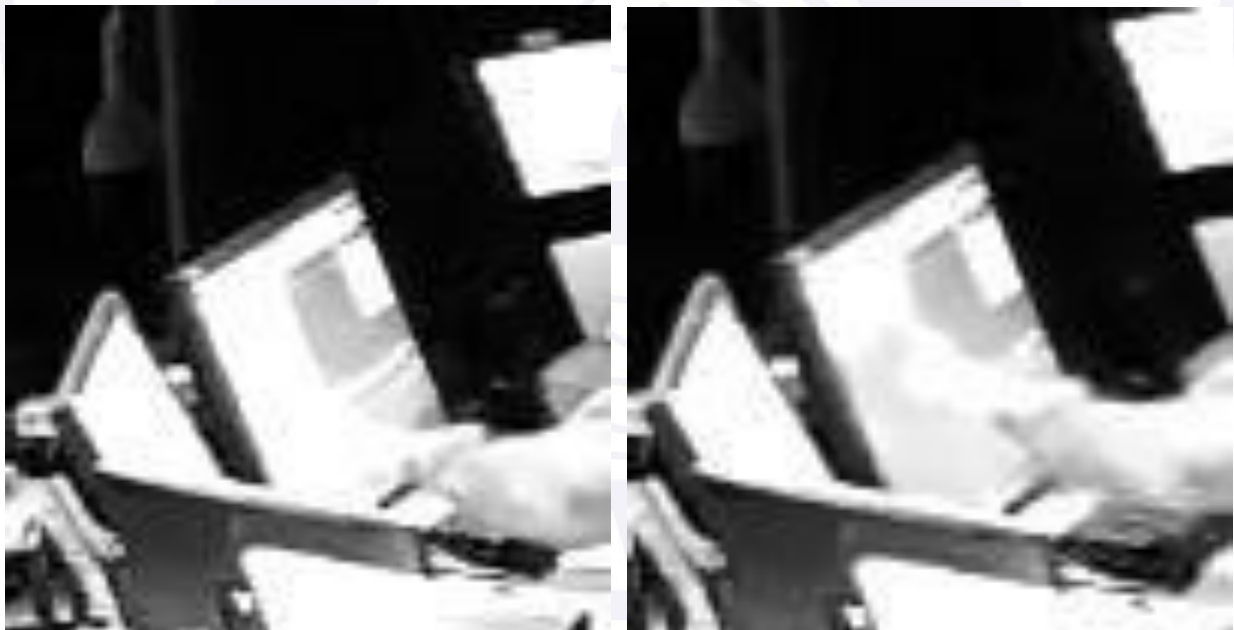
Figure 35 - Moment at which the TATIC screen was unlocked (zoomed view). On the left, the locked screen and, on the right, the same screen unlocked.

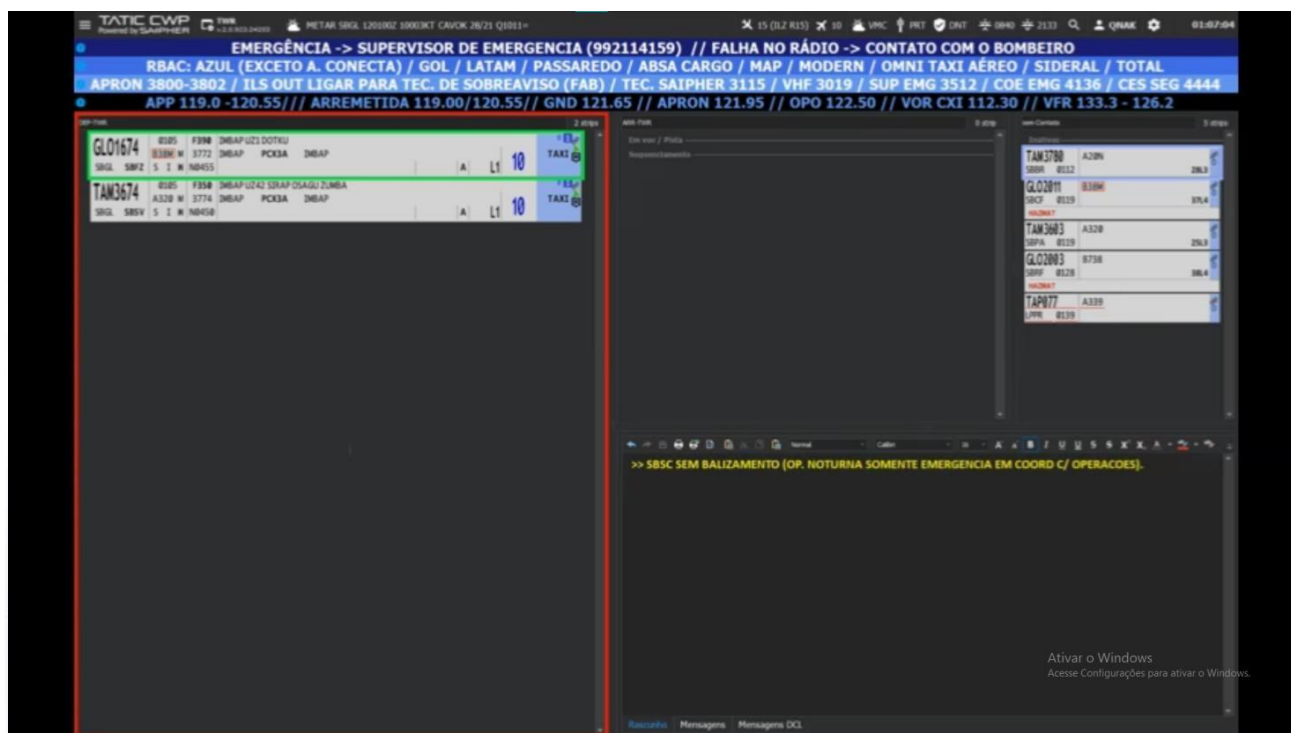
Figure 36 - TATIC screen unlocked after the command Issued by the ATCO at the TWR Control position.

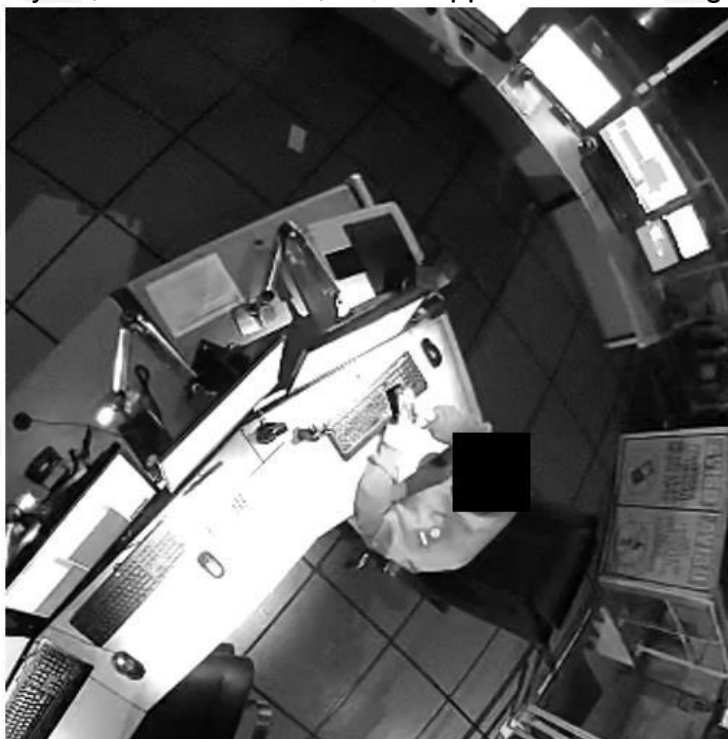
At that moment, the Supervisor, distracted while handling a mobile phone, did not notice that the ATCO had failed to comply with the procedure set forth in the TWR-GL Operational Model (Figure 38).

Figure 37 - Action performed by the Supervisor moments before the takeoff clearance was issued to the aircraft (view from the 360° camera, located on the ceiling of TWR-GL operations room).

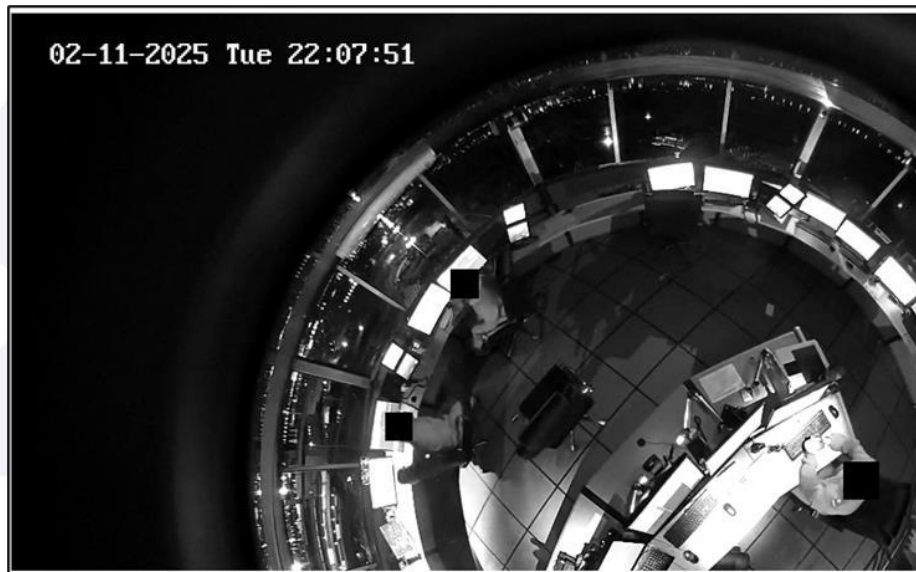
At 01:07:51 UTC, the ATCO at the TWR Control position turned to the Supervisor and asked whether the maintenance vehicle had been removed from the runway: “*Did you remove maintenance?*” (Figures 38 and 39).

Figure 38 - Moment when the ATCO at the TWR Control position asked the Supervisor if the maintenance vehicle had been removed from the runway (view from the 360° camera, located on the ceiling of the TWR-GL operations room).

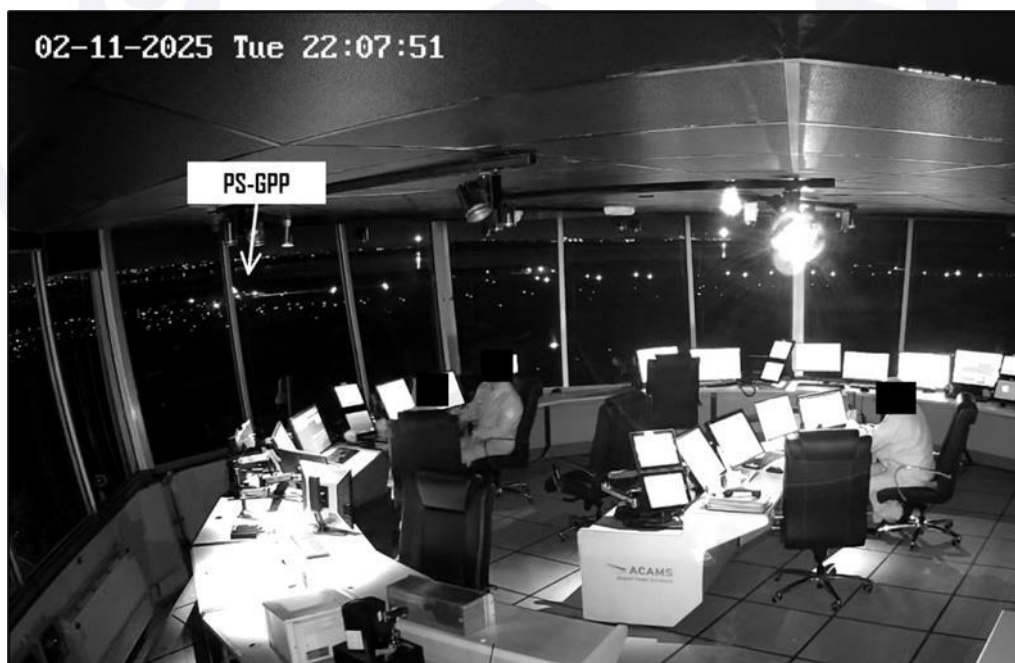
Figure 39 - Moment when the TWR controller asked the Supervisor if the maintenance vehicle had been removed from the runway. In the background, the aircraft can be seen while positioning for takeoff.

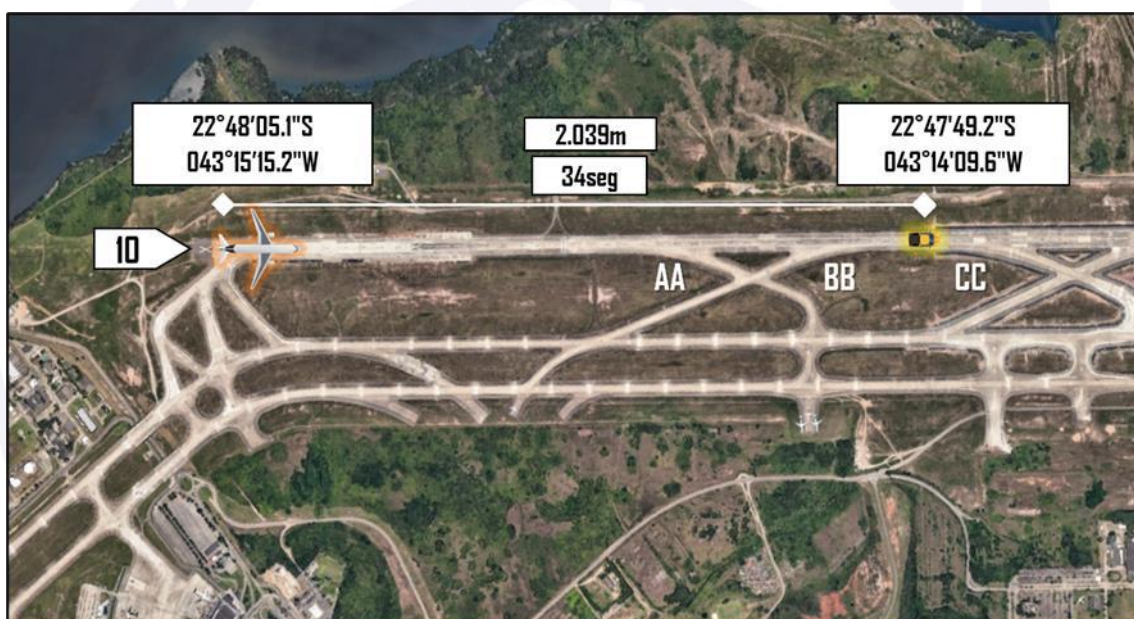
According to the data recorded by the FDR, aircraft PS-GPP began its takeoff roll at 01:07:54 UTC, three seconds after the ATCO recalled that the maintenance vehicle was still on the runway. At the exact moment the pilots applied engine power, the aircraft was 2,039

Figure 41 - Diagram showing the distance (2,039 meters) and time (34 seconds) to the collision at the moment the TWR controller questioned the Supervisor about the maintenance vehicle's presence on the runway (aircraft and vehicle not to scale for better visualization).

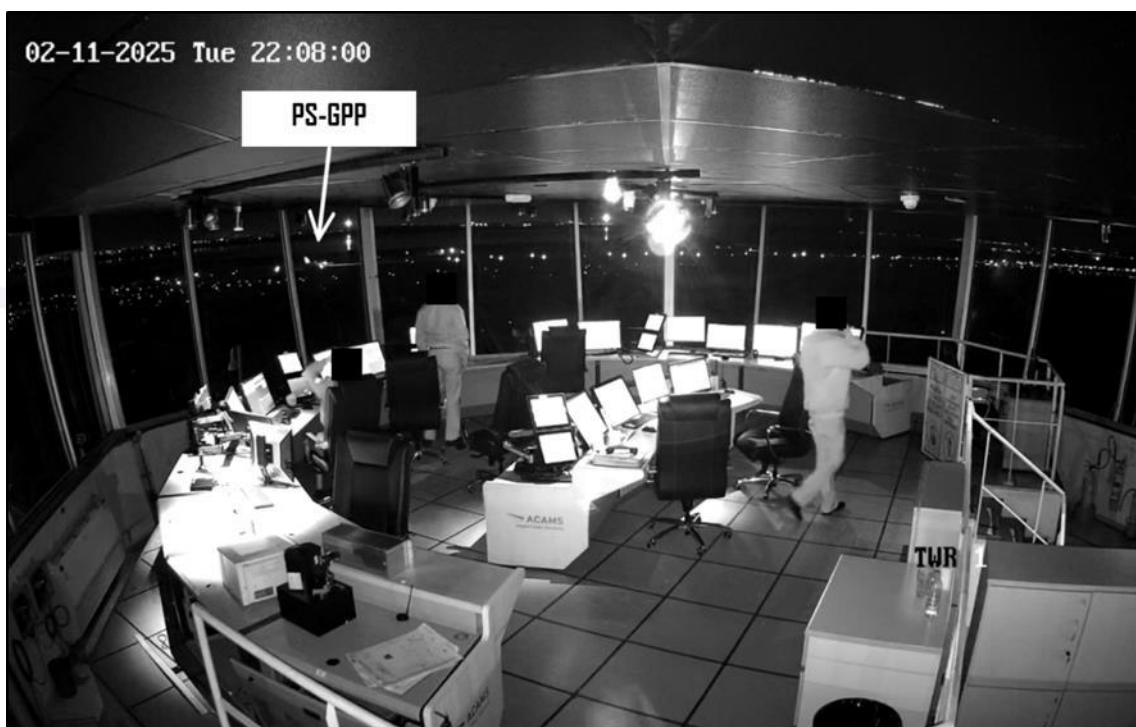
At 01:08:00 UTC, the Supervisor made a call to the lighting-maintenance vehicle, requesting it to clear runway 10 (*"Manutenção balizamento, livre pista uno zero."*). However, the ATCO did not check the vehicle's position, did not instruct an immediate vacation of the runway, and did not inform the personnel that an aircraft was initiating a takeoff on that runway.

Figure 42 - Moment when the Supervisor requested the maintenance vehicle to vacate the runway. In the background, it is possible to see that the aircraft PS-GPP had already begun its takeoff roll.

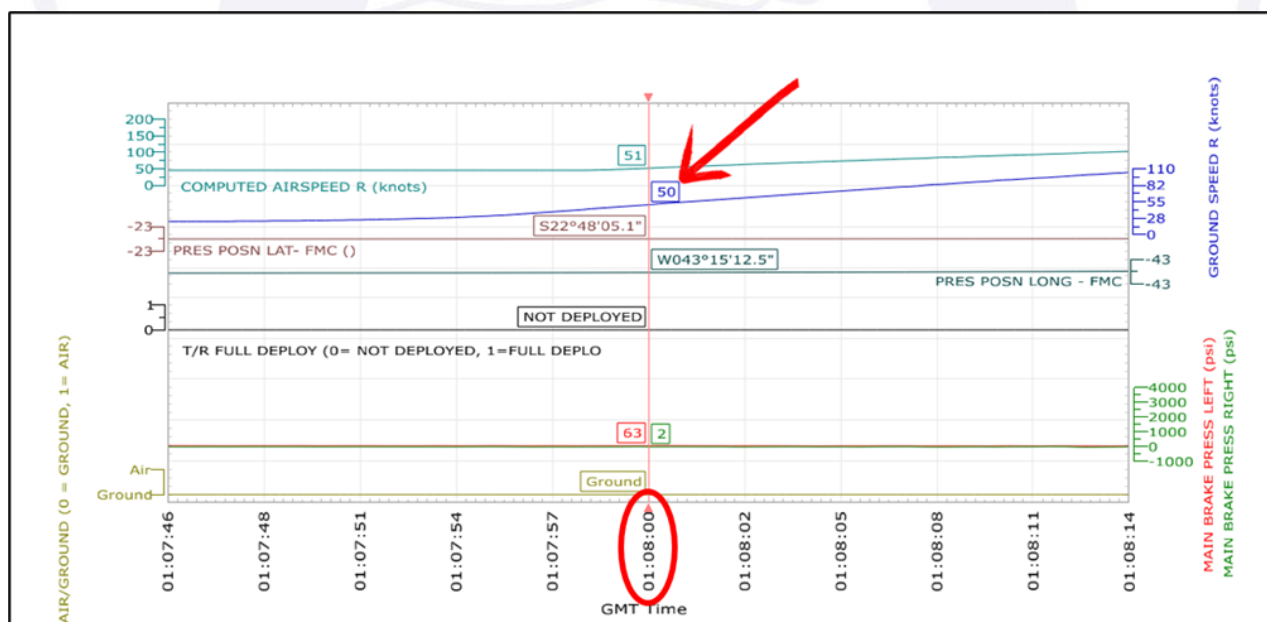
At that moment (01:08:00 UTC, according to FDR data), the aircraft's ground speed was 50 kt, which would still allow a Rejected Takeoff (RTO)⁵ under low-energy conditions (Figure 43).

Figure 43 - Moment when the Supervisor requested that the maintenance vehicle vacate the runway, at 01:08:00 UTC). The arrow indicates the aircraft's speed of 50 kt.

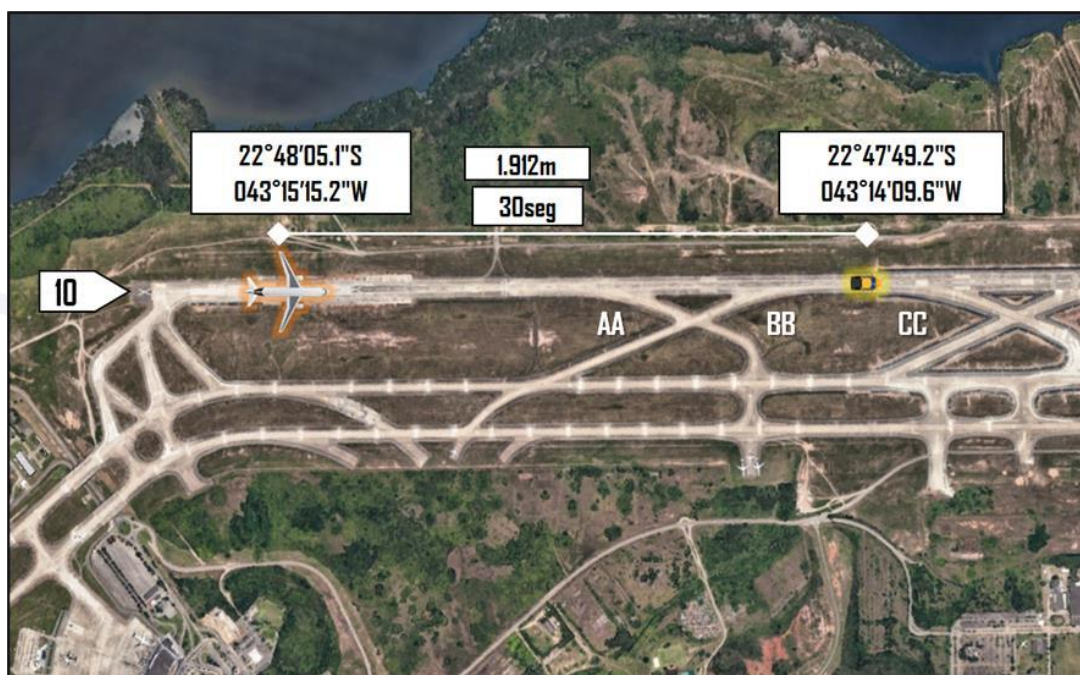
Figure 44 – Diagram showing the distance (1,912 meters) and time (30 seconds) for the collision at the moment the Supervisor requested that the vehicle vacate the runway, according to the FDR (aircraft and vehicle not to scale for better visualization).
Source: adapted from Google Earth.

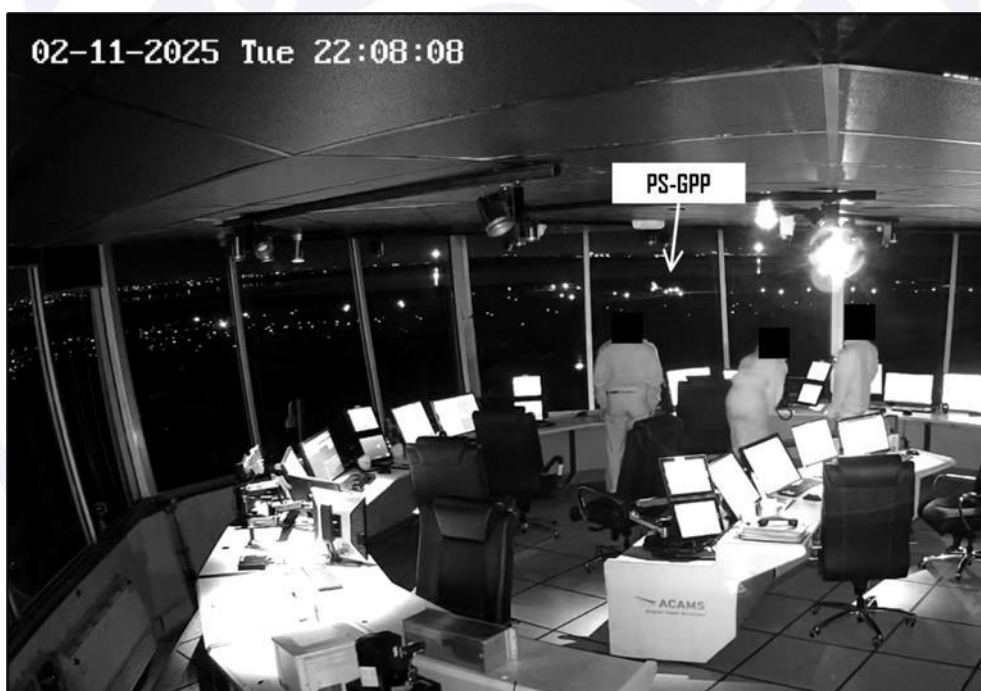
Figure 45 - Controllers attempting to identify the maintenance vehicle's location on the runway during the takeoff roll of aircraft PS-GPP.

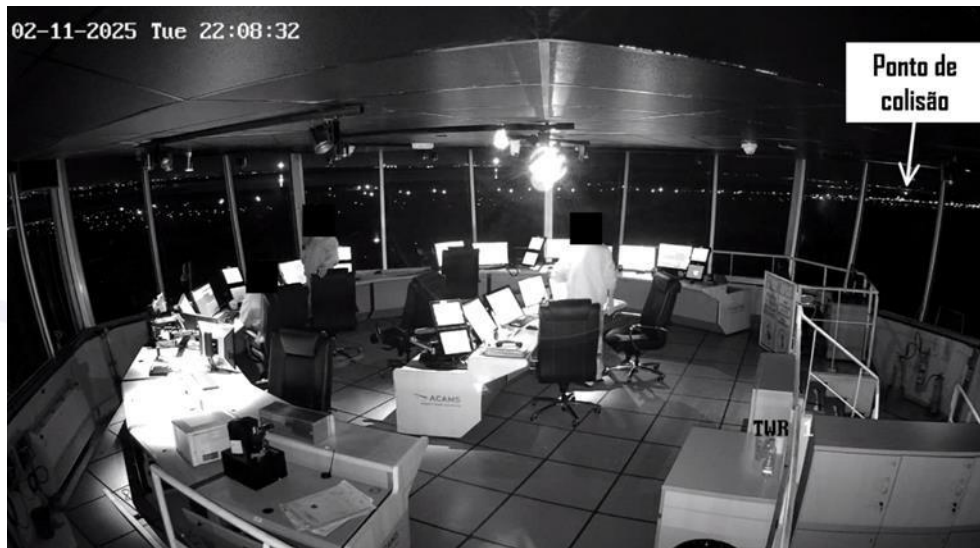
Figure 46 - Moment of impact between the aircraft and the vehicle.
The point of collision is highlighted on the right.

According to the data analyzed, the pilots sighted the vehicle about 0.5 second before impact, at an estimated distance of 185 meters, at which time the aircraft's indicated speed was approximately 153 knots.

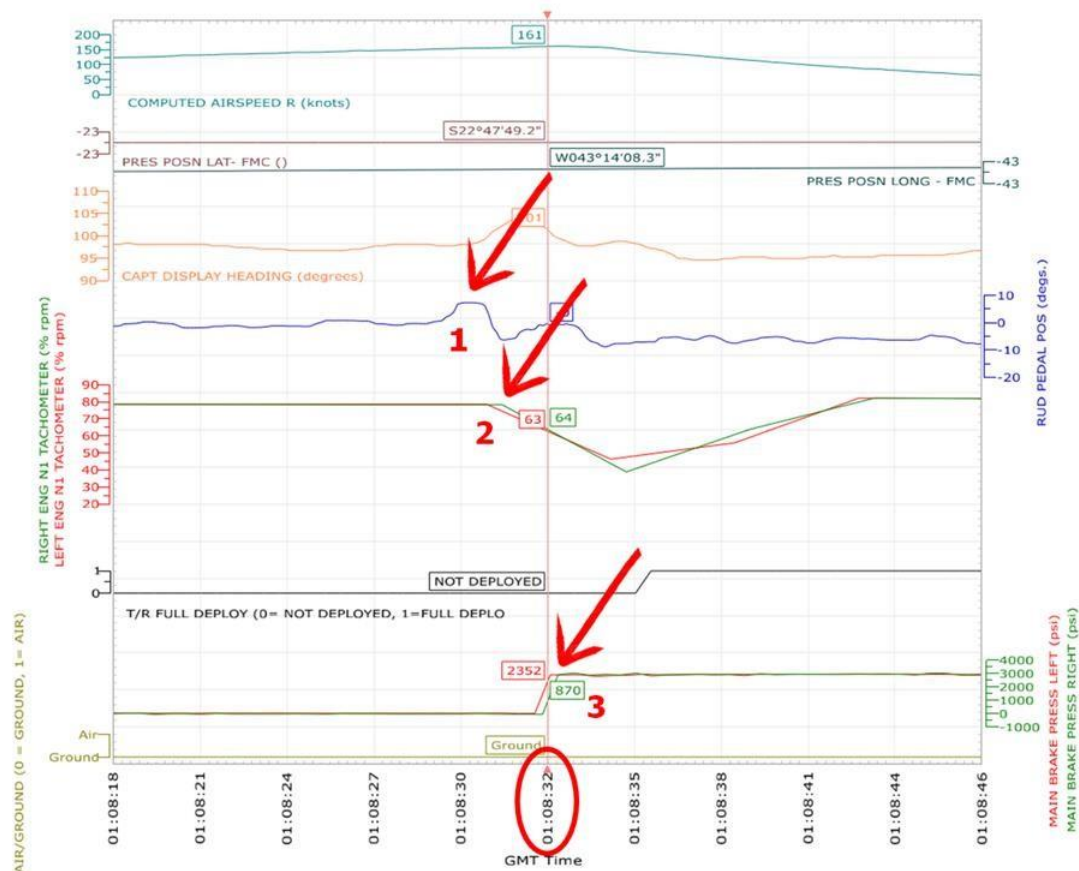
In an attempt to avoid direct impact of the landing gear with the vehicle and a possible excursion off the right side of the runway, the pilots executed an evasive ground maneuver. They then contacted TWR-GL to report the occurrence.

Figure 47 – Moment of the collision between the aircraft and the vehicle, based on FDR data. At point 1, rudder input by the PIC is observed in an attempt to avoid direct impact of the nose gear with the vehicle; at point 2, power reduction; and at point 3, brake application.

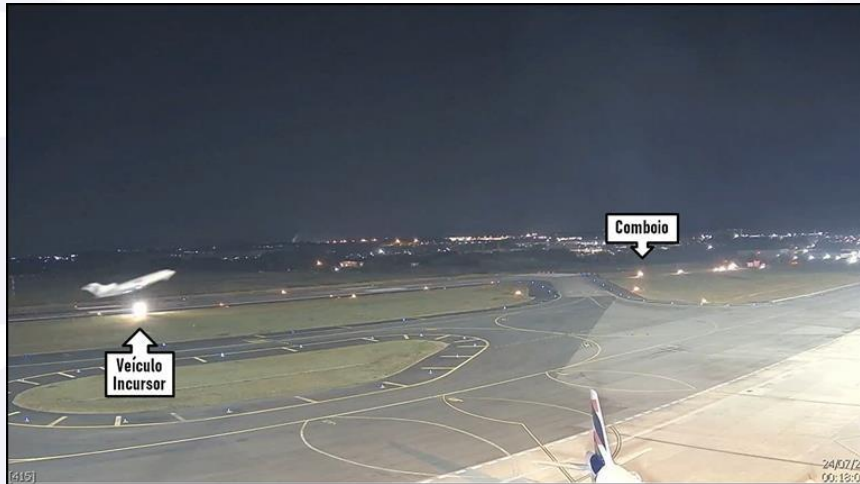
The aircraft's right wing passed approximately 6 meters from the light tower (Figure 54). There was no damage to the aircraft or the vehicle, and no injuries to their occupants.

Figure 54 - Runway incursion at SBCT (Afonso Pena Airport) on July 24, 2024.

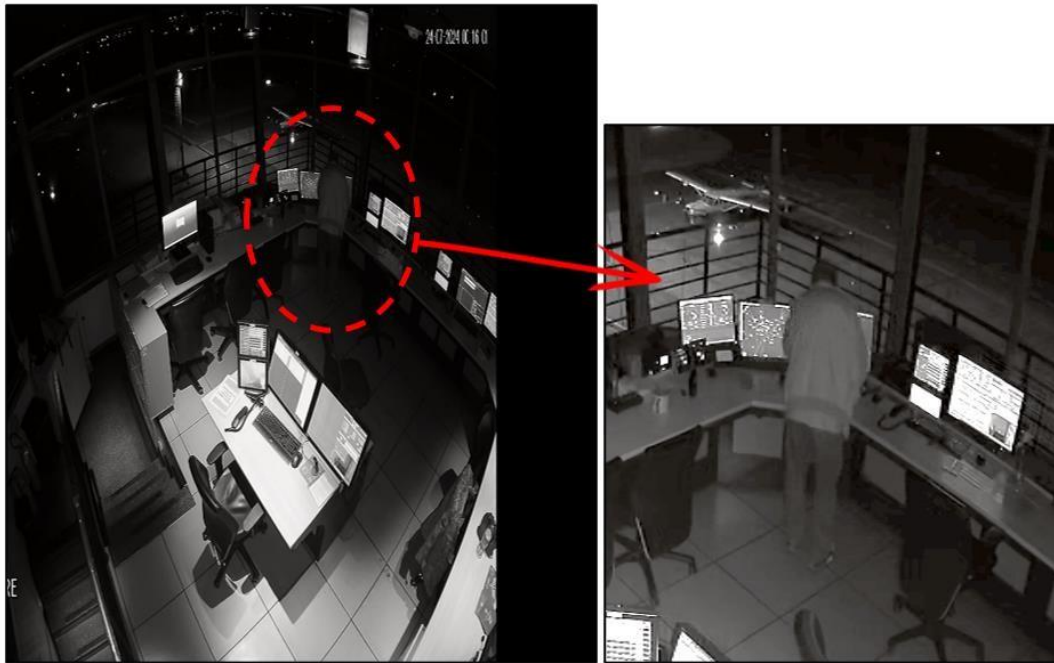
From the analysis of the last frame recorded before the event, at 03:16:01 UTC, and the first frame recorded after the event, at 03:18:08 UTC, it was possible to infer that the ATCO involved in the occurrence was inside the TWR and at his operational position during the runway incursion, but remained motionless, engaged in an activity other than monitoring operations, as prescribed in ICA 100-37 (Figure 55).

Figure 55 - On the left, last frame recorded before the event, at 03:16:01 UTC.
On the right, zoomed-in and enhanced image.

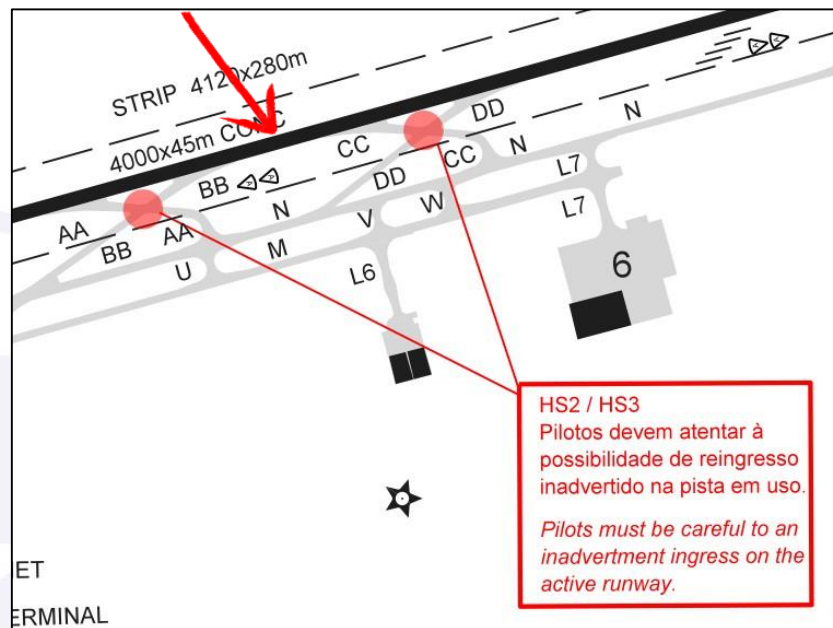
The collision between the aircraft and the vehicle occurred along the centerline of runway 10, within the segment between these two hot spots, as illustrated in Figure 59.

Figure 59 - Runway incursion risk areas on runway 10/28 (hot spots HS2 and HS3).

The arrow indicates the point of collision between the aircraft and the vehicle.
