**COMANDO DA AERONÁUTICA**  
**CENTRO DE INVESTIGAÇÃO E PREVENÇÃO DE**  
**ACIDENTES AERONÁUTICOS**

**FINAL REPORT**  
**A-122/CENIPA/2022**

<b>OCCURRENCE:</b>	<b>ACCIDENT</b>
<b>AIRCRAFT:</b>	<b>PT-DAB</b>
<b>MODEL:</b>	<b>182K</b>
<b>DATE:</b>	<b>29OUT2022</b>

This is the Final Report of the 29<sup>th</sup> October 2022 accident involving the 182K Cessna aircraft of registration marks PT-DAB. The accident received the typification of “[Fuel] fuel related.”

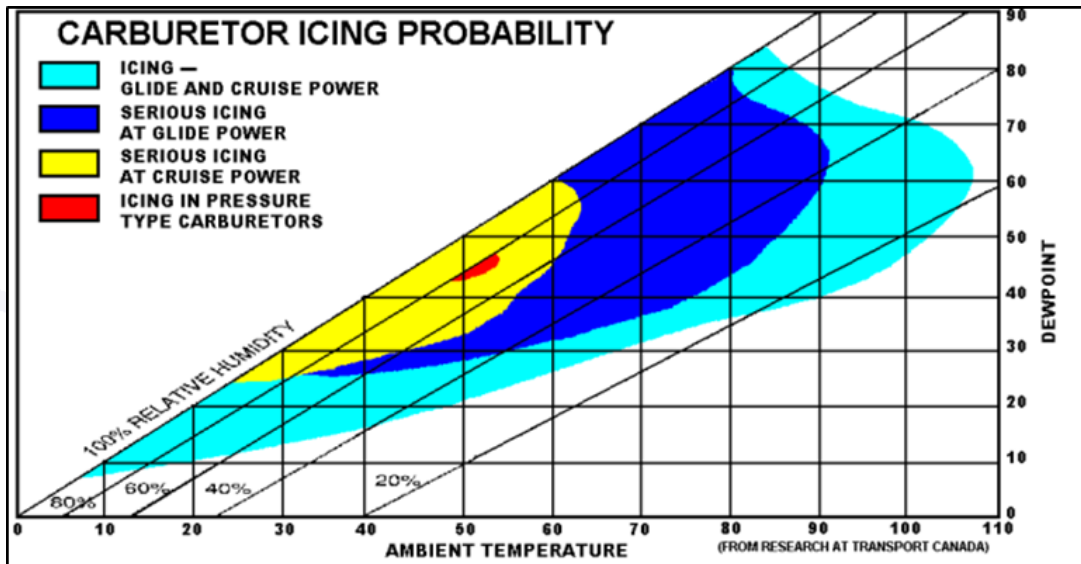
Figure 9 - Carburetor icing probability, with temperature and dew point in Degrees Fahrenheit. Source: MCA 3-6.

Such phenomenon occurs more frequently in small conventional engines in comparison to larger conventional ones, which generally have an injector system that diminishes the likelihood of ice crust formation in the intake system. Carburetor Icing is generally characterized by a gradual power decrease, RPM variation, rough and intermittent engine operation, and black smoke in the exhaust (with a rich mixture). In some engines, carburetor icing will occur when the relative humidity is rather high (above 60%) in good, sunny, and, many times, even in hot weather conditions (15°/20°C – 60°/70°F) [...]

The Manual had a diagram with the probability of carburetor icing, as shown in Fig. 9.
