FINAL REPORT A-054/CENIPA/2019

OCCURRENCE: AIRCRAFT: MODEL: DATE: ACCIDENT PT-FEG EMB-121 A1 02ABR2019

This is the Final Report of the 02 April 2019 accident involving the EMB-121 A1 aircraft of registration marks PT-FEG. The occurrence was typified as "[SCF-NP] System/component failure or malfunction".

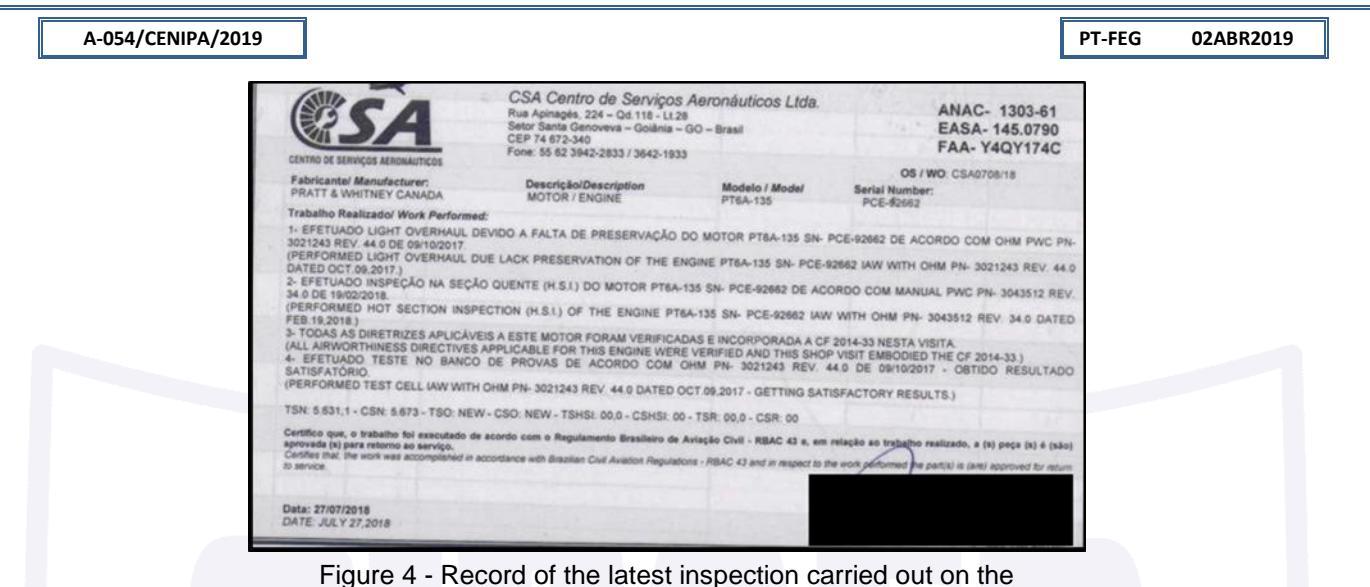
In addition to the inspections mentioned above, according to the maintenance records, one observed that, on 27 July 2018, the engines underwent a Light Overhaul, a Hot Section Inspection (HSI) and a bench test, with satisfactory results, without any further records related to new inspections (Figure 4).

PT-FEG's right-hand engine.

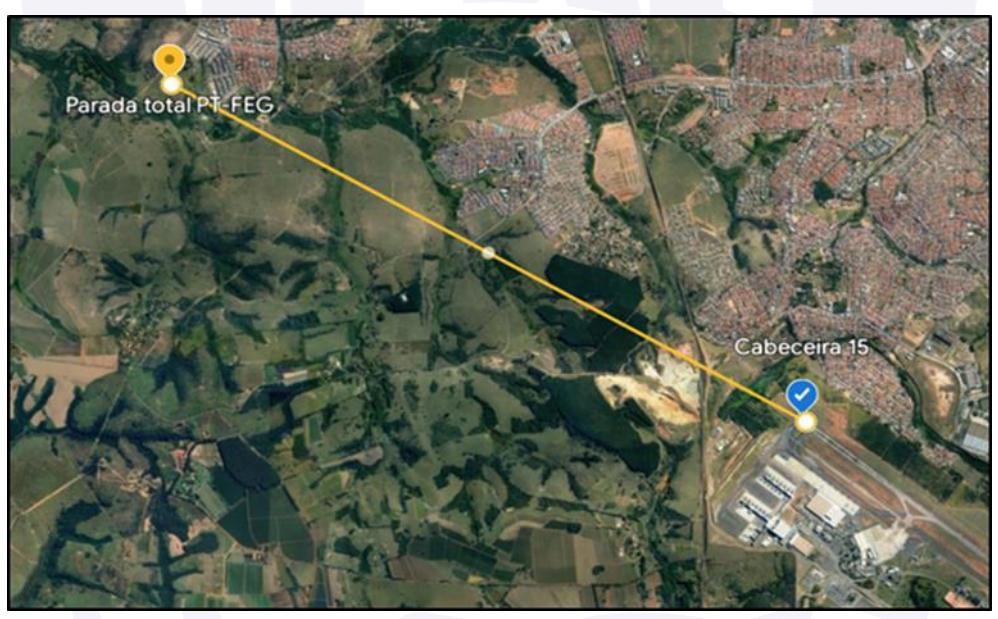
Figure 9 - PT-FEG forced landing site and distance to SBKP threshold 15. Source: adapted from Google Earth.

The aircraft was located in a rural area, outside the airfield zone, at a distance of 3.75 NM from SBKP (Figure 9).
