FINAL REPORT A-070/CENIPA/2022

OCCURRENCE: AIRCRAFT: MODEL: DATE: ACCIDENT PT-HMD HB-350B 09JUN2022

This is the Final Report of the June 9, 2022, accident involving the model HB-350B helicopter of registration marks PT-HMD. The occurrence was classified as "[LOC-G] Loss of Control – Ground."

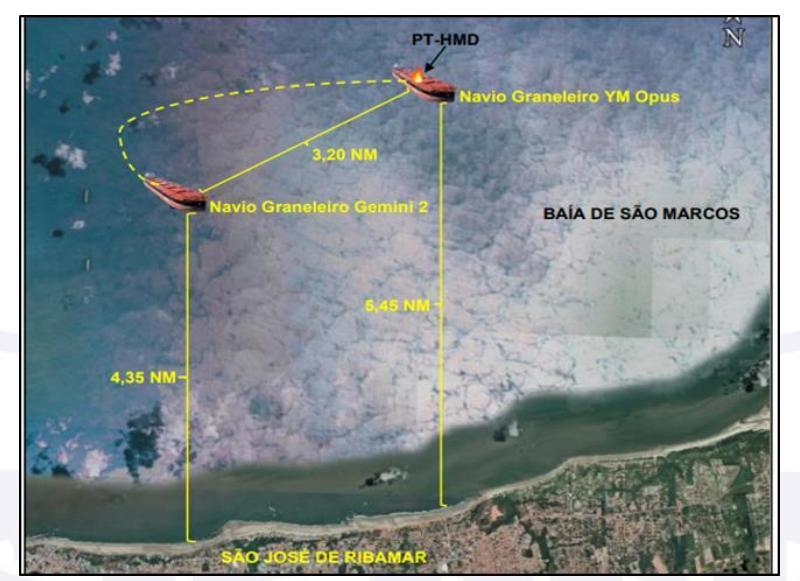
Figure 6 - Sketch of the bulk carriers SM GEMINI 2 and YM OPUS's positions. Source: adapted from Google Earth.

Nonetheless, he did not rule out the possibility of a mechanical failure, and decided to perform a precautionary landing on the bulk carrier YM OPUS (Figure 6).

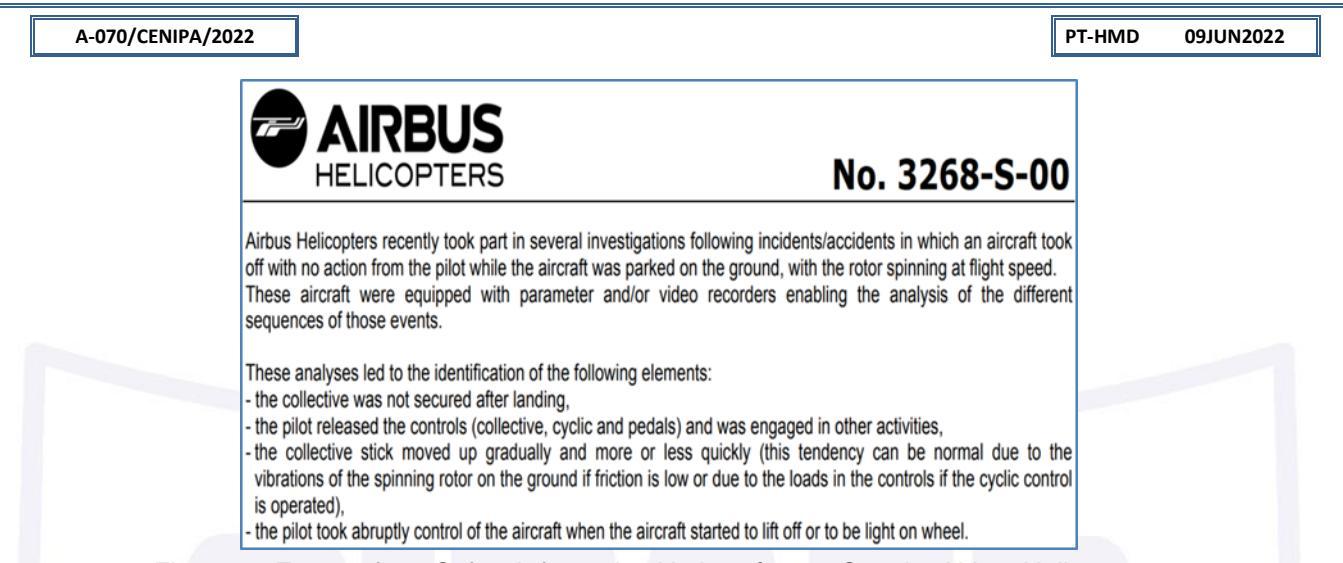
Figure 8 - Excerpt from Safety Information Notice nº 3268-S-00 by Airbus Helicopters.

Additionally, the Airbus Helicopters' Safety Information Notice (SIN) n^o 3268-S-00 warned about incidents in which helicopters inadvertently lifted off due to collective pitch movement without pilot input. The notice concluded that failure to lock the collective after landing was a contributing factor in such events (Figure 8).

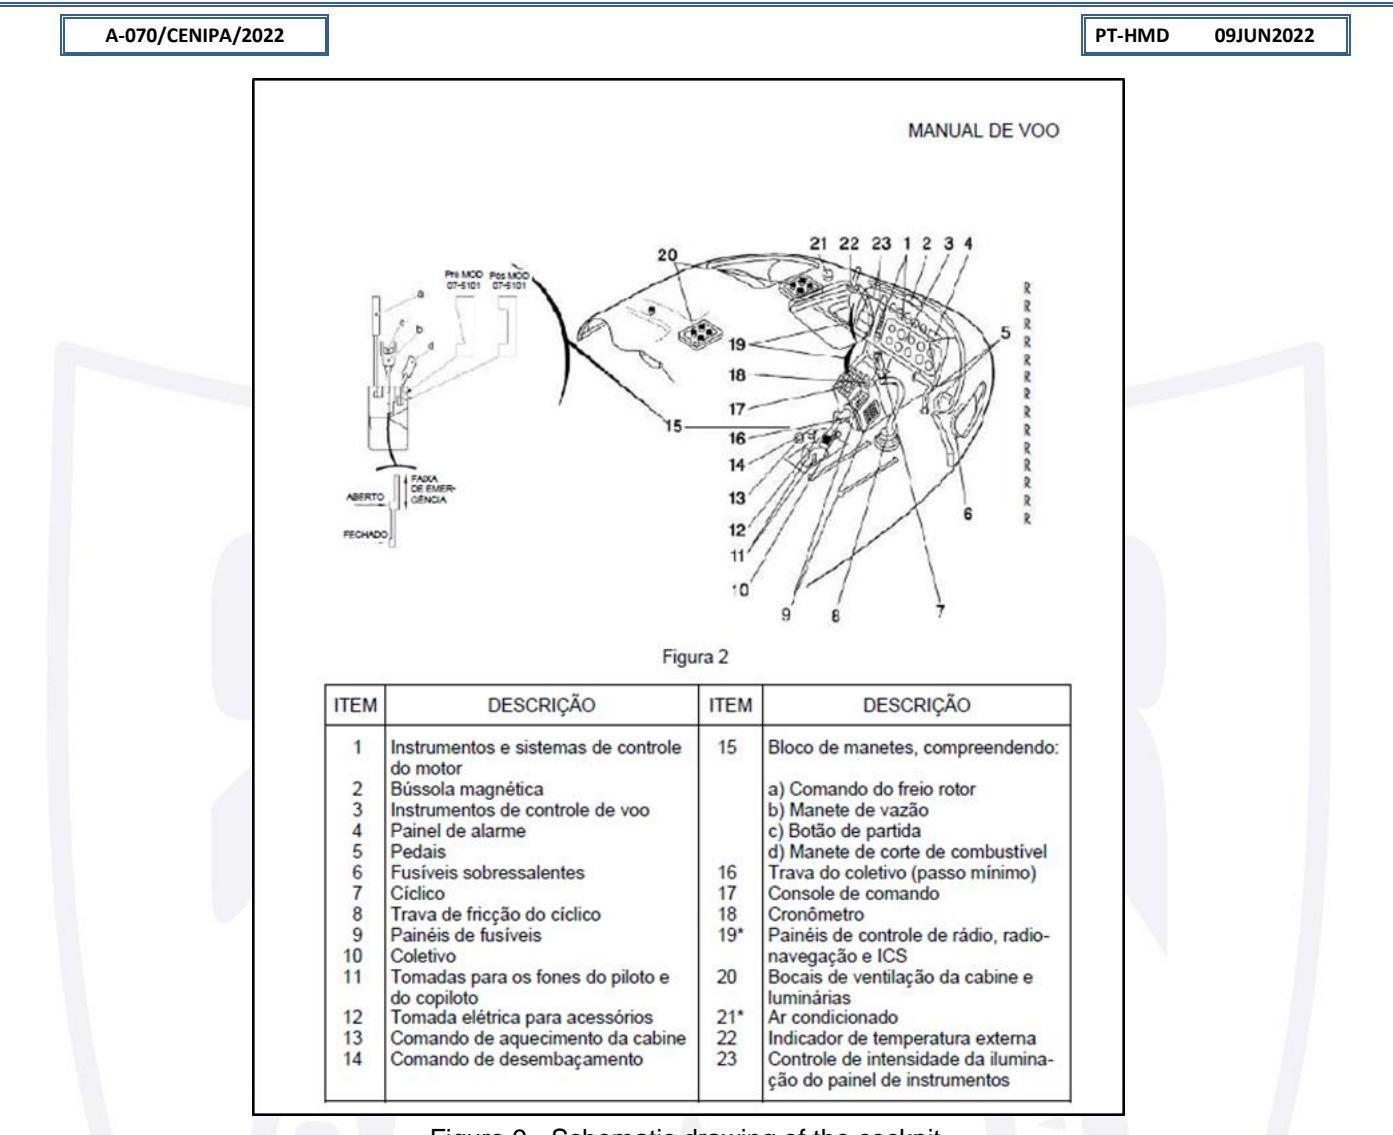
Figure 9 - Schematic drawing of the cockpit. Source: HB-350B flight manual.

It is important to emphasize that both controls had specific locking mechanisms. The HB-350B flight manual, in Section 4.1 - "Operational Procedures", provided cockpit schematics illustrating the locations of the cyclic and collective controls, along with their respective locking mechanisms, as indicated by items 7, 8, 10, and 16 in Figure 9.
