COMANDO DA AERONÁUTICA
CENTRO DE INVESTIGAÇÃO E PREVENÇÃO DE
ACIDENTES AERONÁUTICOS

FINAL REPORT
A-032/CENIPA/2018

OCCURRENCE:	ACIDENTE
AIRCRAFT:	PT-HYW
MODEL:	AS350B2
DATE:	22FEV2018

This is the Final Report of the 22Feb2018 accident with the AS350B2 aircraft, registration PT-HYW. The accident was typified as “[SCF-NP] System/component failure or malfunction and [LOC-I] Loss of control in flight”.

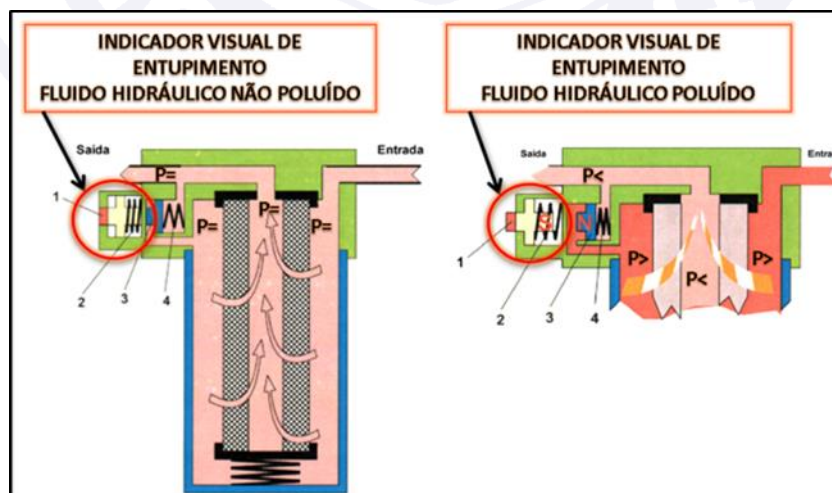
Figure 6 - Detail of the hydraulic-fluid filter-clogging indicator (apparent pin).

The aircraft had a filter-clogging indicator in its hydraulic system, which consisted of a pin (1) that would become apparent to an external observer in case of system operation with polluted hydraulic fluid (Figure 6).

Observing the operation in detail, one sees that the pressure difference (ΔP) between the filter inlet and outlet is detected by the magnetic piston (3) and spring (4) assembly.

While the hydraulic fluid is clean, the (ΔP) is small. The spring (4) keeps the magnetic piston against the wall that separates it from the clogging visual indicator (1). The visual indicator (1) is attracted against the wall by the magnetic field of the piston (3), and compresses the spring (2). As the filter element clogs, the pressure at the filter inlet increases. When (ΔP) reaches 2.7 bar, the pressure pushes the piston (3), compressing the spring (4). The magnetic attraction is broken, the spring (2) pushes the visual indicator (1) and the pin of the indicator emerges to indicate filter pollution.

At the initial action of the investigation, upon checking the PT-HYW hydraulic filter clogging indicator, the investigators observed that the pin was apparent (Figure 8).

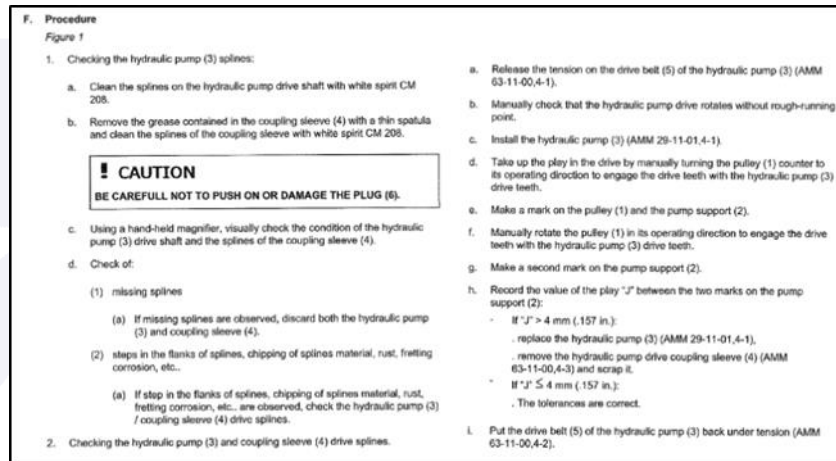
Figure 16 - Extract from the inspection of the *Drive splines of the belt-driven hydraulic pump* (Airbus AMM 63-11-00, 6-3, 2013.11.05, Page 2-3).

Figure 16 shows the extract of the procedures to be adopted in compliance with the inspection of the *Drive splines of the belt-driven hydraulic pump* (Airbus AMM 63-11-00, 6-3, 2013.11.05 - Page 2-3).

O AMM 63-11-00, 6-3 described the criteria for inspection of the splines of the hydraulic pump and pulley:

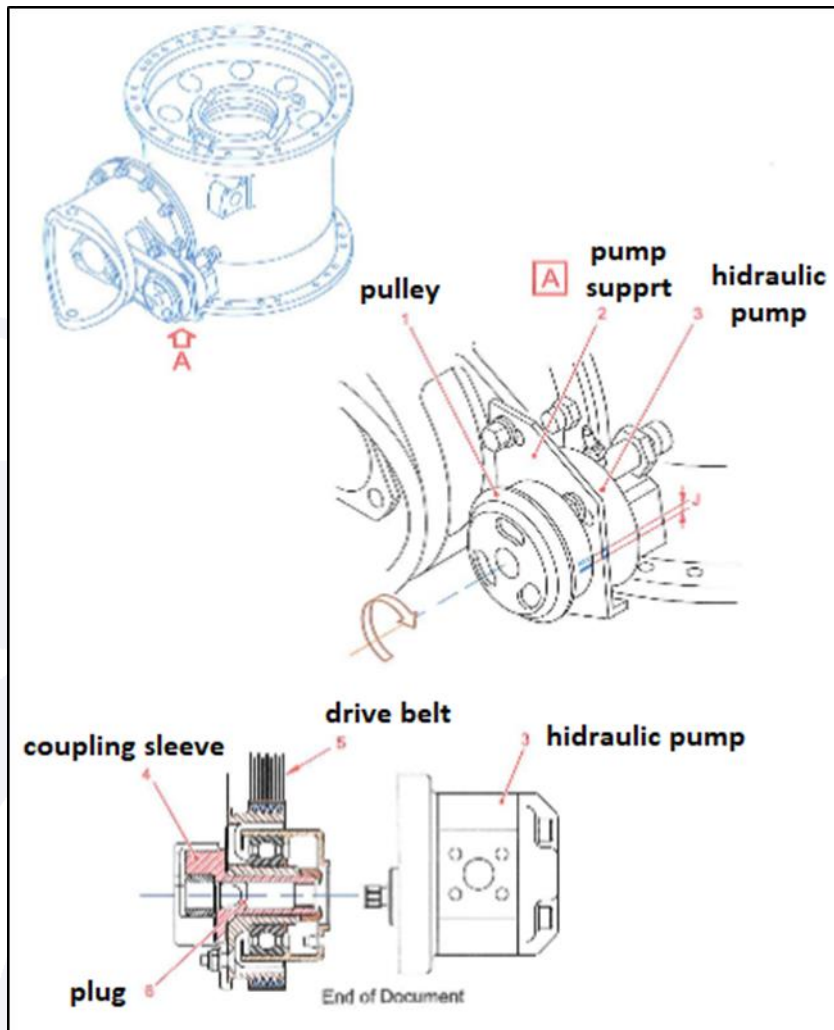
Figure 17 - Inspection Criteria - Hydraulic Pump Spline Belt Drive.
Source: Adapted Airbus AMM 63-11-00, 6-3, 2013.11.05, page 4.

- c. Using a hand-held magnifier, visually check the condition of the hydraulic pump (3) and the splines of the coupling sleeve (4);

(1) Missing splines;

- (a) If missing splines are observed, discard both the hydraulic pump (3) and the coupling sleeve (4).

(2) Steps in the flanks of splines, chipping of splines material, rust, corrosion, etc.;

If steps in the flanks of spines, chipping of splines material, rust, fretting corrosion etc. are observed, check the hydraulic pump (3) and coupling sleeve (4) drive splines.

Figure 17 shows the numbers corresponding to the items marked in the extract from the inspection of the *Drive splines of the belt-driven hydraulic pump*.
