COMANDO DA AERONÁUTICA
CENTRO DE INVESTIGAÇÃO E PREVENÇÃO DE
ACIDENTES AERONÁUTICOS

FINAL REPORT
A-160/CENIPA/2020

OCCURRENCE:	ACCIDENT
AIRCRAFT:	PT-KCK
MODEL:	177B
DATE:	29DEZ2020

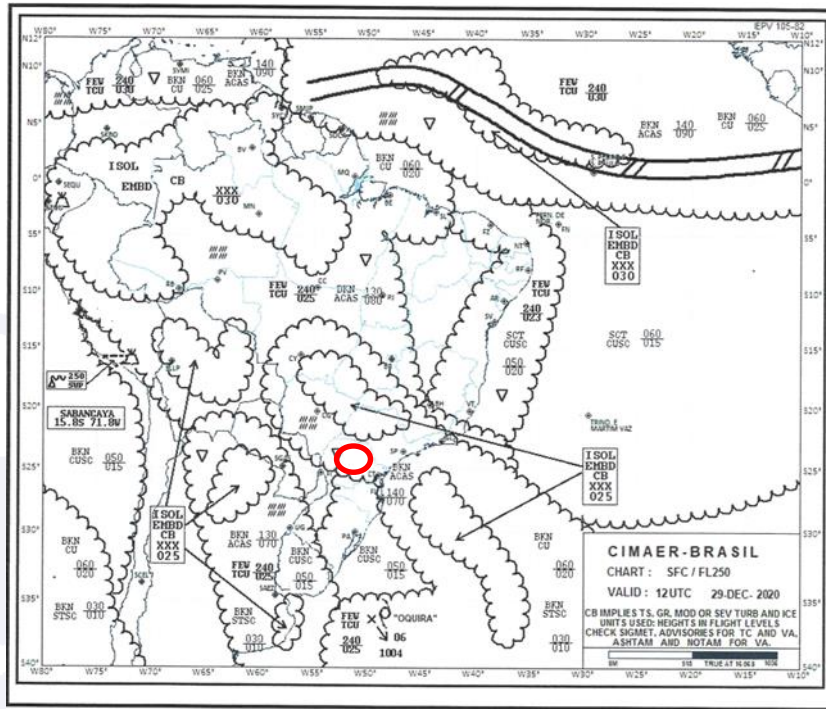
The Significant Weather chart for the State of *Paraná* contained forecast of cloudy skies with isolated showers and rain, base of clouds at 1,000 ft., in addition to convective cloudiness with base at 3,000 ft. (Figure 2).

Figure 2 - SIGWX chart, valid until 12:00 (UTC) of 29Dec2020 (area of the accident highlighted by a circle in red).

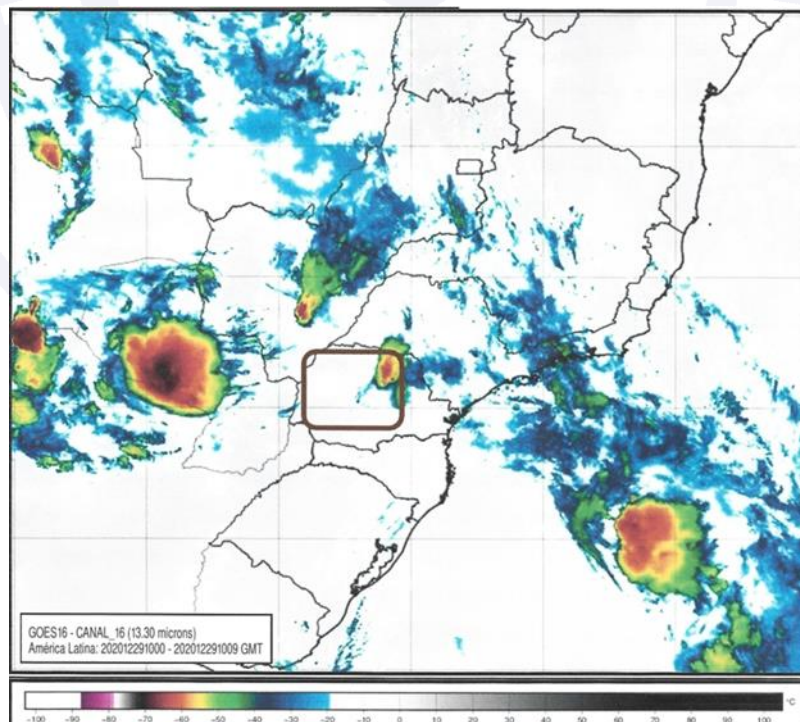
The meteorological analysis indicated a significant increase in cloud cover, occurrence of isolated atmospheric electrical discharges, rain in the form of showers, and possibility of turbulence at low levels due to the sudden variation in the wind direction/intensity caused by convective cloudiness (Figures 3 and 4).

Figure 3 - GOES 16 satellite (infrared) image at 10:00 UTC of 29Dec2020.

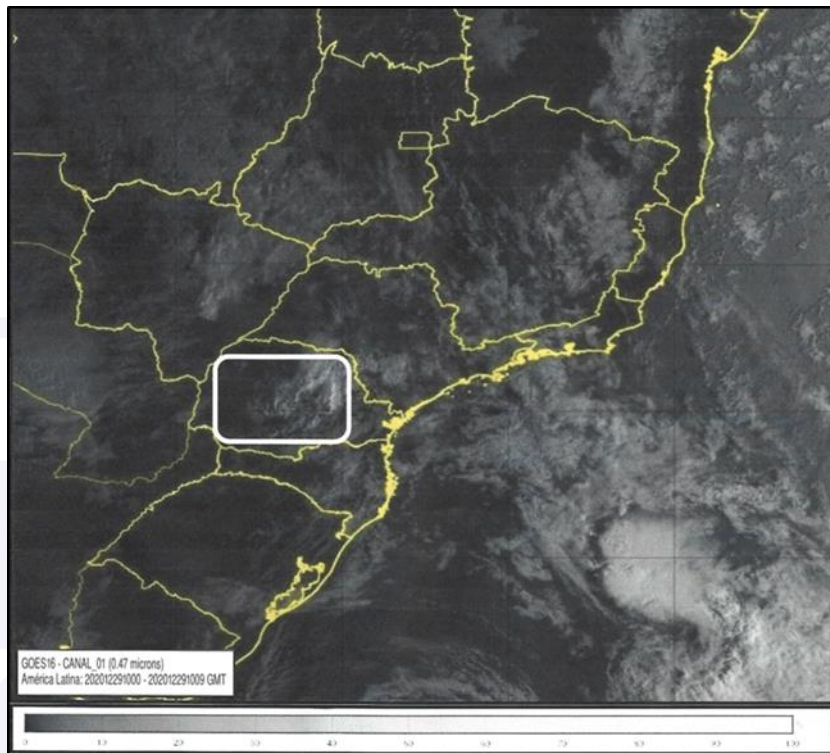
Figure 4 - GOES 16 satellite image (visual) at 10:00 UTC of 29Dec2020.

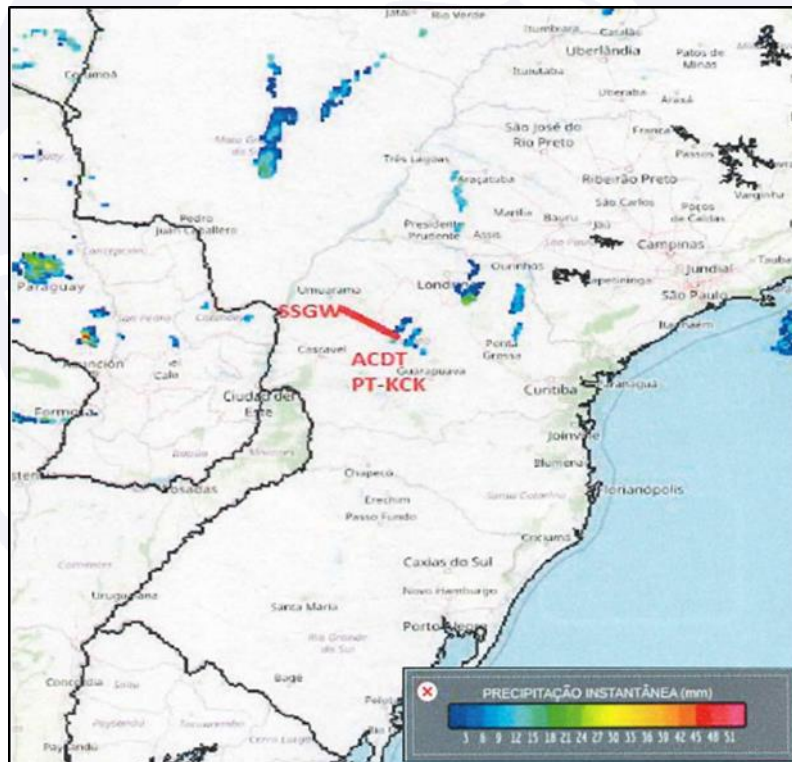
There was precipitation of up to 15 millimeters next to the place of the occurrence (Figure 5).

Figure 5 - Satellite Image of Instantaneous Precipitation at 10:00 UTC of 29Dec2020.

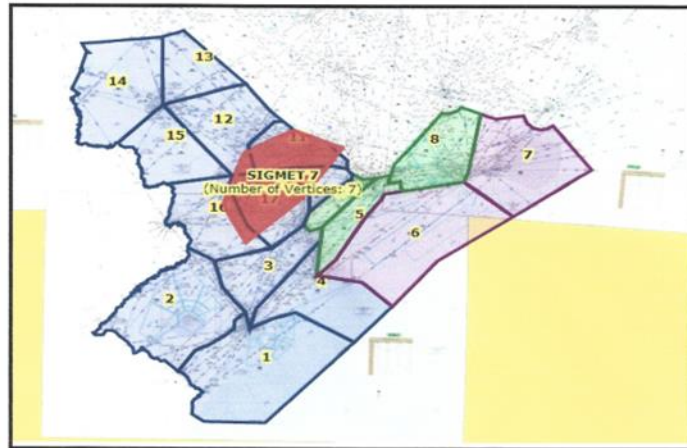
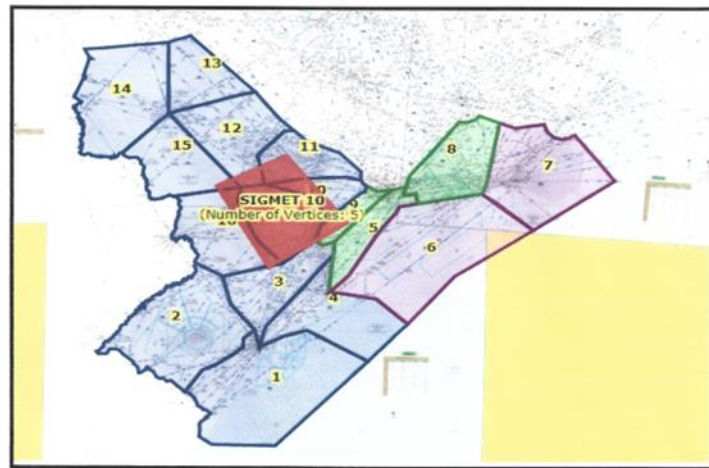
The SIGMET (Significant Meteorological Information) showed built-in thunderstorms in the State of *Paraná* (Figure 7), and the GAMET (General Aviation Meteorological Information, FIR Area/Sub-area Forecast) predicted ceiling layers at 300 ft. and 1,000 ft. (Figure 8).

Figure 7 - 29Dec2020 SIGMET between 06:30 and 13:45 UTC.

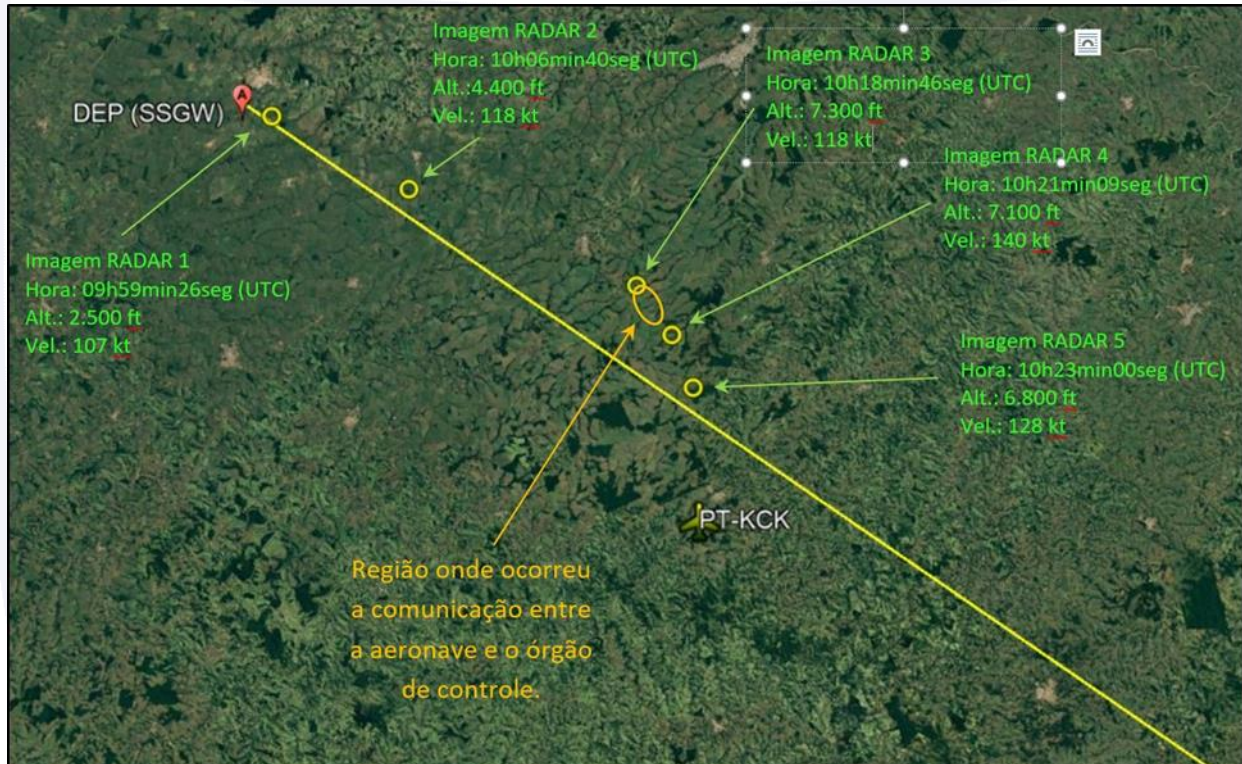
The investigation committee accessed some RADAR images of the aircraft, from the first contact at 09:59:26 UTC until 10:23:00 UTC, when the ACC-CW lost RADAR contact with the aircraft, as shown in Figure 9.

Figure 9 - Points where RADAR contact was recovered, and moment radio communication exchange between the aircraft and the ATC agency.

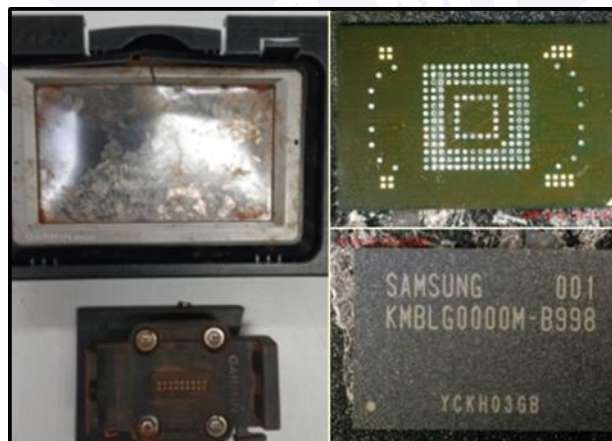
Figure 10 - Garmin Aera 500 (left) and respective memory chip (right).

The aforementioned GPS was sent to the USA for analysis by the Vehicle-Recorders Division of the National Transportation Safety Board (NTSB), which concluded that it did not contain any significant data.

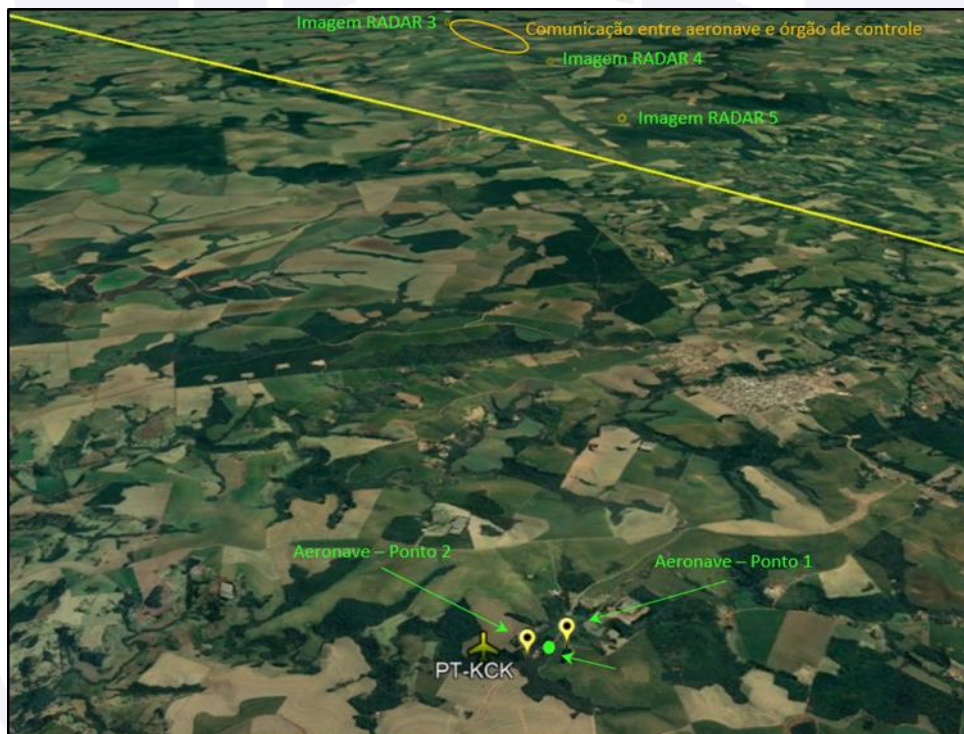
A dweller of a farm close to the accident site reported having seen the PT-KCK still in flight at low altitude. After the aircraft disappeared among the treetops, a very loud noise was heard. The dweller, for not being familiar with aviation, was not able to specify whether the aircraft was under the pilot's control or falling uncontrollably (Figures 11, 12, 13 and 14).

Figure 11 - Possible travel of the aircraft, according to the RADAR and the observer.

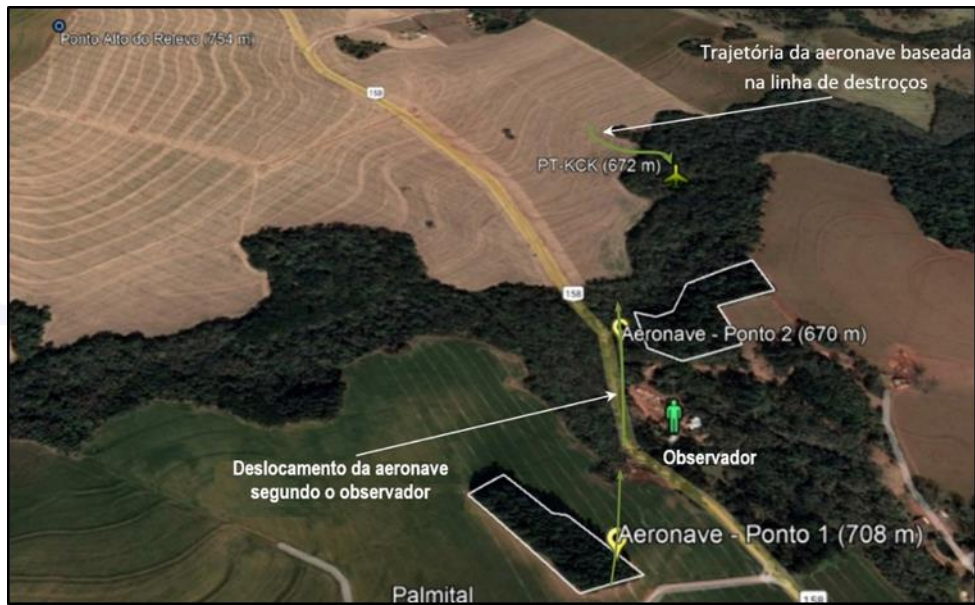
From the observer's report, it was possible to infer that the aircraft entered a valley, about 85 m below the highest point of the relief.

Figure 12 - Top view of the possible aircraft travel segments in the valley.

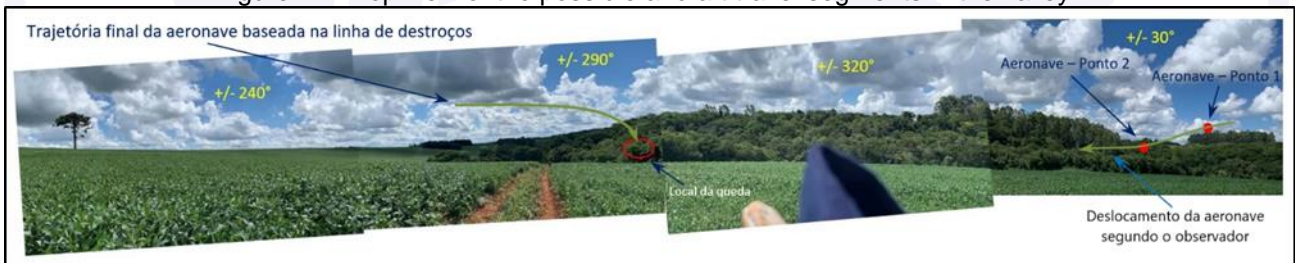
Figure 13 - Panoramic image of the accident site with the possible aircraft travel segments.

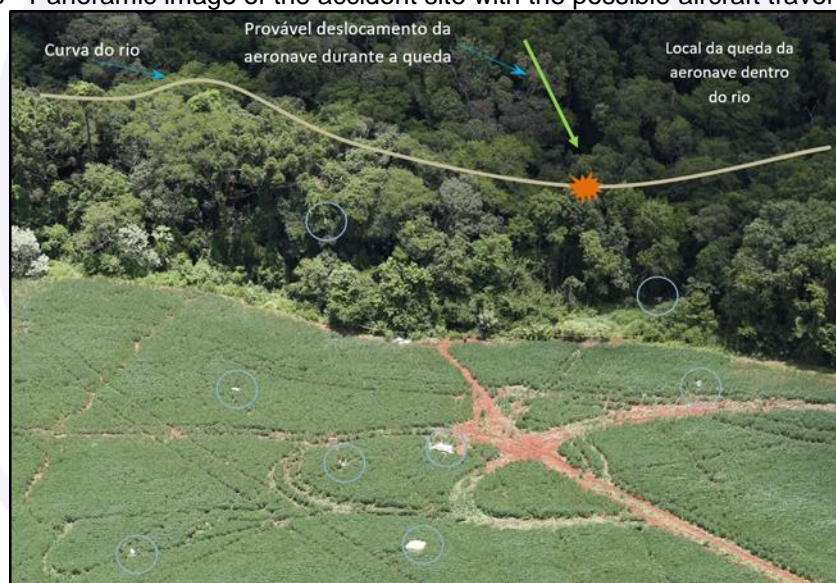
Figure 14 - Image of the probable downward travel (fall) of the aircraft.

Most of the aircraft was found submerged in a river of the region, and only a few tree branches along the vertical path traveled by the aircraft were broken. Several other components lay scattered between the riparian forest and a nearby crop, as shown in Figure 14.

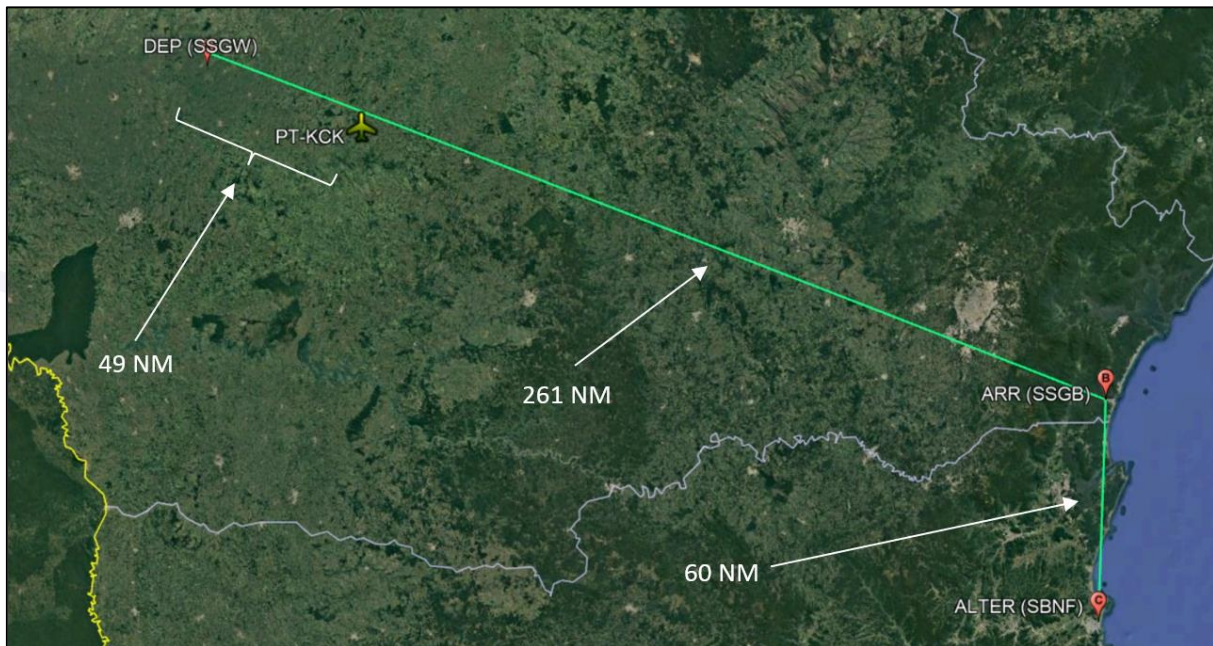
The flight plan included the intention to maintain a VFR flight after takeoff, climbing to flight level 075 (FL 075), maintaining a cruise speed of approximately 110 kt, and proceeding directly to the destination aerodrome (SSGB) , as shown in Figure 29.

Figure 29 – Illustration the planned flight, and distance traveled up to the crash site.
