COMANDO DA AERONÁUTICA
CENTRO DE INVESTIGAÇÃO E PREVENÇÃO DE
ACIDENTES AERONÁUTICOS

FINAL REPORT
A-190/CENIPA/2013

OCCURRENCE:	ACCIDENT
AIRCRAFT:	PT-KGK
MODEL:	PA-34-200
DATE:	21OCT2013

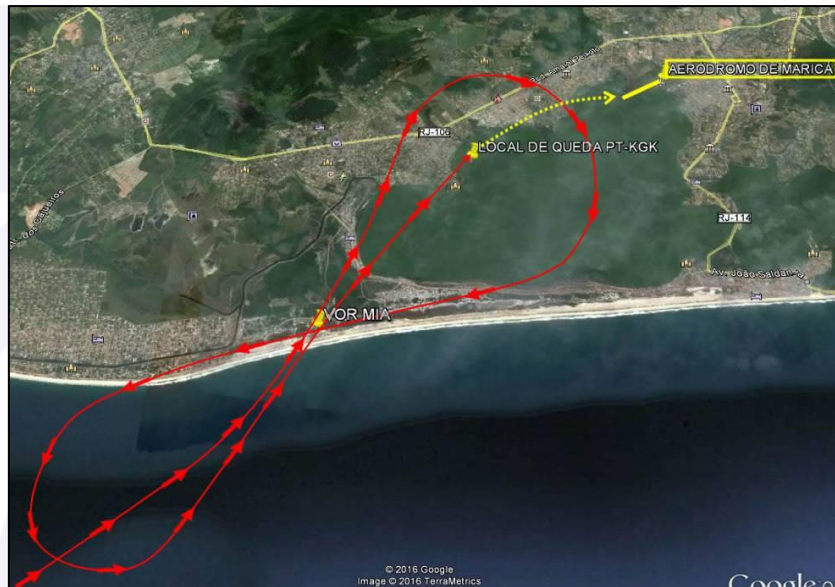
The RADAR image of the Rio de Janeiro Terminal Area Control (APP-RJ) showed that the PT-KGK aircraft flew a couple of times over *Maricá* (MIA) VOR and *Maricá* Lagoon (Figure 1), until radar contact was lost over *Maricá* Lagoon.

Figure 1 - Illustration of the aircraft trajectory over MIA VOR and *Maricá* Lagoon (solid red line) and the intended route for landing in *Maricá* Aerodrome (after the point where the crash occurred).

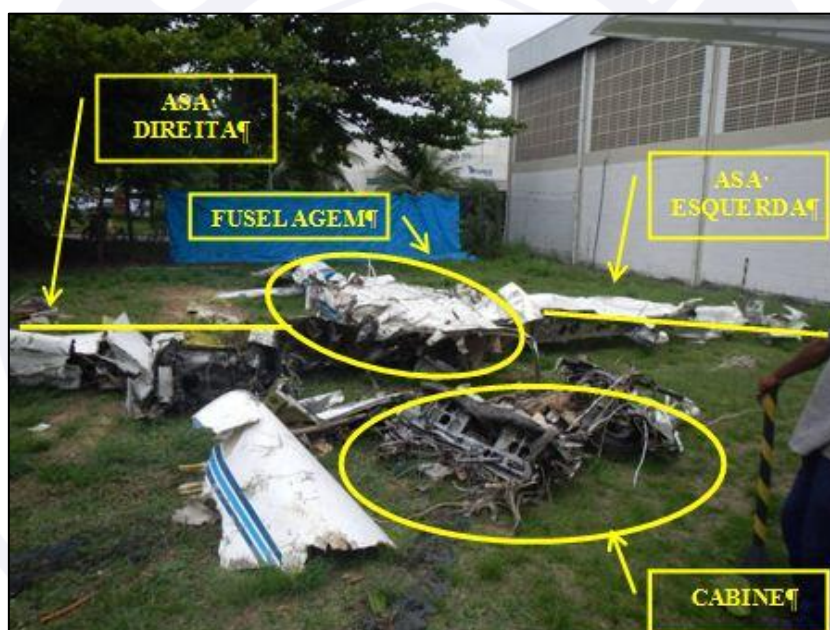
With most of the wreckage retrieved, a reconstitution (mockup) of the aircraft was made (Figure 5).

Figure 5 - Reconstitution of the aircraft, front view.

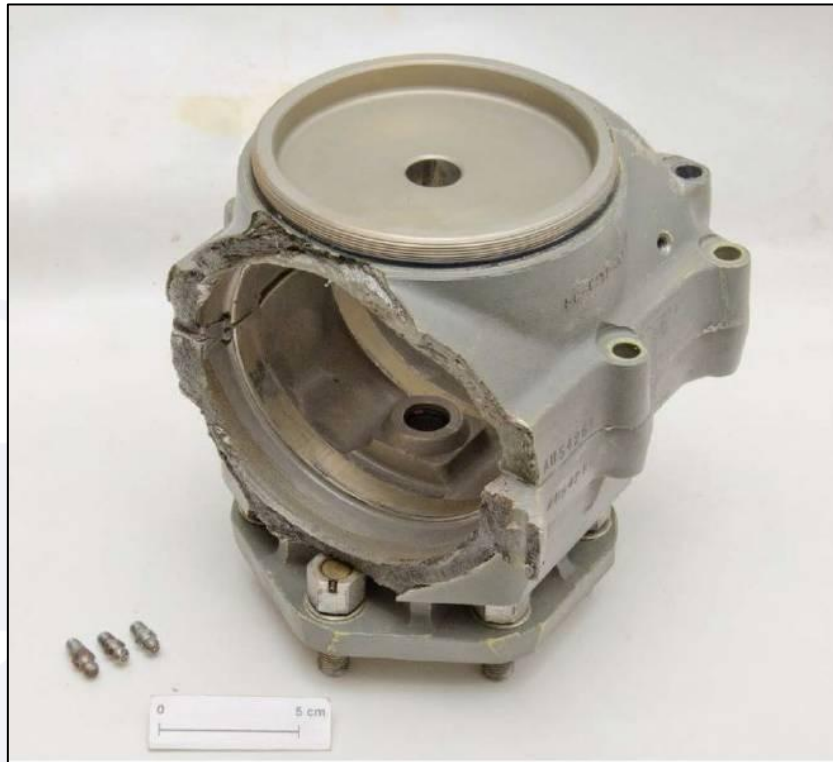
On account of the aforementioned pieces of evidence found during the process of propeller disassembly, and with the purpose of identifying the characteristics of the fracture, the damaged propeller-hub (#1) and the grease nipples were sent for macroscopic, stereoscopic, and microscopic analyses (Figure 10).

Figure 10 - Propeller-hub sent for analysis.

The result of the analysis was that the surface of the fracture of the propeller-hub had characteristics of failure due to fatigue (Figure 11), and that the grease nipples had differences, being two of them equal to each other, while the third one was of different size, thickness, and thread (Figure 12). In spite of the differences, one verified that the nipples seemed not to have connection with the origin of the fracture which resulted in the hub failure.

It was not possible to identify the point of origin of the fracture, since the missing part of the hub was not found by the go-team during the field investigation.

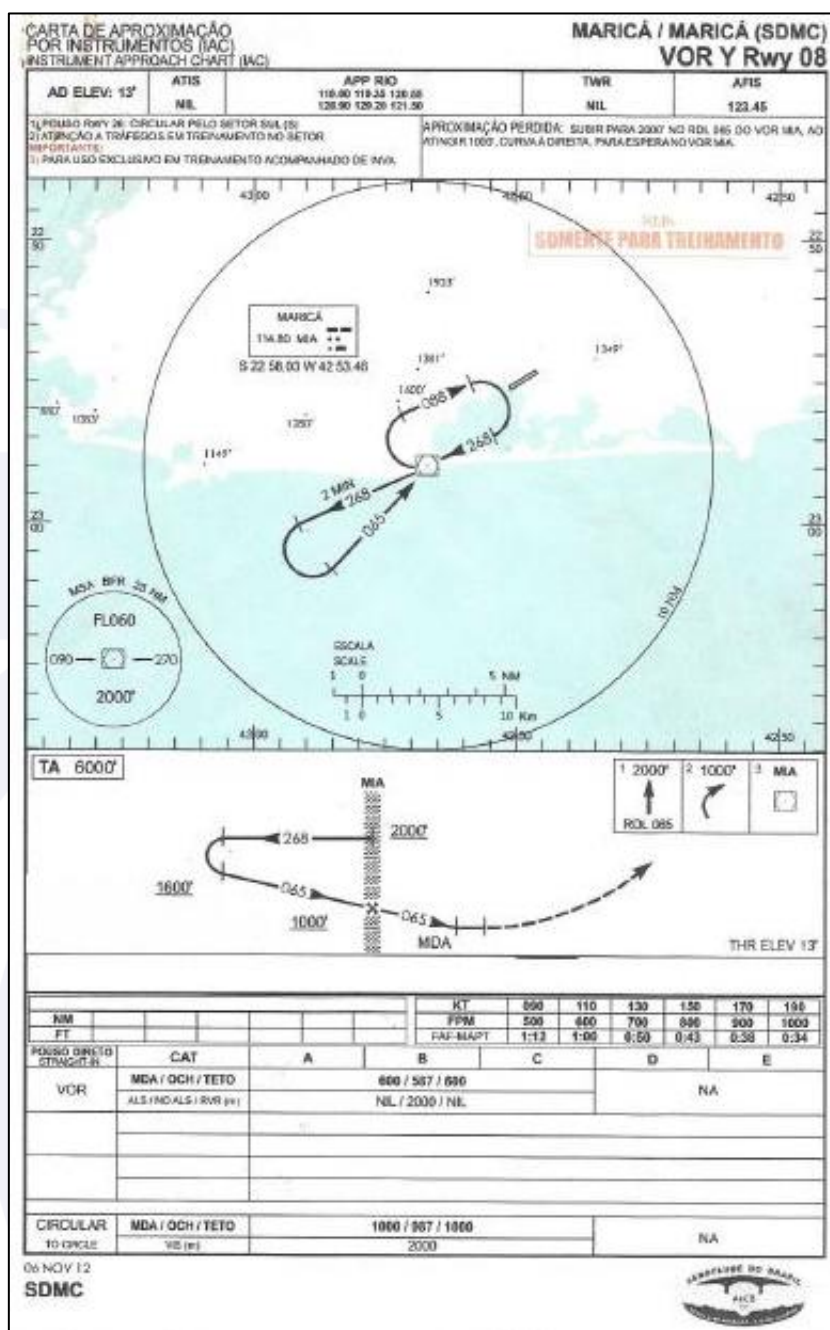
Figure 17 - Non-homologated VOR procedure chart (MARICA VOR Y RWY 08), utilized by *Aeroclube do Brasil* for training purposes.

Upon crossing over the primary fix, the aircraft started a flight profile very similar to the one of an IFR procedure, with the aircraft crossing over the fix, making a displaced entry with a turn to the left, followed by an approach turn to the right, crossing over the fix again, and flying an outbound track, as described in the illustration relative to the aircraft trajectory (Figure 1), and in accordance with the profile of the procedure (IAC *MARICÁ* VOR Y RWY 08) utilized by *Aeroclube do Brasil*.
