COMANDO DA AERONÁUTICA
CENTRO DE INVESTIGAÇÃO E PREVENÇÃO DE
ACIDENTES AERONÁUTICOS

FINAL REPORT
A-024/CENIPA/2021

OCCURRENCE:	ACCIDENT
AIRCRAFT:	PT-KQE
MODEL:	A36
DATE:	13FEV2021

This is the Final Report of the 13 February 2021 accident with the A36 aircraft, registration marks PT-KQE. The accident received the typification of “[SCF-PP] Engine failure or malfunction | In-flight engine failure”.

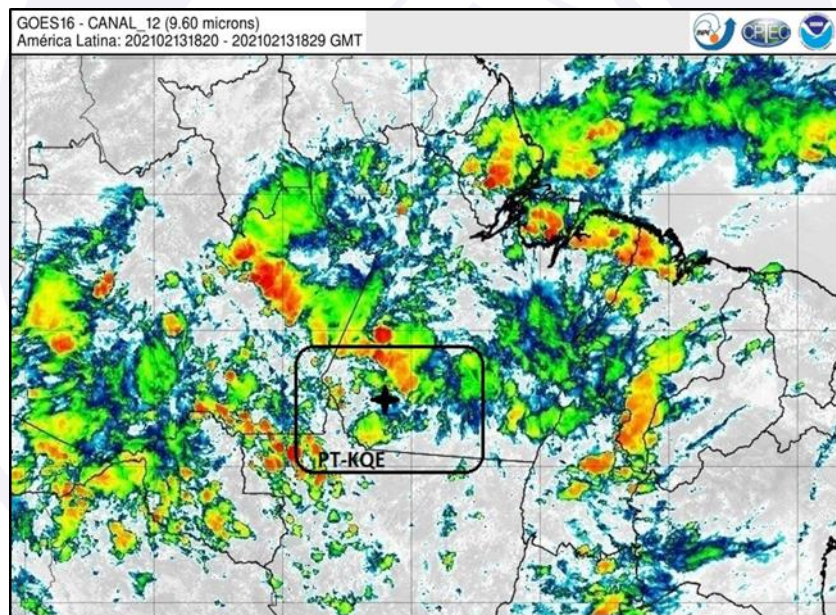
The satellite image generated at 18:20 UTC by CPTEC (Center for Weather Forecasting and Climate Research) showed the existence of significant meteorological formations along the route (Figure 5).

Figure 5 - Enhanced satellite image of 18:20 UTC, showing the meteorological conditions around the take-off time. Source: CPTEC.

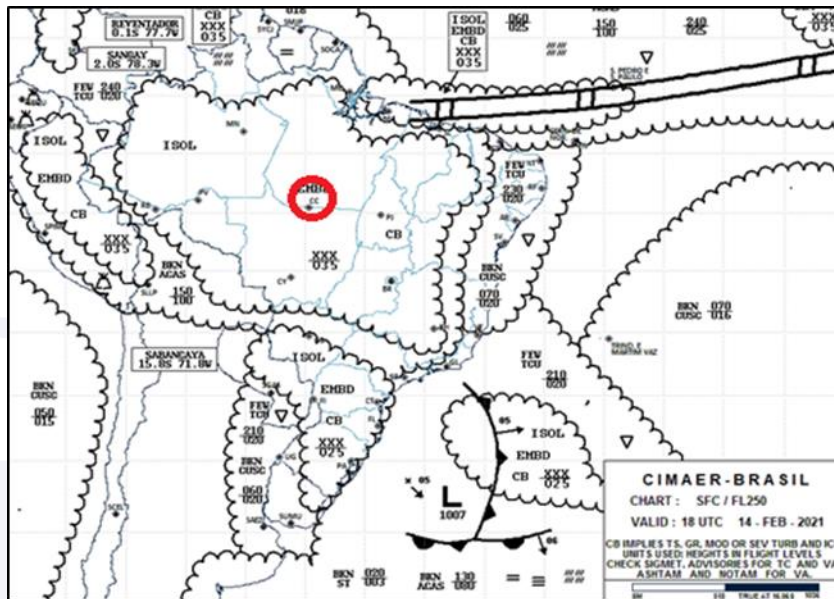
Additionally, the Significant Weather Chart (SIGWX) generated by CIMAER (*Centro Integrado de Meteorología Aeronáutica*), issued at 18:00 UTC on the day of the occurrence, showed the presence of CB clouds, both isolated and embedded in layers of other clouds, with base at 3,500 ft and top above 25,000 ft (Figure 6).

Figure 6 - SIGWX, valid until 18:00 UTC of 14 FEB 2021, with the approximate location of the occurrence. Source: CIMAER.

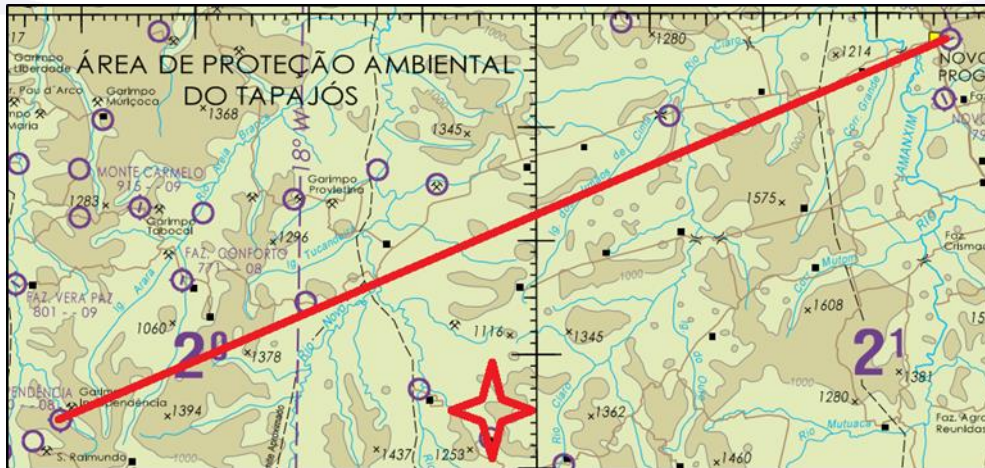
The aircraft's planned route would be from SDUA to SITT. During the flight, there was a drift to the left, and aircraft struck the ground at a lateral distance of approximately 13 NM away from the intended route.

Figure 10 - Croquis of the route (red line) and site of occurrence (star).
