FINAL REPORT
A-105/CENIPA/2023

OCCURRENCE:	ACCIDENT
AIRCRAFT:	PT-KUM
MODEL:	170A
DATE:	19JUN2023

This is the Final Report of the June 19, 2023, accident involving the model 170A aircraft of registration marks PT-KUM. The occurrence was typified as “[SCF-PP] Powerplant failure or malfunction.”

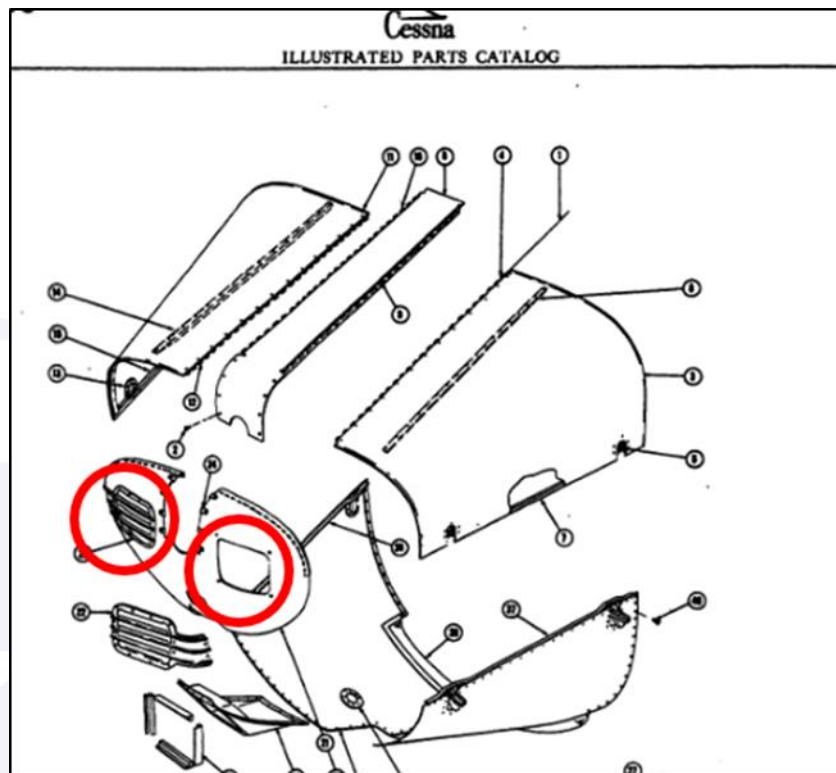
The aircraft was originally certified with an engine lubrication oil cooling system that used two front openings in the cowling through which ram air was directed to a component called *oil cooler equipment*. This system provided cooling for the engine oil.

Figure 2 – Engine cowling, highlighting the front openings.
Source: Cessna Aircraft Company 170A Model Illustrated Parts Catalog.

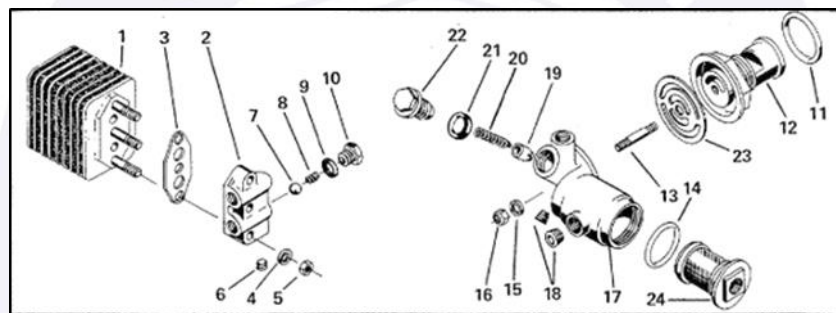
Figure 3 – Oil cooling equipment.
Source: Continental Aircraft Engine Model O-300 Illustrated Parts Catalog.
