**COMANDO DA AERONÁUTICA**  
**CENTRO DE INVESTIGAÇÃO E PREVENÇÃO DE**  
**ACIDENTES AERONÁUTICOS**

**FINAL REPORT**  
**A - 132/CENIPA/2019**

<b>OCCURRENCE:</b>	<b>ACCIDENT</b>
<b>AIRCRAFT:</b>	<b>PT-MHC</b>
<b>MODEL:</b>	<b>208B</b>
<b>DATE:</b>	<b>16SEPT2019</b>

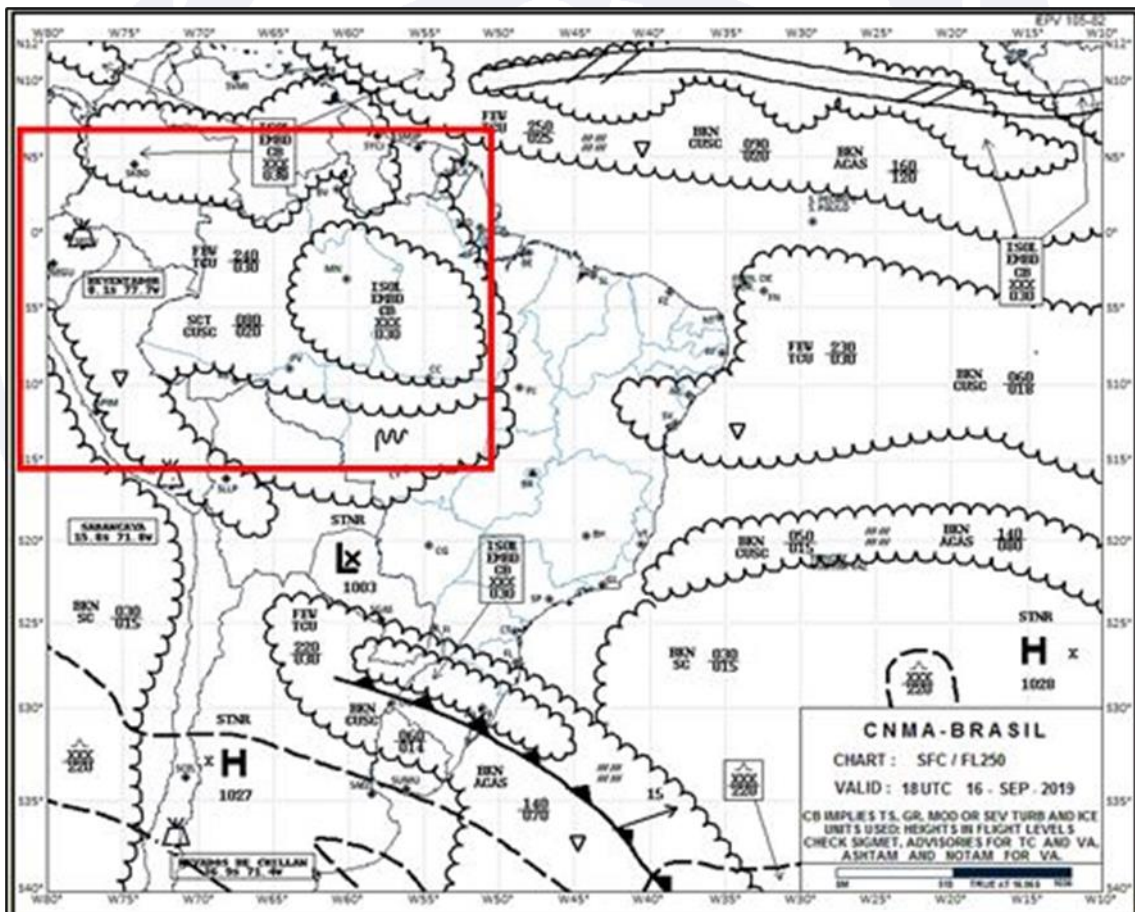
According to the SIGWX chart, which presented the weather forecast at 1800 (UTC), on 16SEPT2019, with projections in the period between 1500 and 2100 (UTC), there were three types of cloudiness: FEW clouds of the TCU type, with base at 3,000 ft and top at 24,000 ft; SCT clouds of the CU and SC types, with base at 2,000 ft and top at 8,000 ft; the presence of ISOL and EMBD Cumulonimbus in layers of other clouds, both with base at 3,000 ft and top above FL250; in addition to rain showers (Figures 3 and 4).

Figure 3 - SIGWX chart, referring to South America, taken from the REDEMET website, valid for 1800 (UTC), on 16SEPT2019. In detail, the area of the system that affected the region of Manaus at the time of the accident.

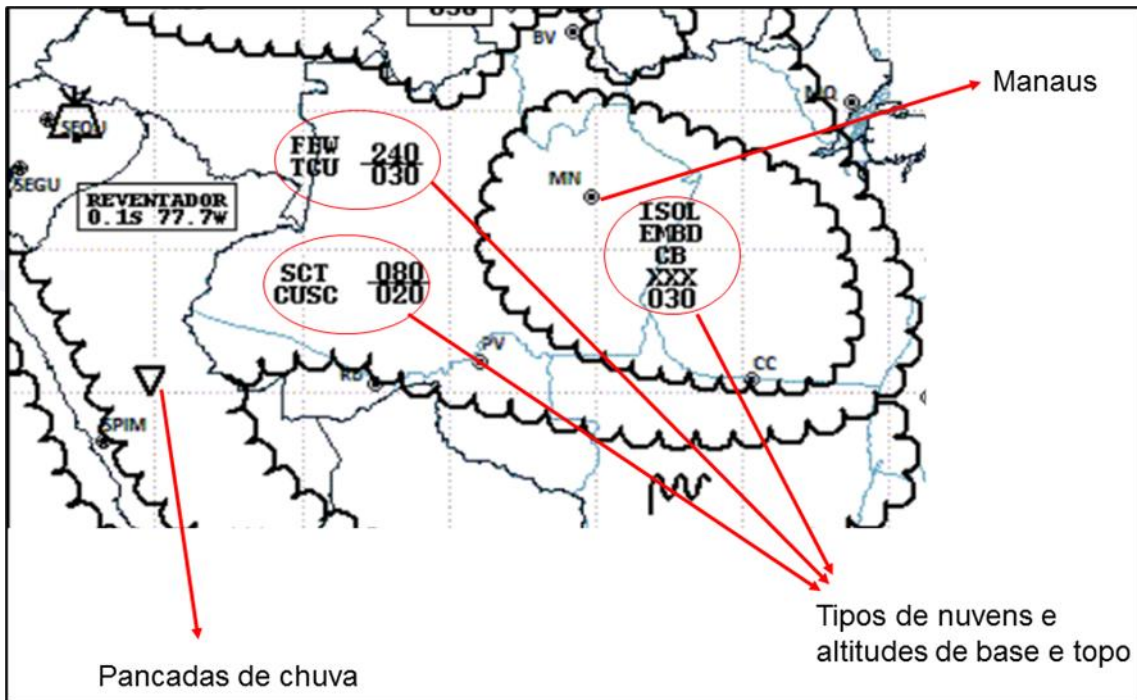
Figure 4 - Detail of the SIGWX chart, expanding the Northern region and identifying the symbols mentioned above.

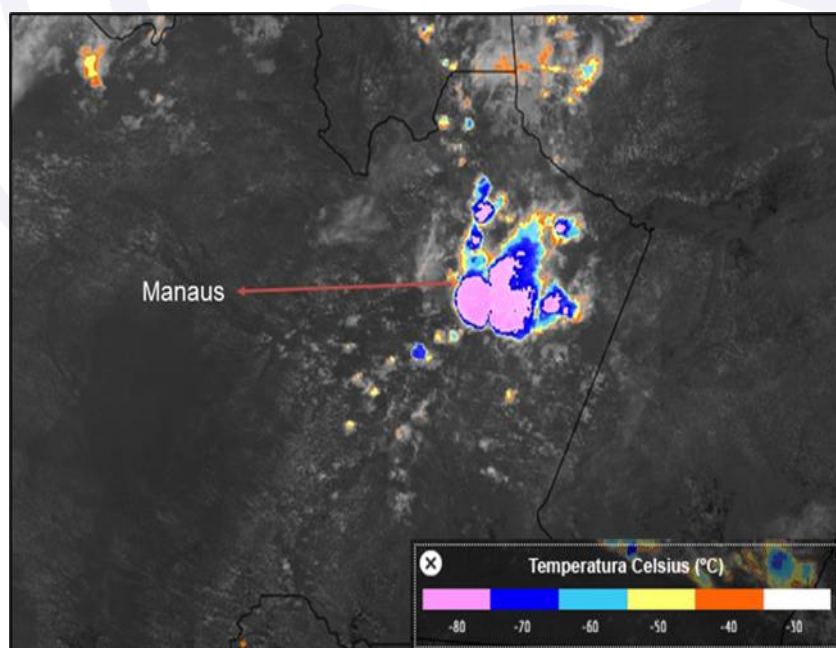
In these images, it was observed that there was a large formation that intensified, that is, increased in size, and moved to the West of the Manaus region, identified with the purple color, in the period from 1600 to 1640 (UTC).

Figure 5 - Close-up view of the enhanced satellite image at 1600 (UTC). Manaus is the orange dot at the beginning of the red arrow. The formation shown in purple-pink was shifting to the left (West).

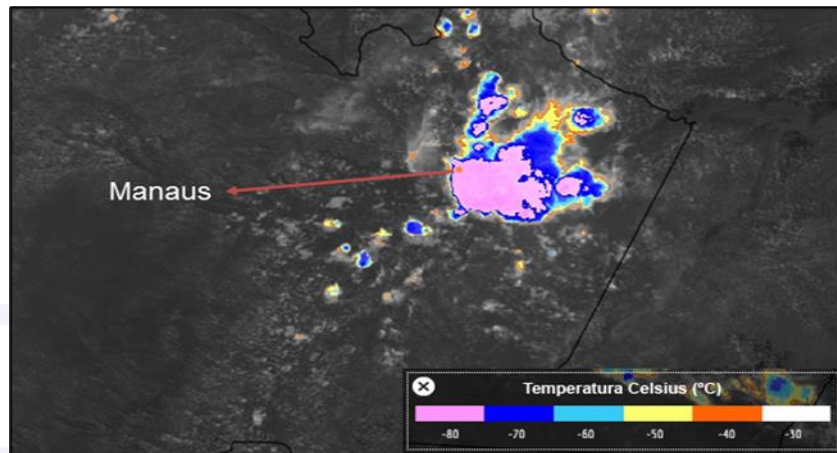
Figure 6 - Close-up view of the enhanced satellite image at 1620 (UTC). Manaus is the orange point at the beginning of the red arrow, already under the formation, which continued its displacement to the left (West).

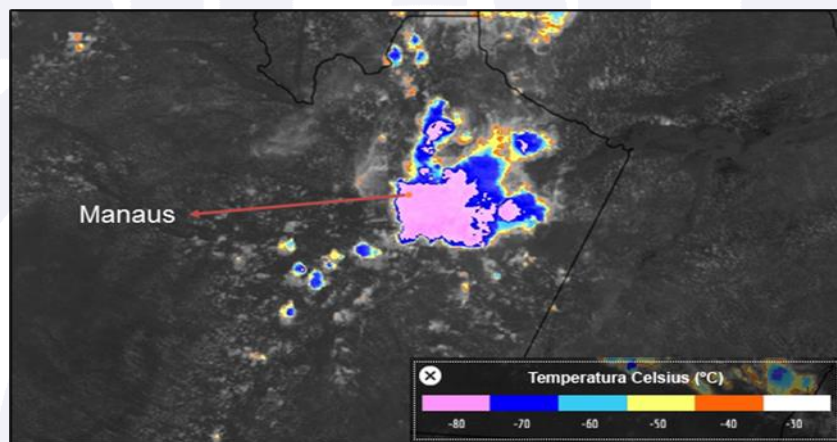
Figure 7 - Close-up view of the enhanced satellite image at 1630 (UTC). Manaus is the orange dot at the beginning of the red arrow below the formation, which continued to move to the left (West).

According to satellite images, it was found that, at 1630 (UTC), formations with CB and TCU characteristics intensified over the Manaus region, and then, at 1650 (UTC), they moved away from the city.

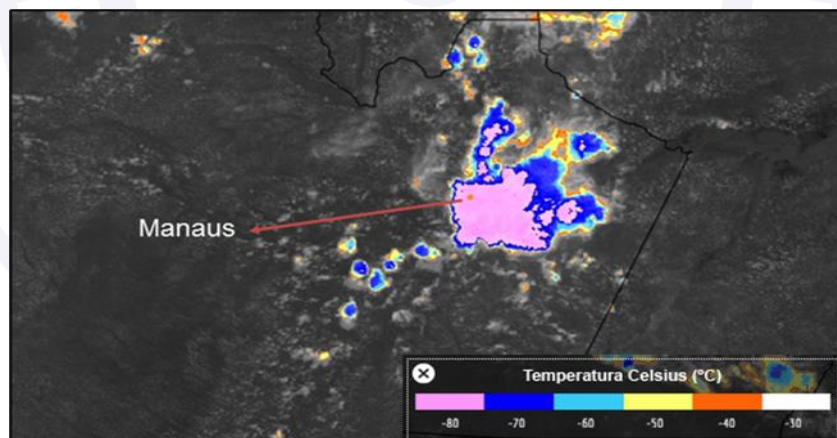
Figure 8 - Close-up view of the enhanced satellite image at 1640 (UTC). Manaus is the orange dot at the beginning of the red arrow below the formation, which continued to move to the left (West).

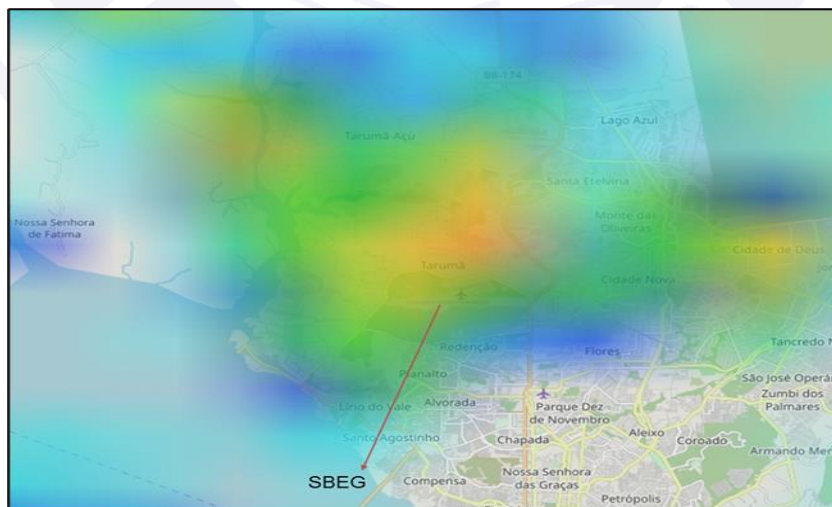
It was found that, at 1620 (UTC), there was a greater intensity (red return of the RADAR) indicating heavy precipitation, with the possibility of storms, lightning, and severe turbulence (Figures 11 and 12).

Figure 11 - Close-up image of the meteorological RADAR at 1620 (UTC). The beginning of the red color is observed, due to the existing formations in the vicinity of SBEG, indicating strong reflectivity and precipitation.

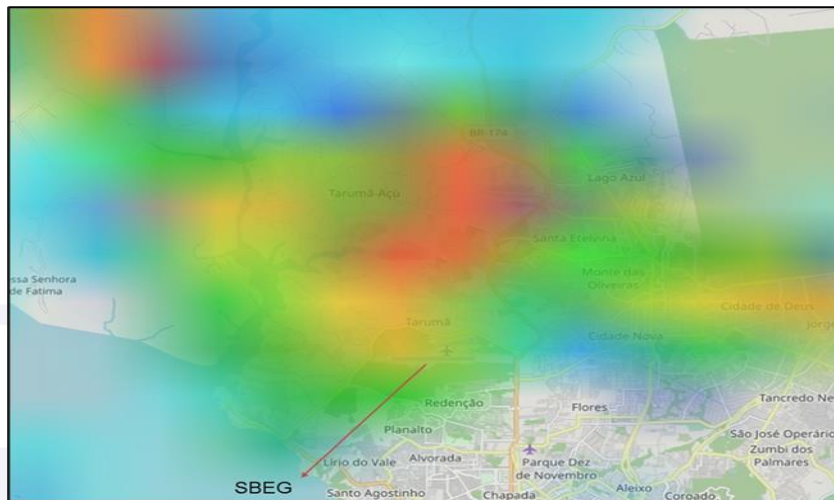
Figure 12 - Close-up image of the meteorological RADAR at 1625 (UTC). The meteorological formation existing in the vicinity of SBEG is observed, with an intensified and more comprehensive red color, indicating strong reflectivity and precipitation.
