**COMANDO DA AERONÁUTICA**  
**CENTRO DE INVESTIGAÇÃO E PREVENÇÃO DE**  
**ACIDENTES AERONÁUTICOS**

**FINAL REPORT**  
**A-063/CENIPA/2022**

| <b>AIRCRAFT:</b> | <b>PT-OQR</b> |
| <b>MODEL:</b> | <b>208</b> |

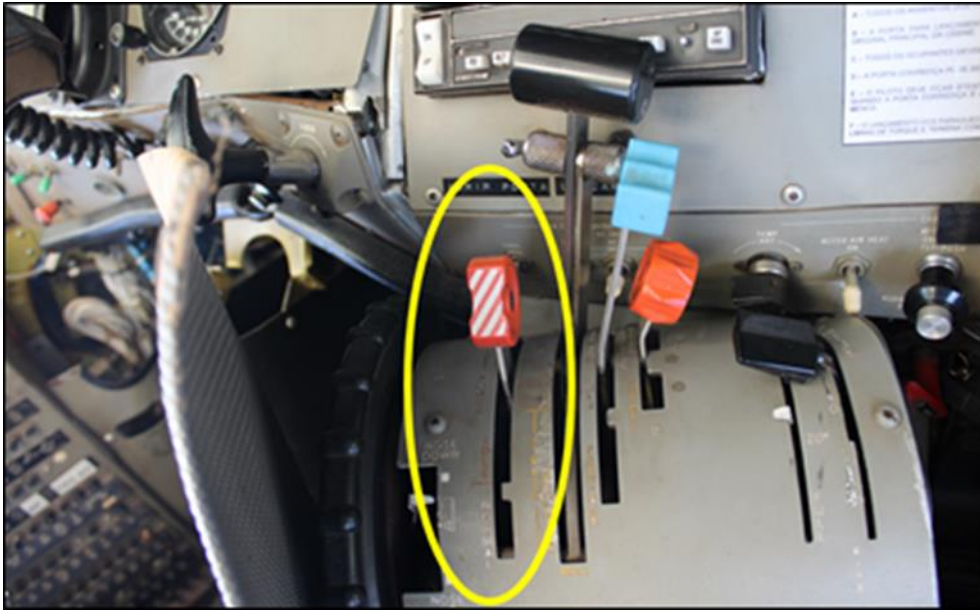
Figure 5 – Throttle quadrant of the PT-OQR after the accident, highlighting the EPL.

Regarding throttle operation, this engine was normally controlled via a Power Lever, a Propeller Control Lever, and a Fuel Condition Lever. In addition to the mentioned levers, the aircraft was also equipped with an Emergency Power Lever (EPL), which was used for manual override of the FCU (Figure 5).

The EPL was a safety component installed on some turboprop-powered aircraft, such as the PT-OQR. Its primary function was to provide manual control of the engine's fuel flow in emergency situations when the automatic control was unavailable or had failed.

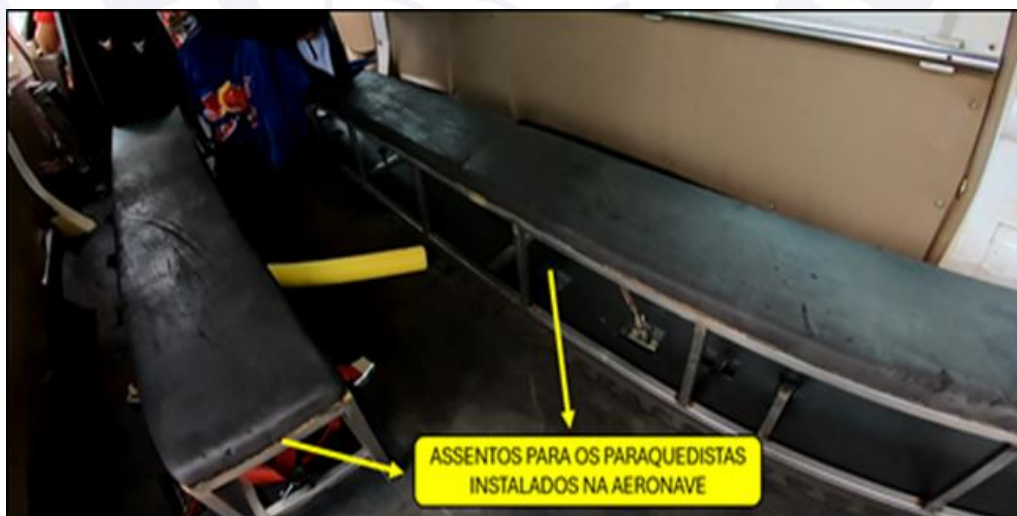
Figure 8 – Internal configuration of the aircraft for the transport and drop of parachutists during the accident flight.

During the accident flight, it was observed that PT-OQR was configured with two longitudinally oriented benches for parachutists, as shown in Figure 8.

There was only one seat available for the pilot, and no seat was installed in the Second in Command (SIC) position.

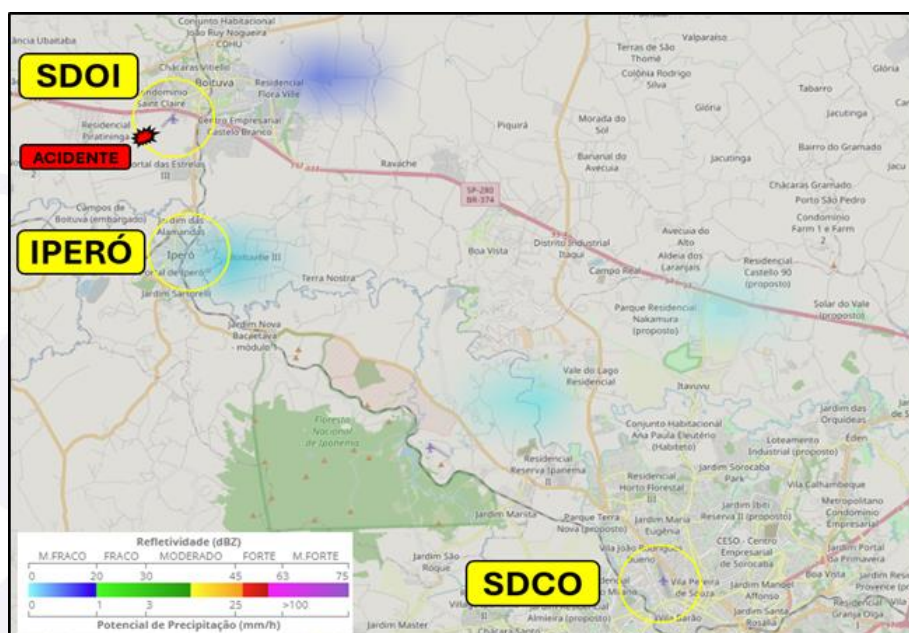
Figure 13 – *Maxxcappi* radar image from May 11, 2022, at 1507 UTC.  
Source: adapted from <https://www.redemet.aer.mil.br/>.

Denser cloud formations were observed on radar to the east and south of *Boituva*, State of *São Paulo*, as shown in the *Maxxcappi* radar image from May 11, 2022, at 1507 UTC (Figure 13).

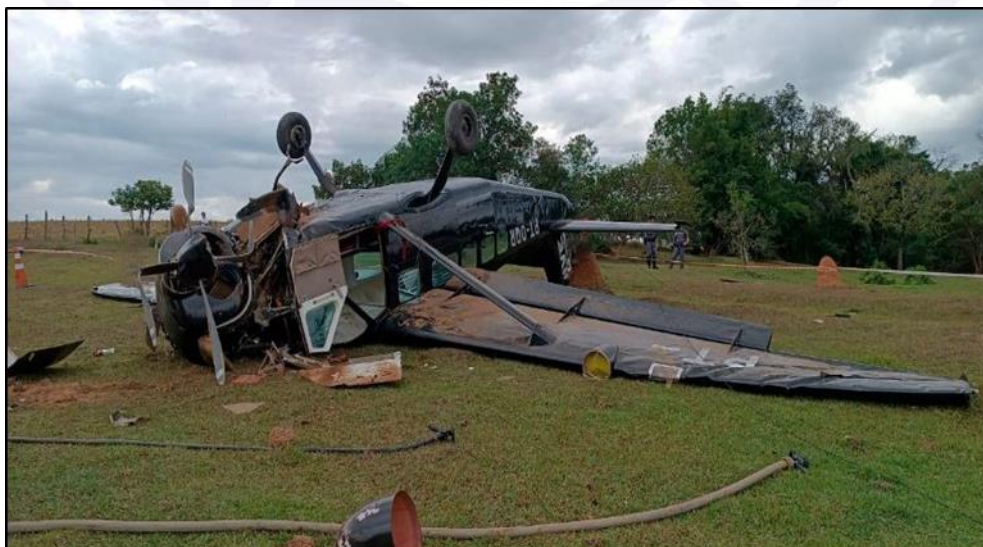
Figure 15 – Presence of clouds at the accident site shortly after the occurrence.

In addition, in the images captured shortly after the accident, horizontal visibility was consistent with the METARs issued for *Sorocaba* Aerodrome at 1400 UTC, 1500 UTC, and 1600 UTC, as well as the presence of vertical cloud formation and surrounding clouds at the accident site, indicating a ceiling above the minimums, as seen in Figures 15 and 16.

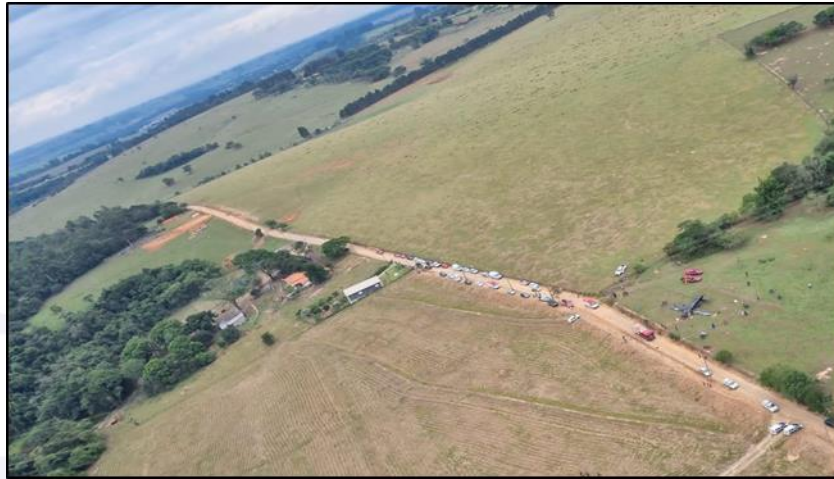
Figure 16 – Horizontal visibility at the site, shortly after the accident.

Accordingly, it was concluded that the meteorological conditions were above the minimums required for the operation under visual flight rules (VFR).

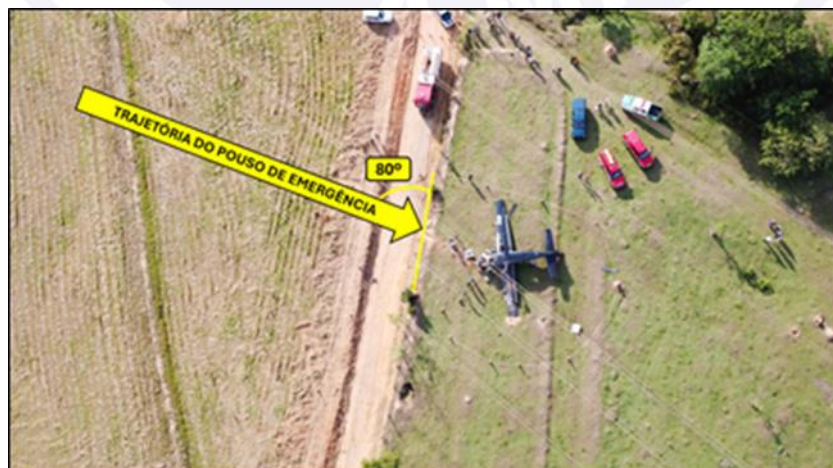
Figure 17 – Final trajectory of the aircraft.

The first tire contact with the ground during the emergency landing occurred in a nose-high attitude, with forward momentum, on uphill terrain. The final impact occurred against a slope, at an angle of approximately  $80^\circ$  relative to the direction of the dirt road, as shown in Figures 17 and 18.

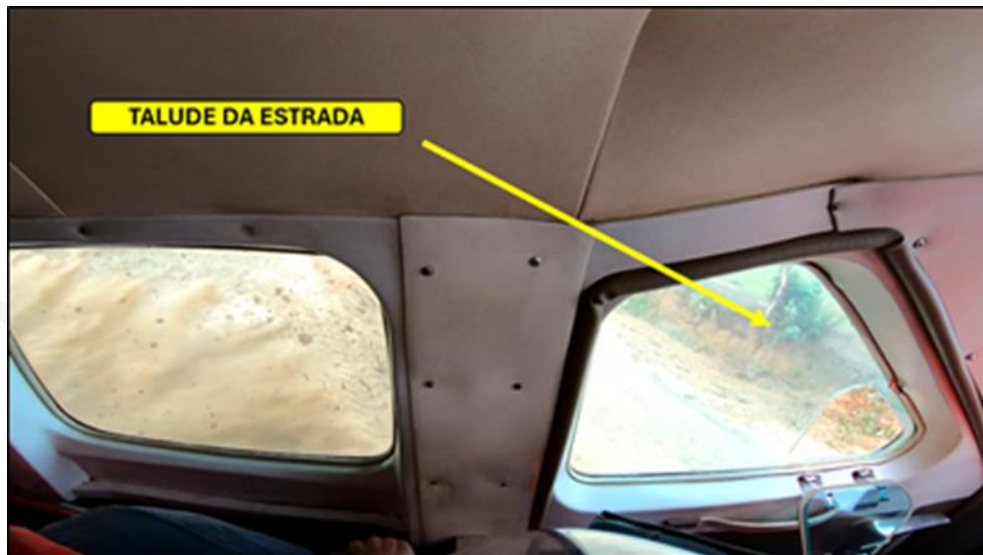
Figure 18 – View from the helmet camera of one of the parachutists, highlighting the slope struck in the final collision.

The nose landing gear separated at the final impact, and the left main landing gear struck the slope before the right main gear, generating a yawing moment to the left and causing the aircraft to overturn.

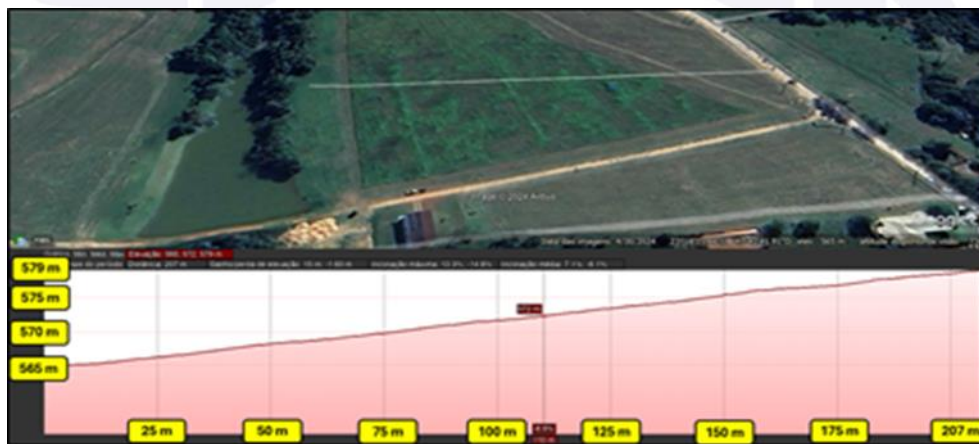
Figure 21 – Elevation profile view of the emergency landing site.

The terrain where the emergency landing took place had an approximate length of 200 meters, was uphill, and had an irregular surface, as shown in Figure 21.

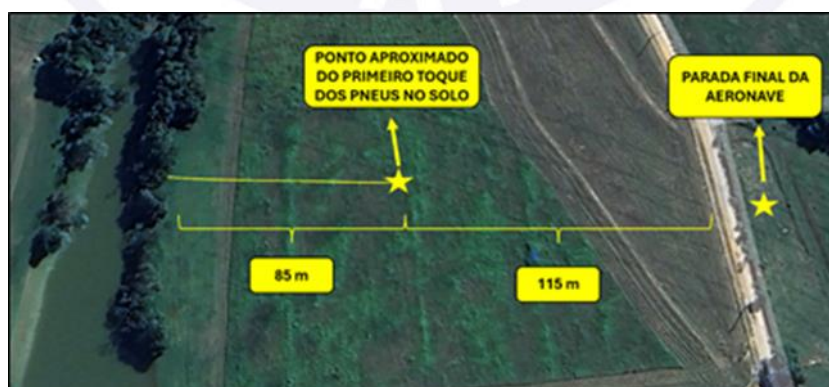
Figure 22 – Approximate distances traveled by the aircraft during landing.

After passing over a line of trees, the aircraft flew approximately 85 meters over the landing terrain, leaving 115 meters for deceleration after initial touchdown, as shown in Figure 22.

After the first tire contact with the ground, the aircraft floated and made three additional contacts on irregular terrain with several contour changes, heading toward the higher ground.

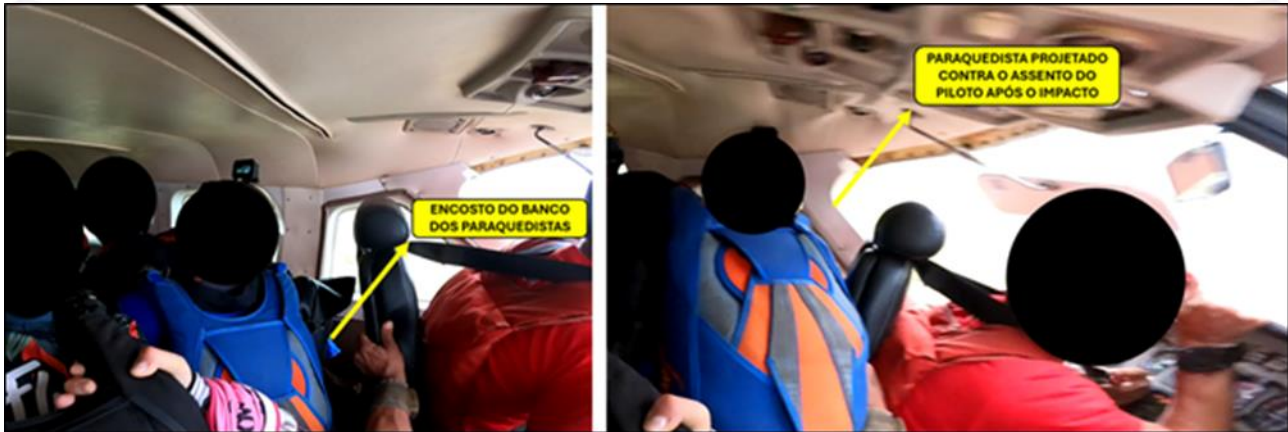
Figure 23 – First parachutist on the left bench of the aircraft (closest to the pilot) with back away from the seat backrest, pre-impact (left) and post-impact (right).

Regarding the parachutists' positioning at the time of impact, it was observed that the first parachutist seated on the left bench of the aircraft (closest to the pilot) had his back away from the seat backrest, as shown in Figure 23.

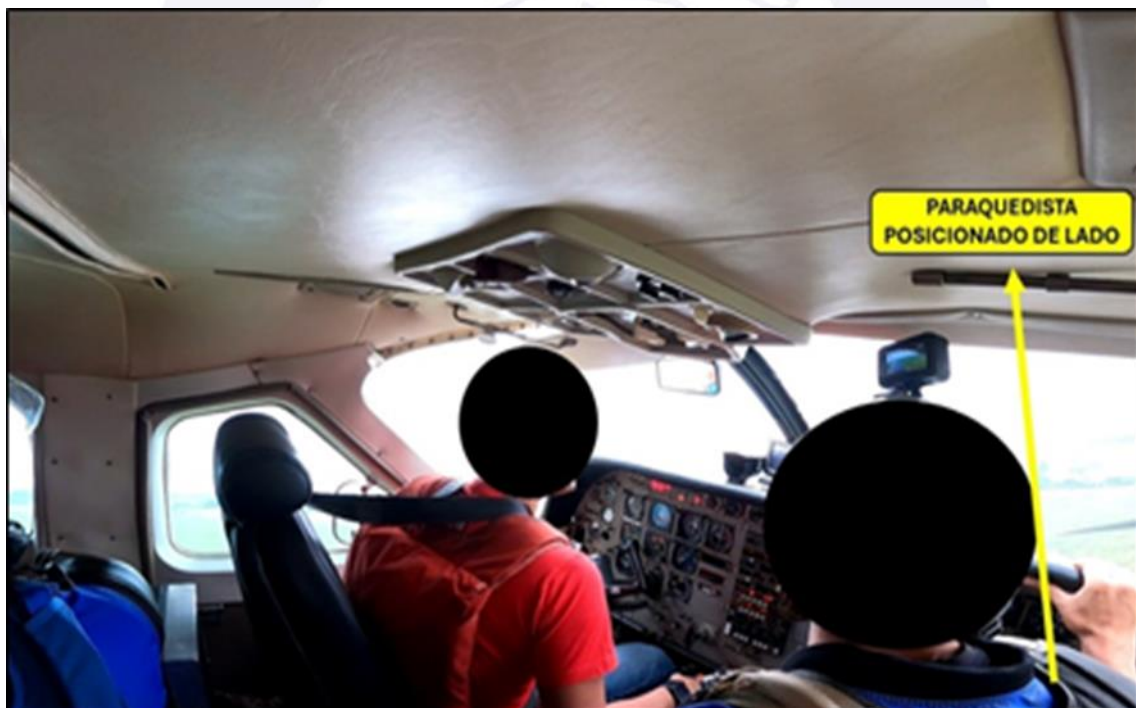
Figure 24 – First parachutist on the right bench (pilot's right side) seated sideways with his back away from the seat backrest.

The first parachutist on the right bench of the aircraft (to the pilot's right) also had his back away from the parachutist bench backrest and was sideways relative to the direction of aircraft movement at the moment of impact, as shown in Figure 24.

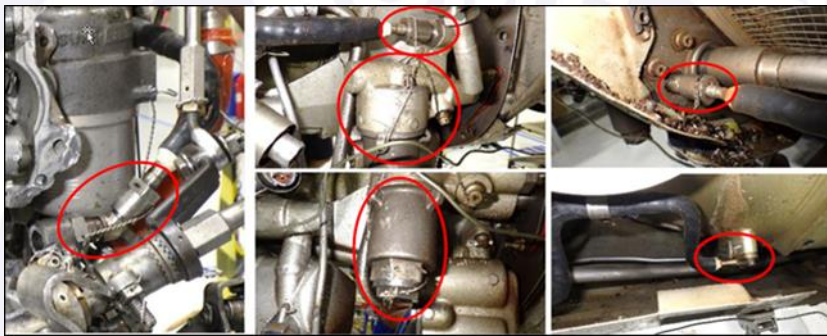
Figure 33 – P3 line properly installed and safety-wired.

The torque and safety wiring of the engine pneumatic line connections were verified, and it was found that they were properly torqued and safety-wired, as shown in Figures 33 and 34. In addition, the PY and P3 lines were tested, and no leaks were found along their lengths.

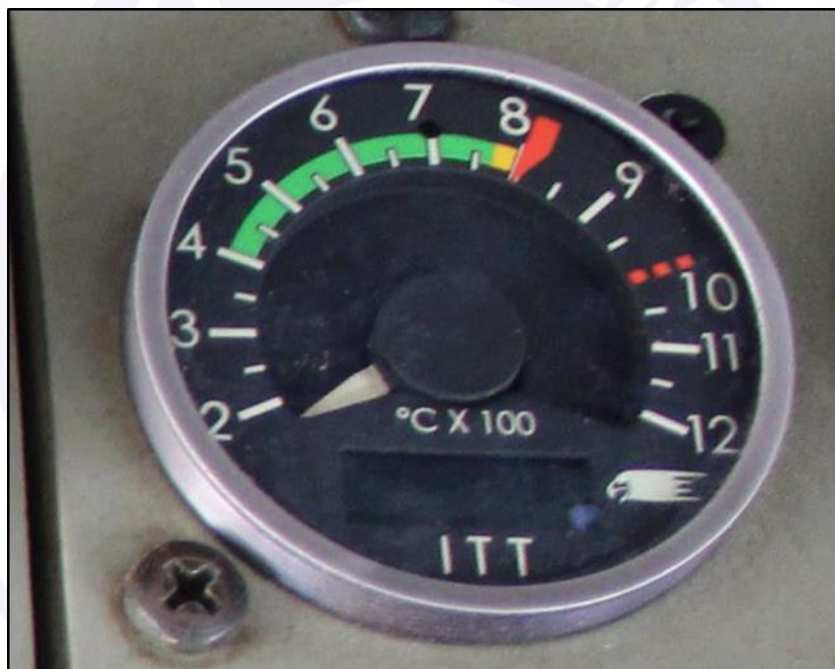
Figure 44 – Photo of the ITT indicator taken after the accident.

Footage from a helmet-mounted camera worn by one of the parachutists showed that the Interstage Turbine Temperature (ITT) indication was near the upper limit of the instrument's range, as shown in Figure 43.

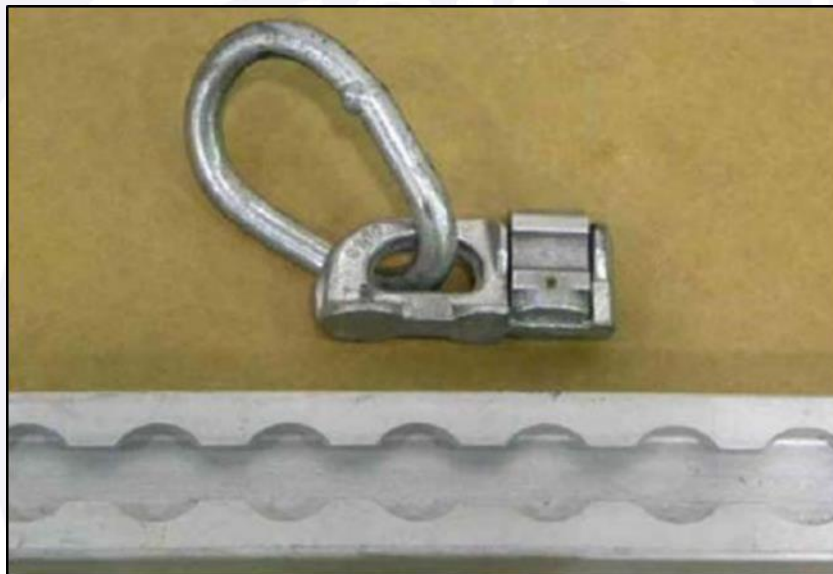
Figure 46 – Double-pin quick-release track fitting.  
Source: FAA Advisory Circular n° 105-2E.

This circular addressed, in its Appendix 3, seats and restraint systems, and presented information on quick-release track fittings, stating that single-pin types would detach from the track under dynamic loads lower than their nominal load rating. The document also clarified that quick-release fittings with double pins did not exhibit this behavior during dynamic testing. Therefore, double-pin quick-release track fittings, such as the one shown in Figure 46, would provide more reliable anchorage than single-pin fittings.
