FINAL REPORT IG-010/CENIPA/2022

OCCURRENCE: AIRCRAFT: MODEL: DATE: SERIOUS INCIDENT PT-OSO C90 19JAN2022

This present Final Report pertains to the serious incident involving the King Air C90 aircraft (registration marks PT-OSO). The incident occurred on 19 January 2022 and was classified as "[SCF-NP] System/component failure or malfunction".

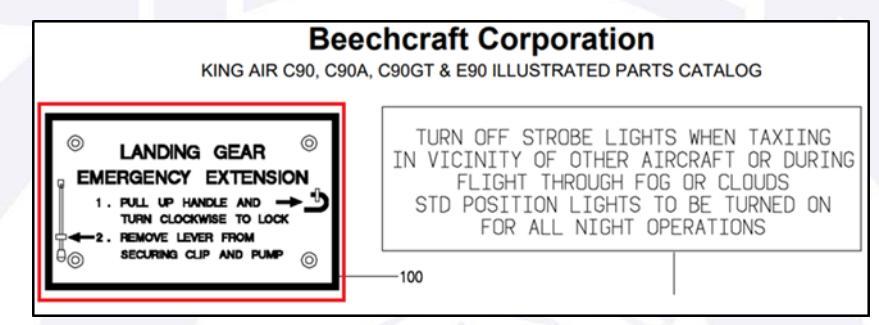
This placard was included in the *Illustrated Parts Catalog* of February 2019, in the *Interior Placards* Section, page 0A, item 100, as depicted in Figure 4.

Figure 4 - Item 100 of the Illustrated Parts Catalog (edited image).

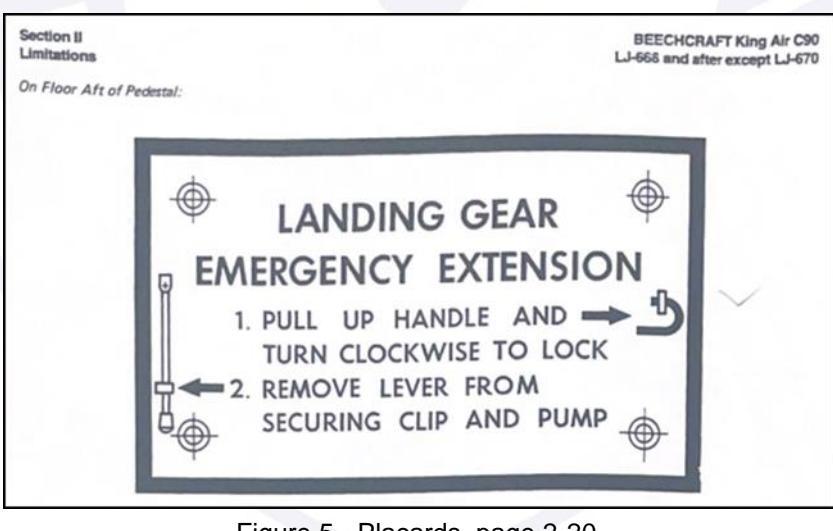
The placard was also listed as a mandatory item, as per the transcription, "On Floor Aft of Pedestal", on page 2-20 of the Aircraft Flight Manual (AFM), Section II, Placards, dated April 1980, illustrated in Figure 5.

Figure 5 - Placards, page 2-20. Source: AFM.

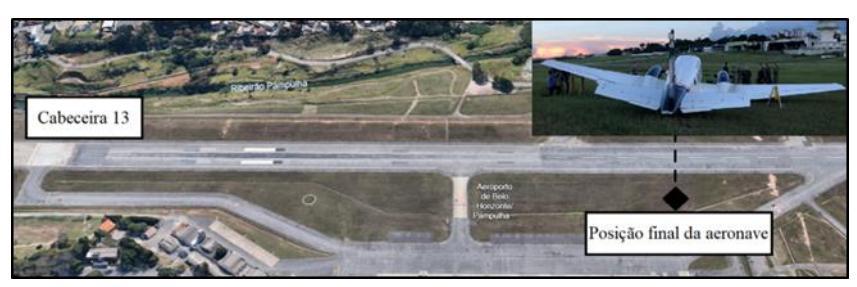
The aircraft veered off the runway centerline in a right turn and exceeded the lateral runway boundary. It came to a final stop near taxiway "C", as shown in Figure 9.

Figure 9 - Final position of the aircraft after stopping. Source: adapted from Google Earth.

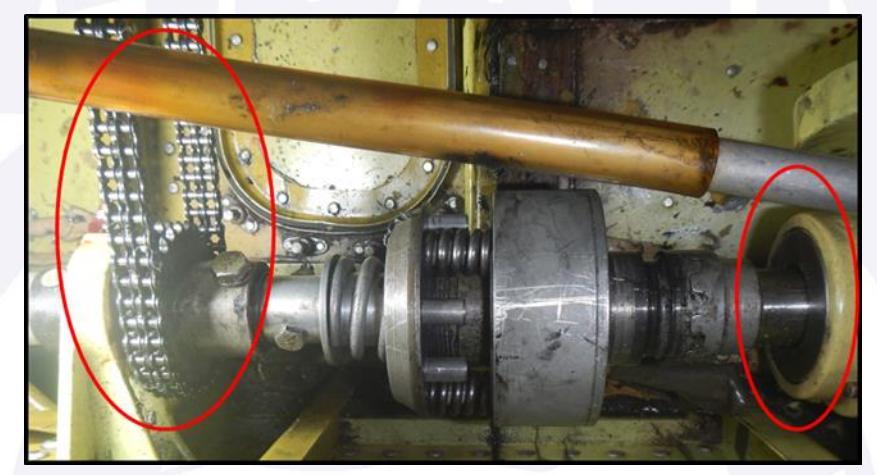
The landing gear emergency (manual) extension method involved disconnecting the electric motor from the shaft and manually operating a lever in the cockpit. When activated, this lever transmitted movement through a chain connected to the shaft, allowing the landing gear to be extended manually. In the image below, it is possible to observe, on the right, the position of the electric motor that moved the landing gear shaft (normal method) and, on the left, the chain that moved the shaft via the emergency method (Figure 11).

Figure 11 - Image of the landing gear drive shaft.

Regarding the manual (emergency) extension system, no faults were found that could explain its malfunction. The procedure was performed with the aircraft supported on stands, and the system operated normally.

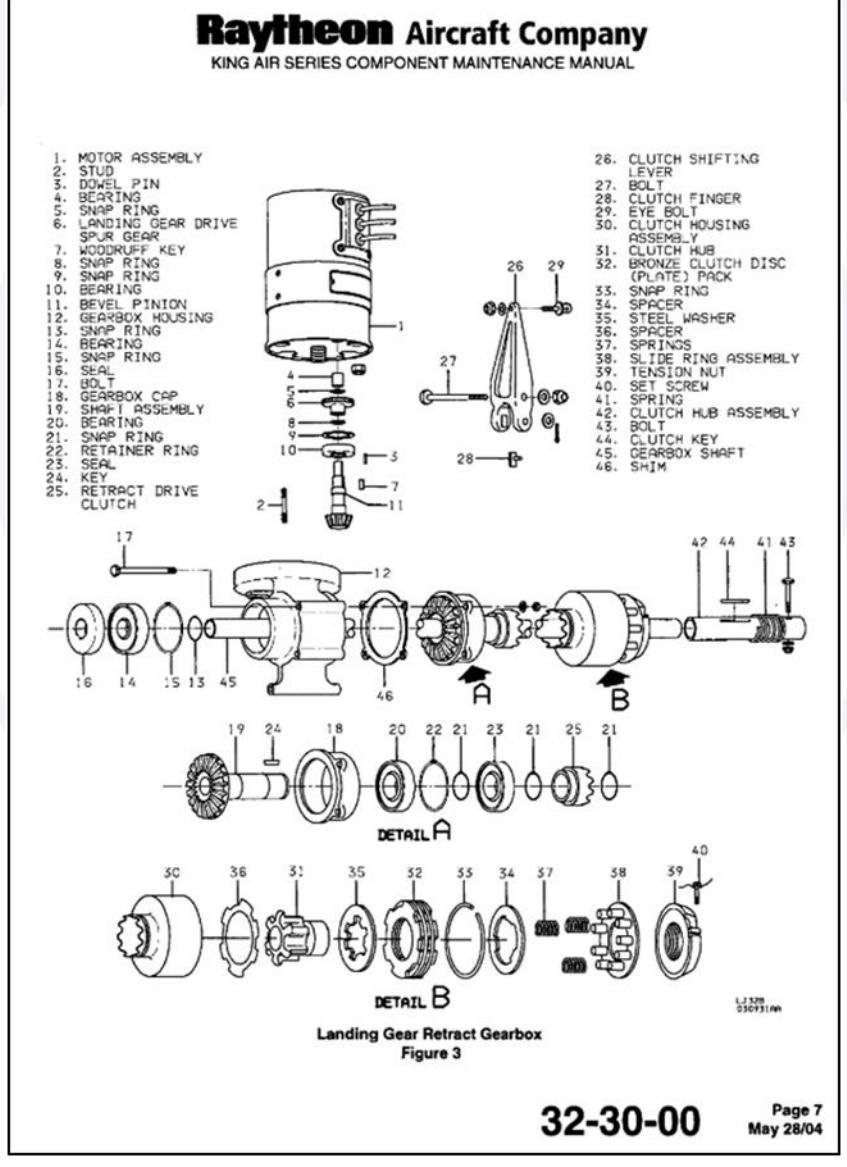
According to the *Component Maintenance Manual* of May 1984, revised in April 2018, Chapter 32 - *Landing Gear*, page 7, this screw was listed as item 40 (*Set Screw*) and was positioned to secure the *Tension Nut* to the rest of the assembly (Figure 13).

Figure 13 – Landing Gear Actuation Shaft components.

During the bench test, it was observed that within this assembly, only the Tension Nut moved, meaning the Clutch Housing remained stationary, as the set screw did not secure the Tension Nut. Consequently, this item was unable to transmit the electric motor's movement to the landing gear shaft.
