COMANDO DA AERONÁUTICA
CENTRO DE INVESTIGAÇÃO E PREVENÇÃO DE
ACIDENTES AERONÁUTICOS

FINAL REPORT
A - 116/CENIPA/2020

OCCURRENCE:	ACCIDENT
AIRCRAFT:	PT-POH
MODEL:	SZD-48-3
DATE:	20SEPT2020

This is the Final Report of the 20SEPT2020 accident with the SZD-48-3 aircraft model, registration PT-POH. The accident was classified as “[SCF-NP] System/Component Failure or Malfunction Non-Powerplant and [LOC-I] – Loss of Control in Flight”.

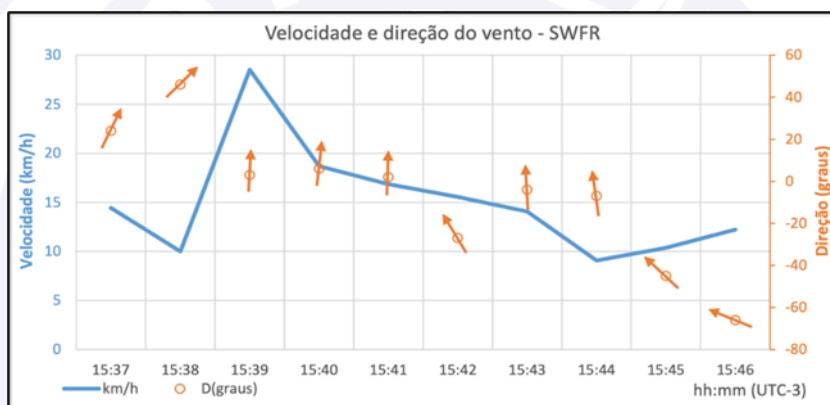
The data from the meteorological station at the Aerodrome indicated moderate wind speed, without significant variations in direction, especially in the period between 15h43min (local) and 15h45min (local).

Figure 2 - Wind graph. The blue line corresponds to the speed in km/h and the orange data shows the direction variation.

In Figure 2, the orange circles/arrows (degrees - true North) were plotted from 15h:37min to 15h46min (local), on 20SEPT2020. Data extracted from the SWFR Aerodrome meteorological station. The arrows are the graphical representation of the information displayed on the secondary axis.

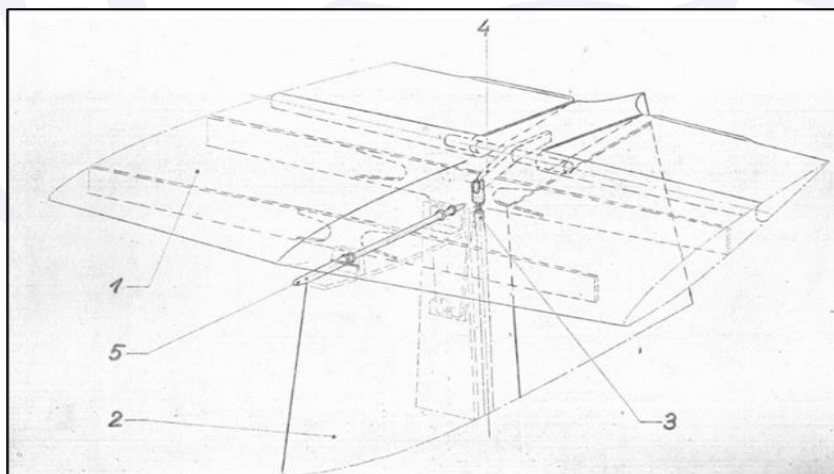
Figure 14 shows the schematic representation of the fitting system of the horizontal stabilizer in the vertical stabilizer.

Figure 14 - Schematic representation of the horizontal stabilizer fitting system in the vertical stabilizer.

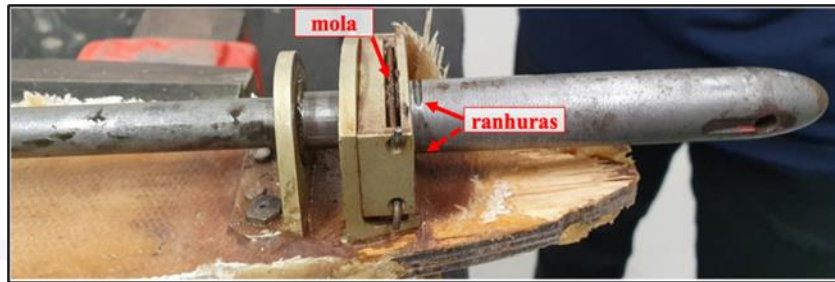
Figure 18 - Fitting the bolt in the vertical stabilizer structure.

During the analysis, it was observed that the conical part of the pin was close to the hole, in such a way that an inappropriate placement, such as not locking it in the slot region, could lead to its displacement and, thus, to the loss of its function. This displacement could still be facilitated by the final conical shape of the pin.
